Behavior of structure type 82/2 (RC frame), during the earthquake of 26 November 2019 in Durrës, Albania

Anjeza Gjini, Hektor Cullufi, Enio Deneko, Princ Xhika

Research Article

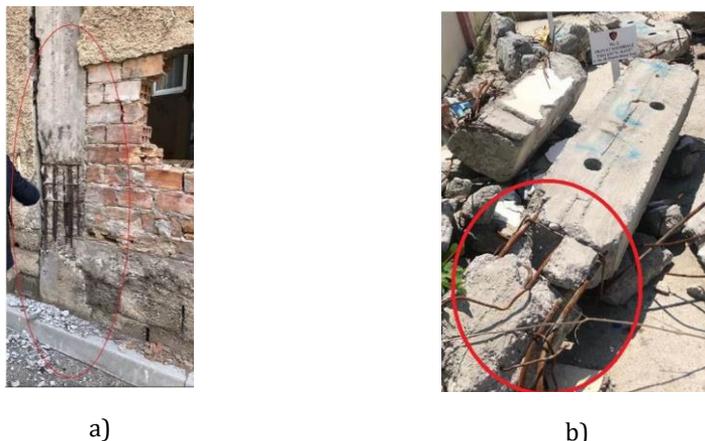
For a reliable structural design of these structures, the proprieties of materials noted in the design papers are considered. From the field inspection (from authors) it was found that in one of the buildings defined for demolition, the concrete of the columns on the ground floor was spalled even with the lightest touch due to the use of sea sand and gravel with large fractions (Figure 12a). This phenomenon has also been influenced by the use of smooth rebar, which reduces the adhesion to concrete (Figure 12b). [15]

Fig. 12 a) Spalling of concrete with hammer (photo by author), b) Smooth rebar for columns reinforcement (photo by author)

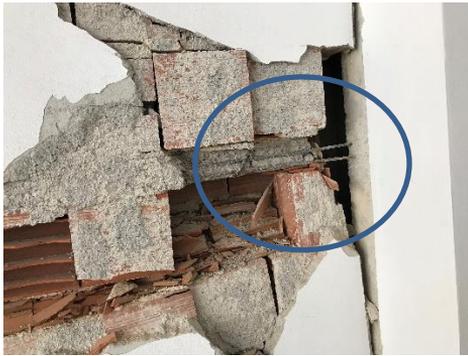
a) Out of plane wall failure (belt beams for infill walls are unlinked with RC columns)

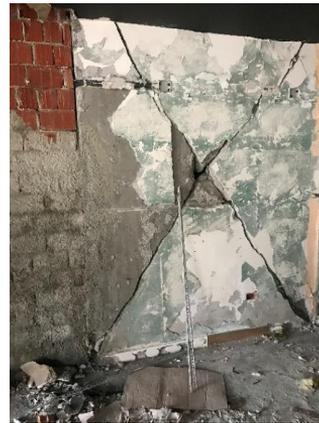
b) Failure of core type shear wall

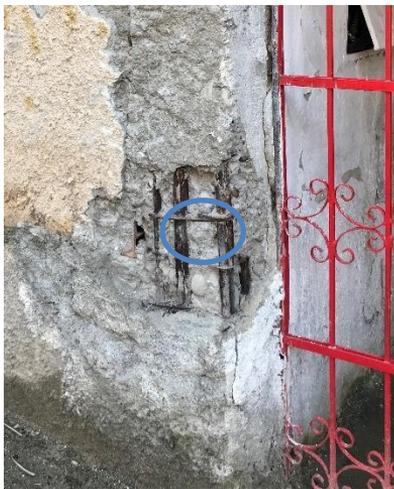
c, d) Longitudinal reinforcement not fastened by stirrup

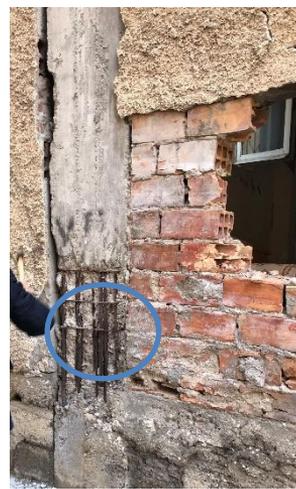
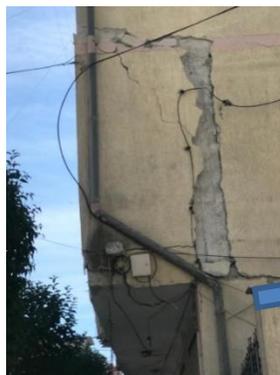
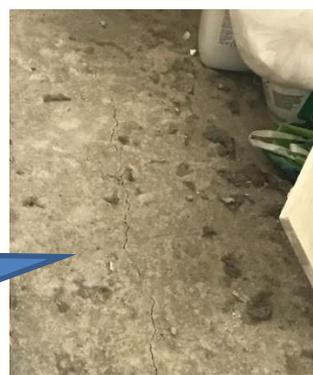
e, f) Deflection of the cantiliver beams (cracks in the slabs)

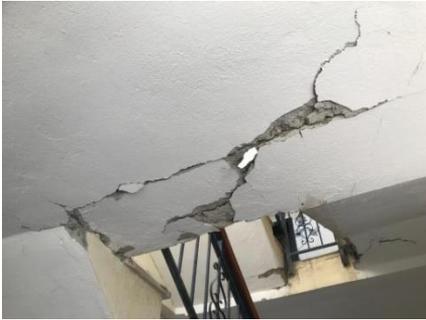
g) Cracks in the stair beam

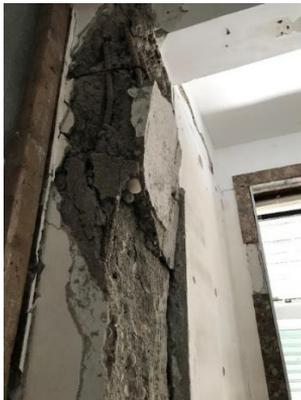
i) Plastic hinge in the upper part of column

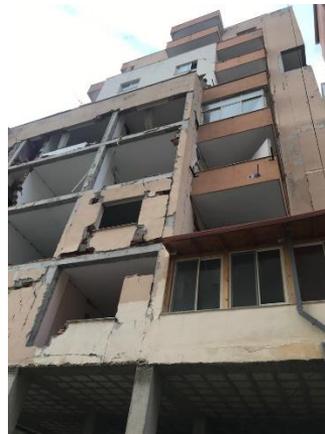
j) Out-of-plane wall failure

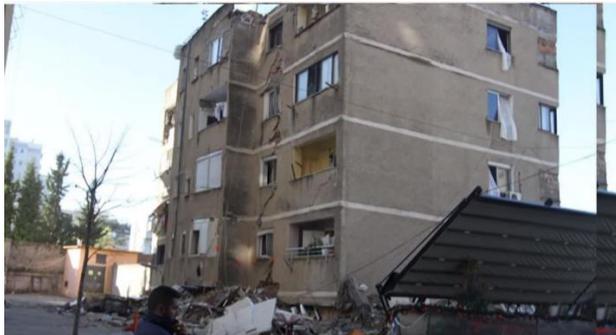
For investigation purposes, concrete and steel samples were taken and laboratory tests were performed. From the tests performed in one of the building type 82/2 (for the object shown in Figure 21) it results that the compressive strength of concrete samples is less than 50% of design requirements, and out of the requirements of KTP (Albanian design code), as shown in figure 10. Whereas, the properties of the steel, from the laboratory tests, turn out to be acceptable according to the design definition and the technical conditions (Figure 11).

Fig. 21 Collapse of the first floor in 5 storey building type 82/2
