Performance of URM structures under earthquake shakings: Validation using a template building structure by the 2019 Albanian earthquakes

Altin Bidaj, Huseyin Bilgin, Marjo Hysenlliu, Irakli Premti, Rrapo Ormeni

Research Article

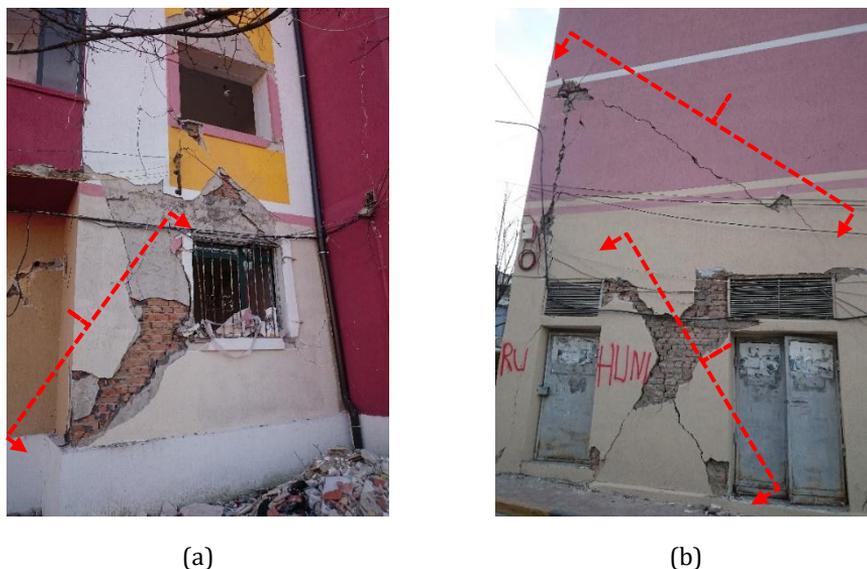
Fig 10. Heavy shear cracks on load bearing walls of the two multi-story masonry buildings

As shown in Figure 10, the load bearing walls were affected by serious cracks at both the raised-up ground and first floors. Most of the damaged buildings presented shear cracks which are diagonal developed along the entire thickness of the walls in both spandrels and piers (Fig 11a-12). Flexural cracks were also observed in several buildings. Moreover, out-of-plane mechanisms were very common both in URM and RC buildings resulting in partial or total collapse of masonry walls (Fig 11b). One of the commonly encountered highlights after the November 26, 2019 earthquake was the out-of-plane collapse of masonry walls (Fig 11b). In some cases, masonry walls collapsed without any vertical load other than their own weight. The most important reason for the out-of-plane collapse of URM walls was the lack of sufficient fastening of the wall with the diaphragm.

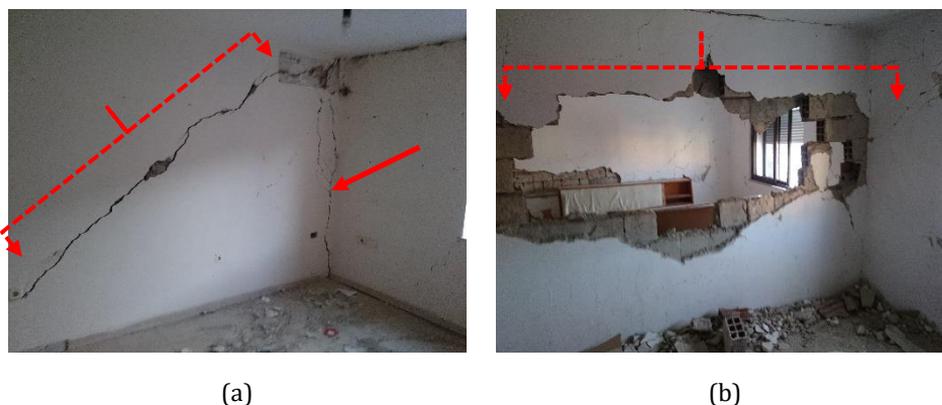
Fig. 11 (a) Extensive shear crack on load bearing wall and separation of two orthogonal masonry walls, (b) Heavily damaged partition wall in an URM building

Diagonal shear cracks were observed in several URM walls of residential buildings. Many masonry constructions had diagonal cracks in the infill panels and in the URM piers between the door/window openings (Figure 12). On-site examination of the mortar used on the part of the destroyed URM building has been carried out and the mortar can be easily crushed with naked fingers, indicating that the mortar has relatively low strength [22].

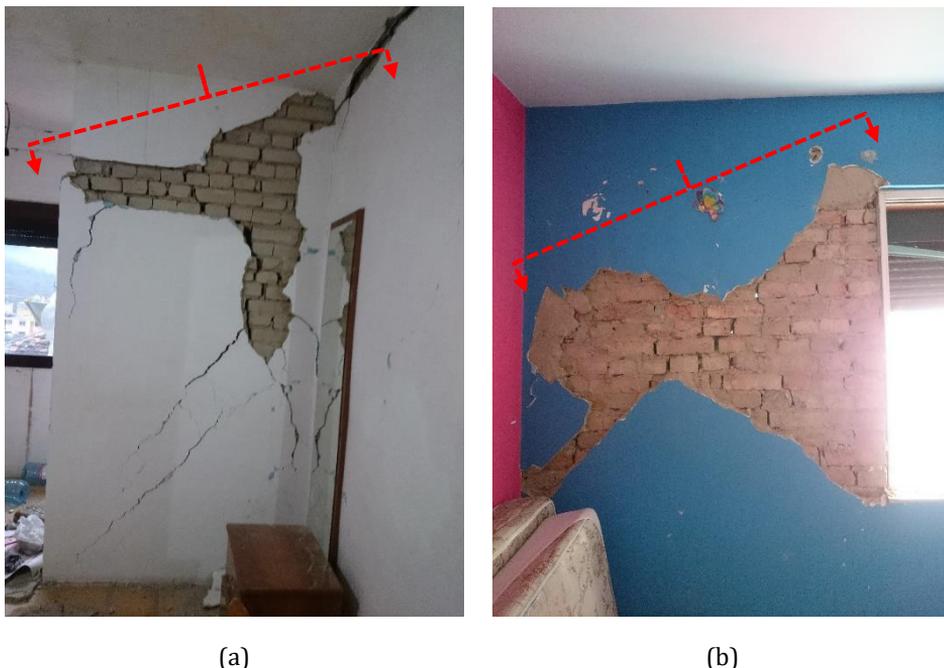
Figure 12 shows a typical diagonal "stair step" cracking of a solid brick wall; this is a sign that the wall has not been able to withstand shear stress from in-plane forces.

Fig. 12 (a) Heavily damaged load bearing wall (built by silicate bricks) and separation of wall and slab edges, (b) Heavily damaged load bearing wall in an URM building built by red clay bricks

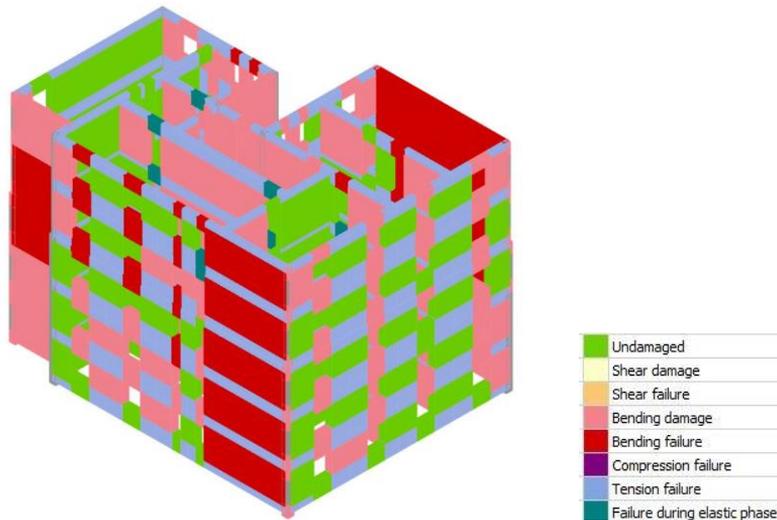
In Figure 20, the damage state of the building from the last step of the pushover analysis is depicted. Bending damage and tension failure are dominant while a couple of walls and spandrels are damaged in shear.

Fig. 20 Damage at maximum deformation capacity in 3D

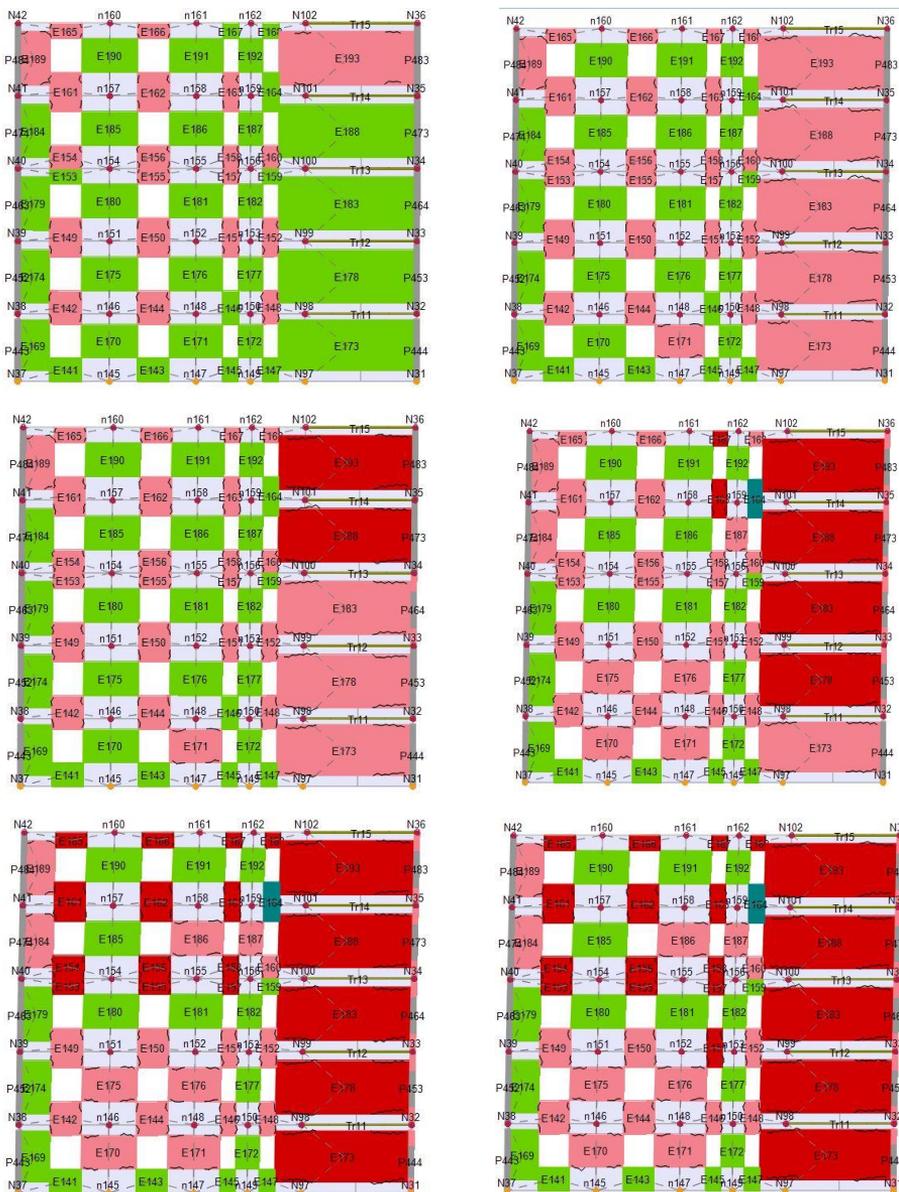
Detailed damage distribution along the height of the walls of the studied building is shown in Figure 21. Building reached failure when perimeter walls reach their load bearing

capacity in both orthogonal directions. Failure is reached when all the right part of the perimeter wall fails in bending and also in the wall in the back part on upper levels.

Fig. 21 Distribution of damage and the failure mechanism of perimeter walls from pushover analysis

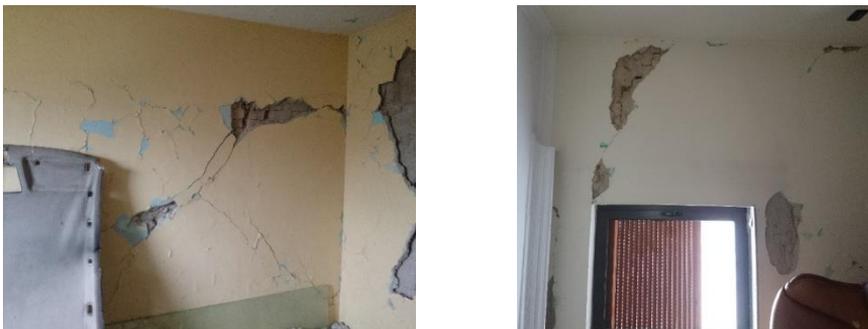
Fig. 23 Typical damage patterns observed at several locations of the studied template design

As seen from the photos, the material quality especially the mortar is very weak and could not prevent the segregation of the bricks in several parts. Damage was concentrated on the 1st, 2nd and 3rd floors. Level of the damage on load bearing walls was severe whereas the partition walls were heavily damaged. Typical damage patterns like bending and shear cracks, spalling of mortar, separation of the load bearing wall segments especially over or under the openings are observed all over the first three floors and are shown in the Figs 23-25.

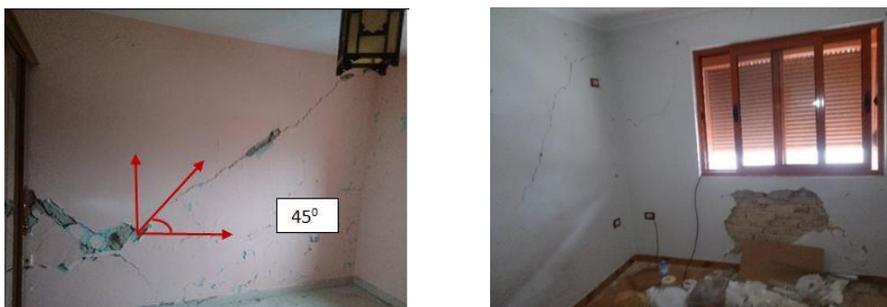
Fig. 24 Diagonal cracks extending over the height of the wall (left), spandrel damage patterns below the openings

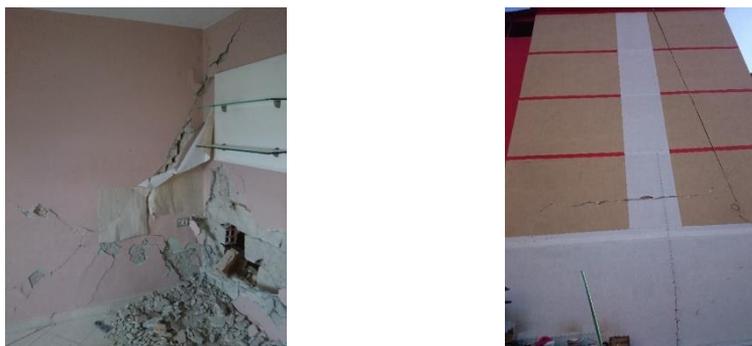
Fig. 25 Heavy cracks (more than 3 cm separation) on load bearing walls and extensive damage on non- load bearing wall (left), serious damage observed on outer facade of the building in lower stories (right)

On the upper floors, it was observed that the doors are not closed properly due to the possible drift concentrations on load bearing elements. According to the inspections and damage surveys done on the buildings, the buildings have serious deficiencies which do not meet the conditions stipulated in Eurocode 8. Especially, on the first 3 floors, severe

damage patterns were observed on load bearing walls and very heavy damage was observed on partition walls. Material quality is extremely weak and caused degradation by time.
