Experimental research of quality of the adhesive repairs of composite structures using non-destructive testing

Kirill Ibrishev, Ekaterina Prilipko, Maksim Soldatkin, Nikolay Kononov

Ibrishev K, Prilipko E, Soldatkin M, Kononov N. Experimental research of quality of the adhesive repairs of composite structures using non-destructive testing. *Res. Eng. Struct. Mater.*, 2025; 11(3): 1051-1065.

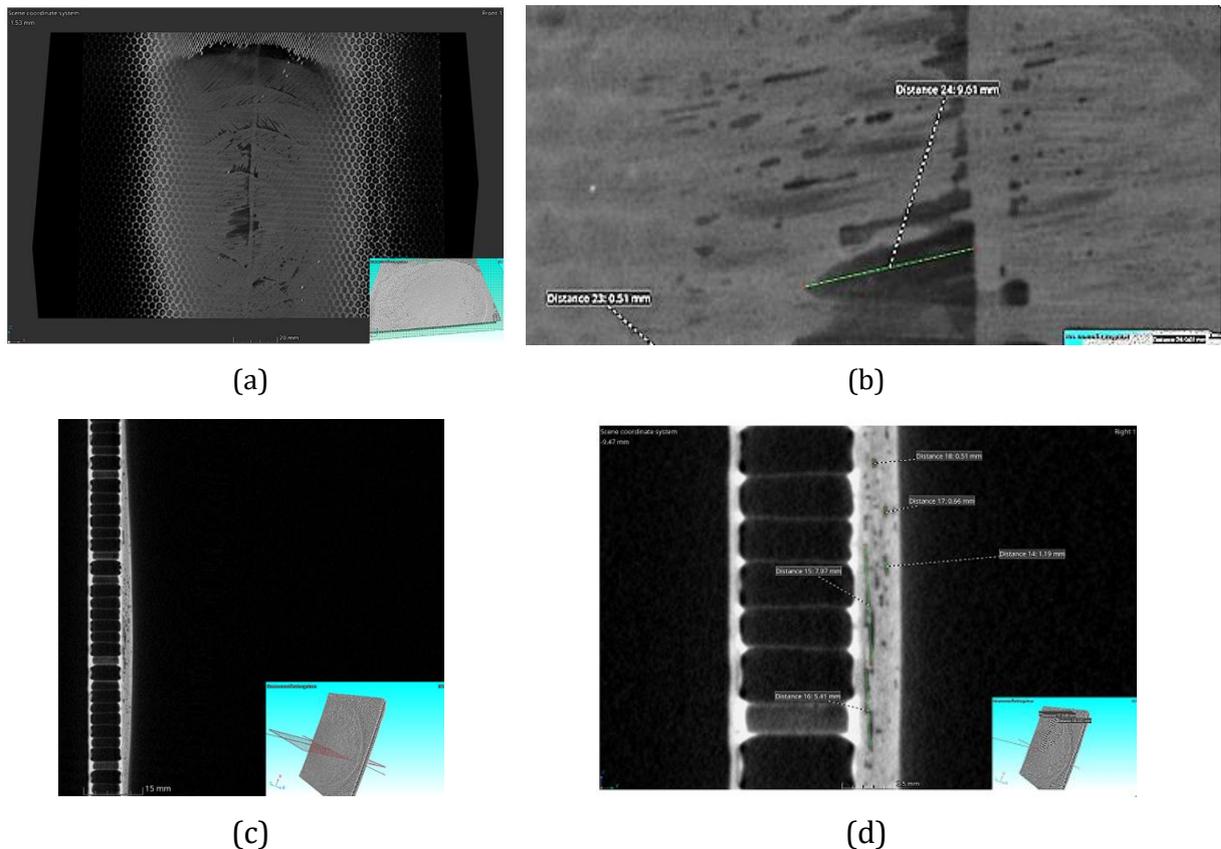
Fig. 8. Results of tomography of repair zone 1, performed by vacuum method (a) General view of the repair patch section; (b) Local repair patch section zone; (c) Side section of the repair patch; (d) Local zone of the side section of the repair patch

From the results of tomography, we can conclude that there are image defects in the form of a ring on 3D models of repair patches, associated with the capture of the axis of rotation of samples when collecting projections. These defects do not affect the research results and are merely superficial display problems. When analysing the results of tomography on the side section of the repair patch, voids related to non-adhesions up to 2.9 mm in size were found. On the sections of the repair patch, numerous defects in the form of metallic inclusions and non-adhesions were also found.

- Zone 1: In the repair zone 1, performed by vacuum method, non-adhesions between the layers of the patch and voids formed during the curing of the resin were found. These types of defects were detected by all NDT methods used in the research. One of the factors for the formation of non-adhesions is the experience and qualification of the staff performing the repair activities, which directly affects the quality of the technological process.
- Zone 2: In repair zone 2, performed by vacuum method with excess pressure, minor non-adhesions and voids were found in the repair patch area. The linear dimensions of the non-adhesions are 2-3 mm, so it was not possible to assess defects with such geometric dimensions using the express method of NDT (shearography). The quality of the repair

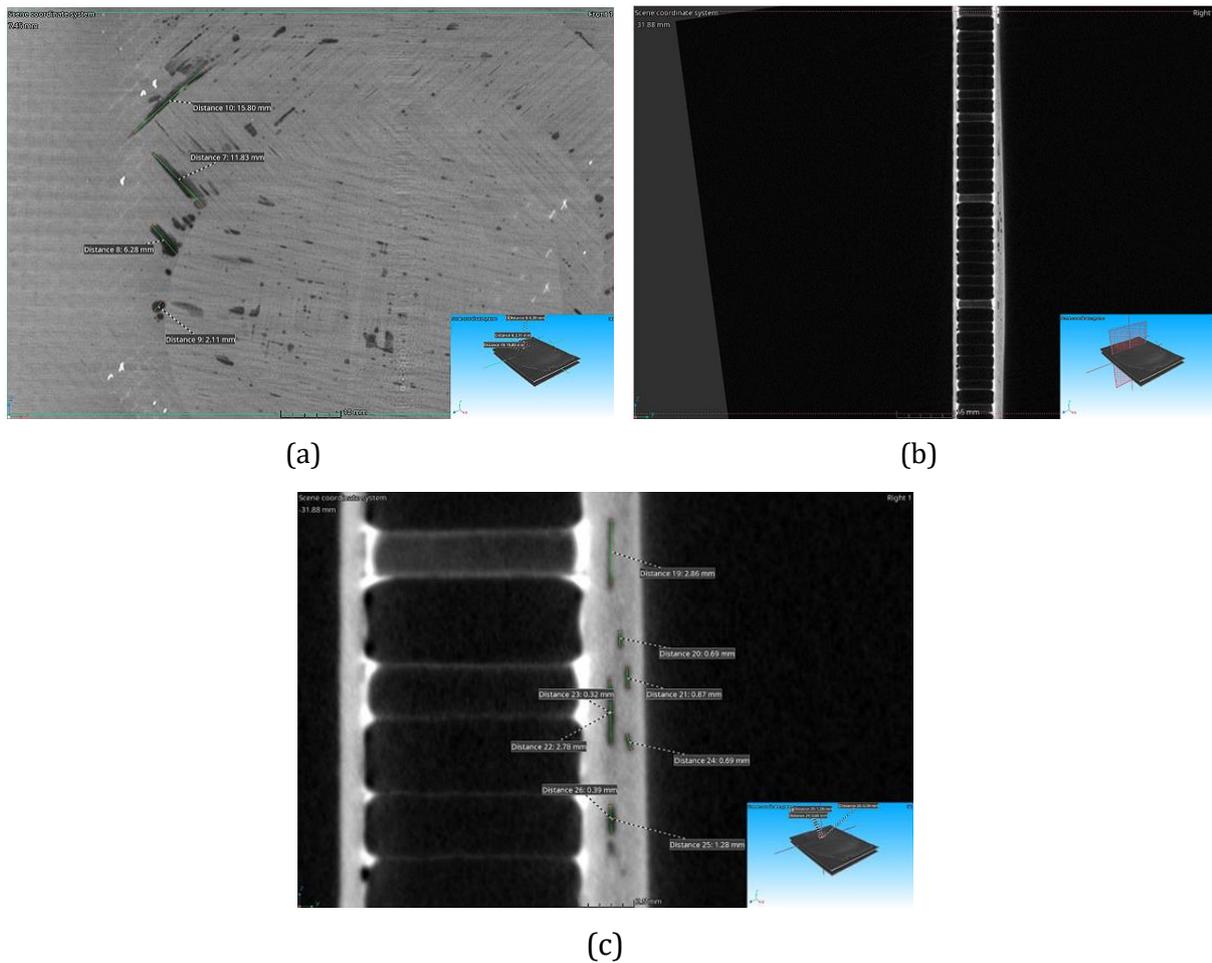
The general view of zone 2, executed by a vacuum method with excess pressure, and a 3D isometric view of the model, are presented in figure 9. When examining the projections of the repair patch, areas of non-adhesion, measuring 25 mm x 35 mm, and metallic inclusions were found, as shown in figure 10.

Fig. 10. Results of tomography of the patch of zone 2, performed by vacuum method with excess pressure (a) - Cross-section of the repair patch of zone 2; (b) - General view of the side section of the repair patch of zone 2; (c) - General view of the side section of the repair patch of zone 2

performed in zone 2 can be assessed as satisfactory, with the smallest number of defects detected by the detailed method of NDT (Tomography).

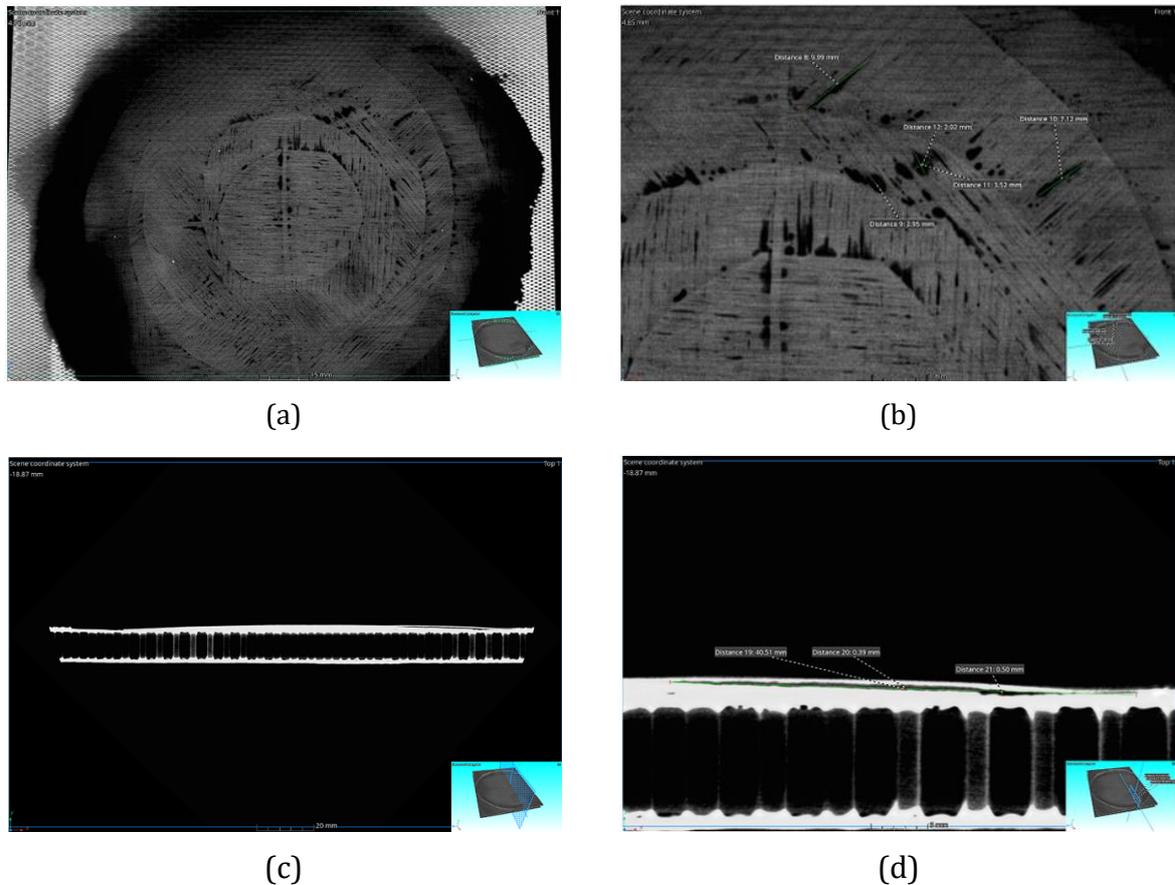
The general view of zone 3 with a repair performed by a vacuum method with an exceeding curing temperature and a 3D isometric view of the model are presented in figure 11. When studying the sections of the repair patch, numerous voids of sizes from 2 to 10 mm were also found, as shown in figure 12.

Fig. 12. Results of tomography of the patch of zone 3, performed by vacuum method with exceeding curing temperature (a) - Cross-section of the repair patch of zone 3; (b) - Local area of the cross-section of the repair patch; (c) - General view of the side section of the repair patch of zone 3; (d) - Local area of the side section of the repair patch with extensive delamination

The side section of the patch was also studied for defects. In the XY plane, in the transition area of repair patch - honeycomb filler, extensive delamination was found with a linear size of 40 mm. Based on the results of tomography, the following conclusions can be made:

- Zone 3: In repair zone 3, performed by vacuum method exceeding the curing temperature, numerous local non-adhesions in the patch area were found, including extensive delamination between the repair layers with linear dimensions of 40x40 mm. The largest defect, due to the detection of which this repair patch can be classified as defective, was determined by all NDT methods used. Smaller linear defects - only by tomography, confirming the need to use the most detailed and lengthy method of analysing the structure of repaired samples at the stage of working out repairs according to various technologies.

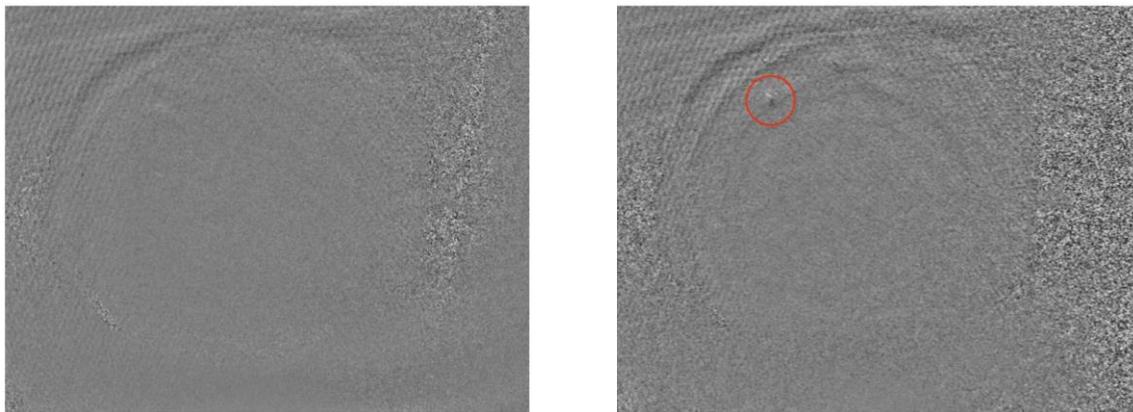
Analysis of shearography results of a patch obtained using a vacuum method revealed characteristic features of the material structure. On the images obtained, shown in figure 13, there is pronounced layering and inhomogeneity, presumably due to the specifics of the technological process of composite material production. Defects found on shearograms indicate possible defects or uneven distribution of components within the material.

Fig. 13. Shearograms of the patch performed by vacuum method

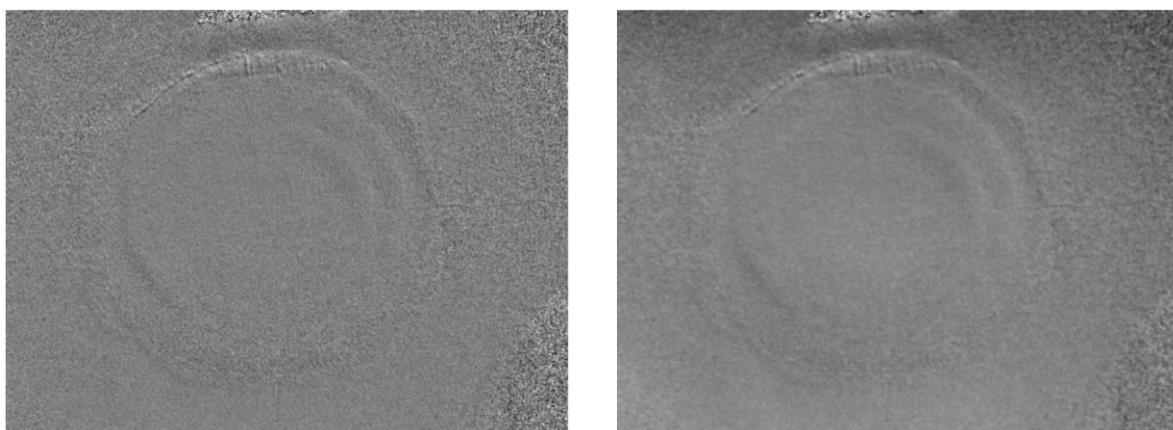
The results of the analysis of the patch obtained by vacuum method with excess pressure demonstrated that the structure can be clearly seen on the shearograms without identified inhomogeneities and defects, as shown in figure 14. This observation testifies to the high level of quality of the patch manufacture and its homogeneity. The absence of inhomogeneities indicates that the vacuum process with excess pressure was performed in accordance with the technological requirements, which contributes to obtaining a material with a homogeneous structure.

Fig. 14. Shearograms of the patch performed by excess pressure

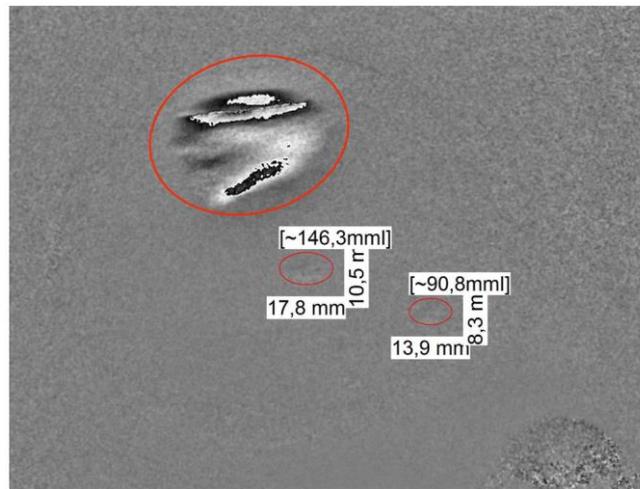
Fig. 15 – Shearograms of the patch obtained using vacuum and exceeding curing temperature

The detected inhomogeneity in the material structure, confirmed by shearographic analysis, may have a negative impact on the mechanical properties and durability of the patch.
