Observed failure modes in existing URM buildings after November 26, 2019 earthquake in Albania

Enio Deneko, Hüseyin Bilgin

Deneko E, Bilgin H. Observed failure modes in existing URM buildings after November 26, 2019 earthquake in Albania. *Res. Eng. Struct. Mater.*, 2024; 10(3): 1085-1107.

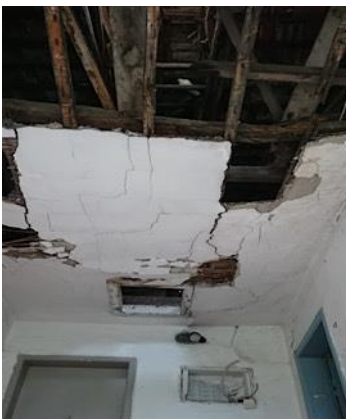
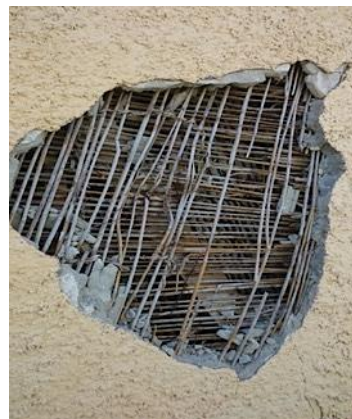
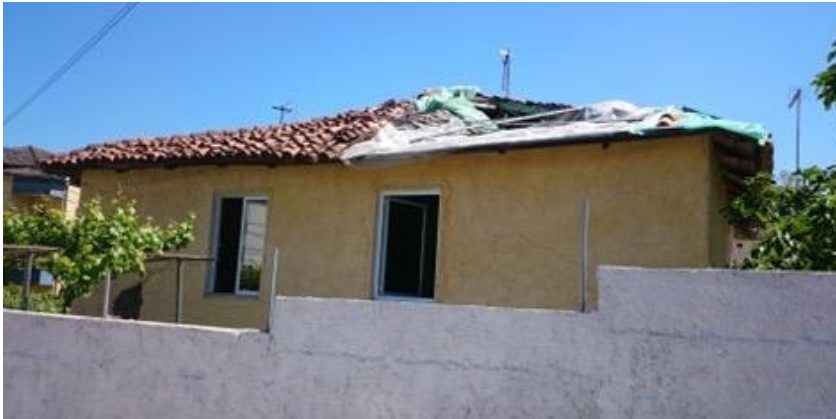
Fig. 6. Collapse of masonry buildings

This category of destruction occurs once the structural integrity of a building is compromised by the impact of out-of-plane mechanisms. In rural areas of Albania, especially in the countryside, dwellings frequently feature roofing systems constructed from locally sourced materials. Many of these masonry buildings employ timber logs for their roofing and flooring systems. Over time, these structures, which are typically old and have been exposed to various environmental conditions, experience a decline in the strength of their walls.

The collapse of these buildings can be attributed to several factors, one of which is the weight of the heavy earthen roofs. To keep the structure away from rain and snow, additional layers of soil are frequently added to the roof. Consequently, the thickness and mass of the earthen roofs gradually increase, resulting in a higher load borne by the building during an earthquake.

The structural walls and timber logs are unable to withstand this heightened horizontal load, causing the walls to shift out-of-plane and leading to a complete collapse. Fig. 6 visually illustrates the observed damage of this particular type across different regions. To reduce the risk of total collapse, it is crucial to refrain from using adobe buildings and earthen roofs. Instead, consider implementing lighter roofing systems that incorporate horizontal and vertical bond beams during construction. This approach helps distribute the loads more effectively and enhances the building's seismic resilience.

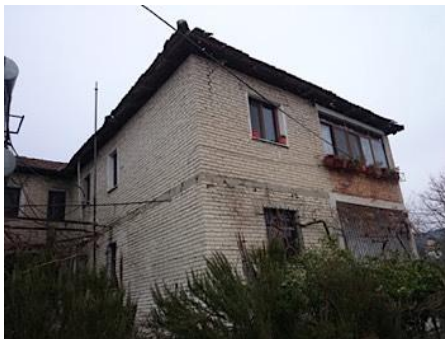
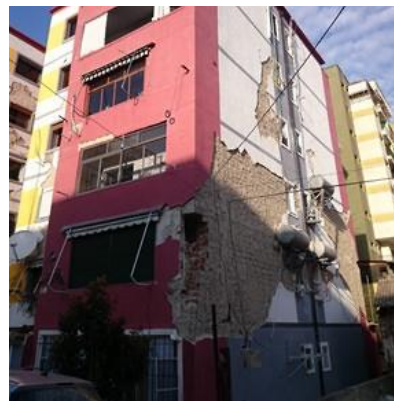
Fig. 7. Observed corner damages

One common consequence of inadequate connections between structural walls is the occurrence of corner damages. These damages commonly occur at connections between walls, primarily due to the lack of strong links between them. Problems such as the utilization of low-quality materials, inferior workmanship, and insufficient provision of bond beams have contributed to the failure of adobe and stone masonry residences. Damage on corners was a prevalent issue observed in buildings within the earthquake affected areas.

In numerous cases, inadequate wooden beams and improper ties were noted at the junctions of the affected buildings. The structural failures were significantly influenced by the weak bonds between the walls, compounded by the lack of horizontal or vertical bonding ties. Fig. 7 depicts a visual representation of the corner damage observed in masonry dwellings during the earthquake in Albania.

To mitigate corner failures, it is recommended to avoid the use of adobe or stone rubble in the construction of structural walls. Instead, hewn stone or brick materials should be employed, accompanied by the incorporation of reinforced concrete (RC) bond beams in both orthogonal directions. Adhering to modern seismic guidelines, it is crucial to maintain uniform thickness for these beams and walls, especially at the structure's edges. Fig. 8 illustrates the application of bond beams in masonry constructions as a preventive measure against corner damages.

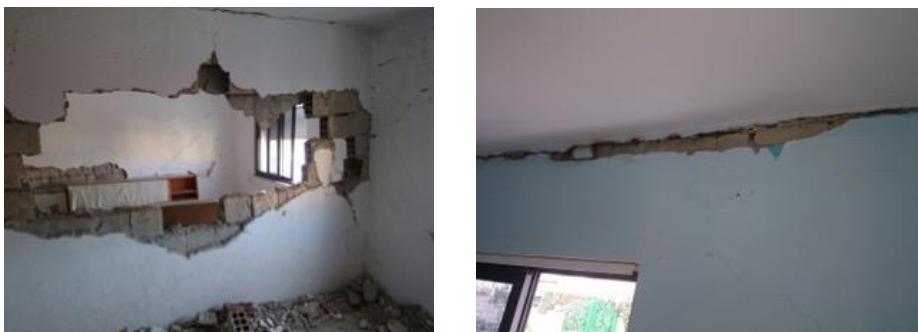
Fig. 10. Observed out-of-plane collapses of walls

A significant contributor to out-of-plane mechanisms is the positioning of timber logs that bear the load of the building's floors in a single direction. This arrangement results in the transfer of earthquake loads from perpendicular walls to the timber logs, making walls without support from these logs susceptible to out-of-plane overturning. Fig. 9 schematically outlines various out-of-plane mechanisms, while Fig. 10 illustrates observed out-of-plane mechanisms in unreinforced masonry (URM) buildings across different villages following the November 26, 2019, earthquake in Albania.

To mitigate the occurrence of this out-of-plane mechanism, several measures can be taken. Firstly, it is crucial to limit the unsupported length of a load-bearing wall. Additionally, incorporate reinforced concrete horizontal and vertical bond beams into the construction, as illustrated in Fig. 11. Moreover, it is vital to ensure the presence of bearing walls in both the x- and y-directions, as recommended in reference [23].

Specifically, vertical bonding girders should be positioned at the edges of the building, extending the full height of the storey. Moreover, these vertical beams should be spaced along the wall at intervals of approximately 4 meters [23, 30-31]. It's advisable to avoid the use of tall and lengthy unsupported walls.

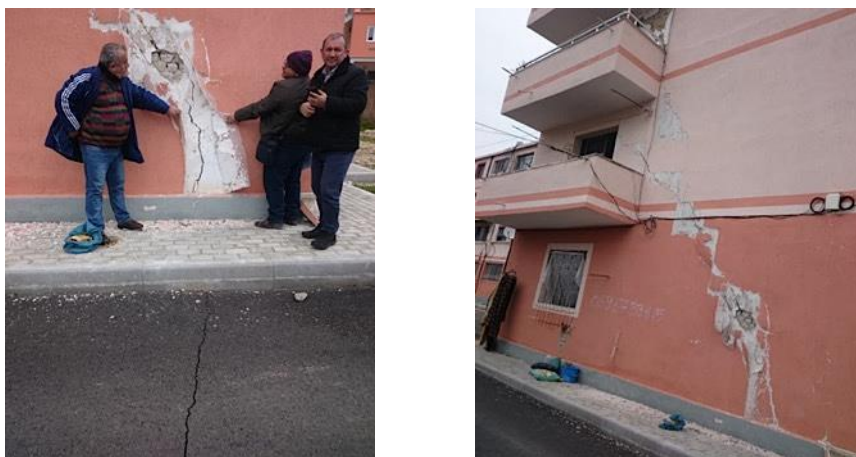
Fig. 15. Shear failure

The prevalence of the in-plane mechanism involving sliding shear in masonry buildings can be attributed to the inadequate shear strength of the masonry walls and the absence of appropriate reinforced concrete (RC) bond beams. Fig. 15 visually presents examples of in-plane failures observed in masonry dwellings across various villages. This type of failure underscores the importance of reinforcing masonry structures to enhance their resilience during seismic events.

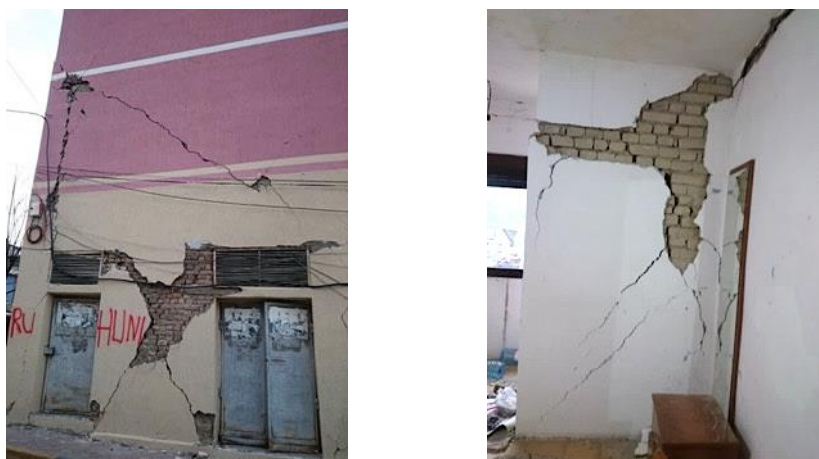
Fig. 16. Shear effect in masonry buildings

The existence of bond beams is essential for establishing structural integrity, but numerous masonry structures in the earthquake-affected villages lacked adequate and suitable bonding girders to enhance the complete horizontal shear capacity of their walls. Moreover, these structures featured sizable openings, which led to a reduction in wall stiffness and an amplification of shear effects. To mitigate this form of damage, it is advisable to incorporate reinforced concrete (RC) bond beams and decrease the size of openings in the load-bearing walls. Fig. 16 visually depicts this type of damage, emphasizing the significance of addressing these structural deficiencies to enhance the seismic resilience of masonry buildings.

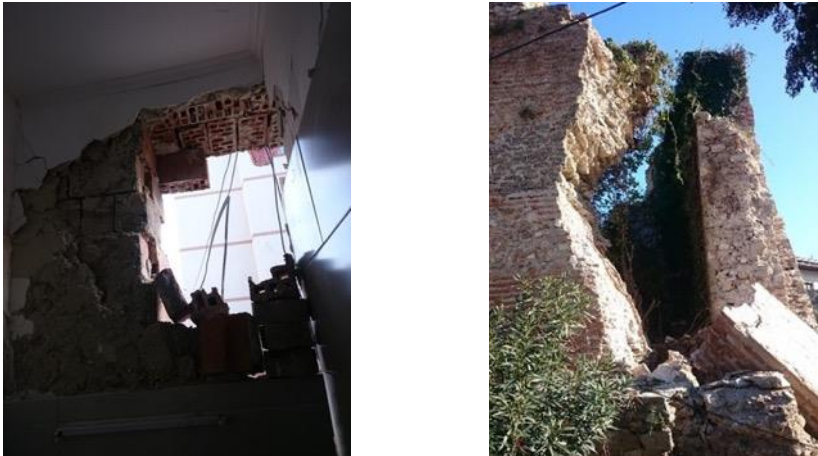
Fig. 17. Crushing failure of the walls

Crushing failure represents another type of in-plane failure, manifesting when the vertical part of earthquake motion is greater than the compressive strength of the load-bearing wall. Initially, vertical cracks propagate across the vertical transverse segment of the wall, followed by splitting along the longitudinal partition. Fig. 17 visually demonstrates the total loss of internal structural integrity in a masonry wall caused by crushing damage resulting from the dividing crash of the masonry segment.

This kind of damage is frequently witnessed in adobe and multi-leaf debris stone wall segments, mainly because of the absence of appropriate flat bonding planks. In other words, insufficient interlocking between connecting bearing walls at corners leads to the occurrence of this type of damage. To prevent this type of failure, it is essential to incorporate proper horizontal bond beams, which can enhance the seismic resilience of these structures.
