Observed failure modes in existing URM buildings after November 26, 2019 earthquake in Albania

Enio Deneko^{1,a}, Hüseyin Bilgin^{*2,b}

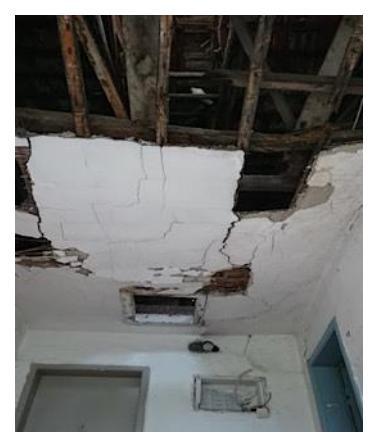
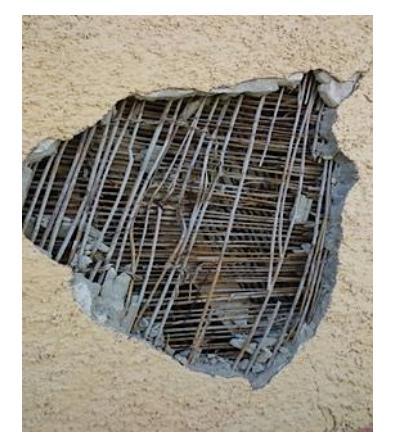
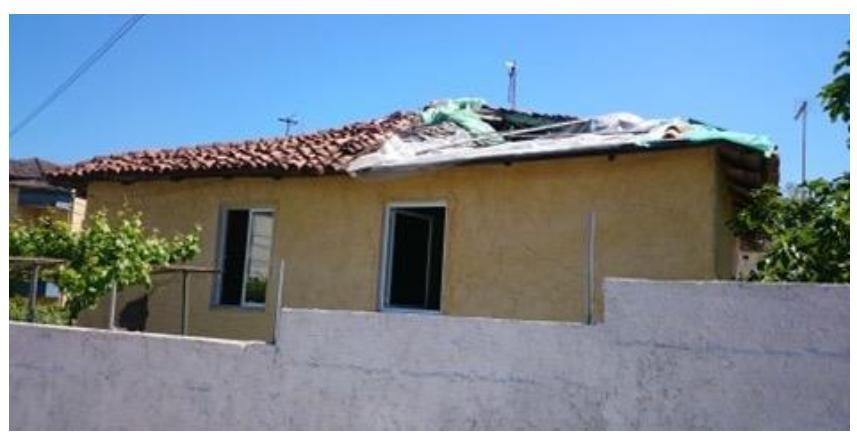
This category of destruction occurs once the structural integrity of a building is compromised by the impact of out-of-plane mechanisms. In rural areas of Albania, especially in the countryside, dwellings frequently feature roofing systems constructed from locally sourced materials. Many of these masonry buildings employ timber logs for their roofing and flooring systems. Over time, these structures, which are typically old and have been exposed to various environmental conditions, experience a decline in the strength of their walls.

The collapse of these buildings can be attributed to several factors, one of which is the weight of the heavy earthen roofs. To keep the structure away from rain and snow, additional layers of soil are frequently added to the roof. Consequently, the thickness and mass of the earthen roofs gradually increase, resulting in a higher load borne by the building during an earthquake.

Fig. 6. Collapse of masonry buildings

The structural walls and timber logs are unable to withstand this heightened horizontal load, causing the walls to shift out-of-plane and leading to a complete collapse.Fig. 6 visually illustrates the observed damage of this particular type across different regions. To reduce the risk of total collapse, it is crucial to refrain from using adobe buildings and earthen roofs. Instead, consider implementing lighter roofing systems that incorporate horizontal and vertical bond beams during construction. This approach helps distribute the loads more effectively and enhances the building's seismic resilience.

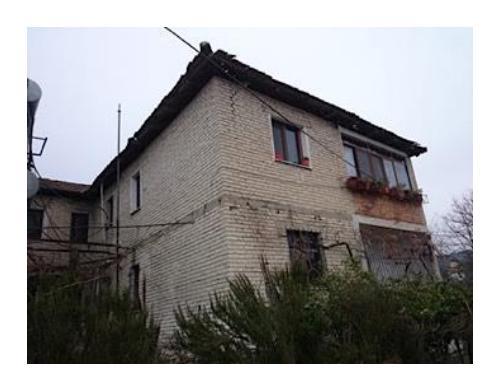
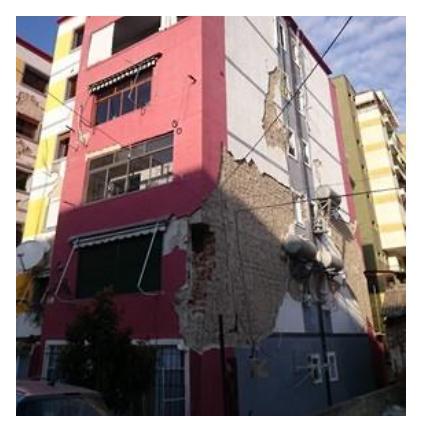
One common consequence of inadequate connections between structural walls is the occurrence of corner damages. These damages commonly occur at connections between walls, primarily due to the lack of strong links between them. Problems such as the utilization of low-quality materials, inferior workmanship, and insufficient provision of bond beams have contributed to the failure of adobe and stone masonry residences. Damage on corners was a prevalent issue observed in buildings within the earthquake affected areas.

Fig. 7. Observed corner damages

In numerous cases, inadequate wooden beams and improper ties were noted at the junctions of the affected buildings. The structural failures were significantly influenced by the weak bonds between the walls, compounded by the lack of horizontal or vertical bonding ties. Fig. 7 depicts a visual representation of the corner damage observed in masonry dwellings during the earthquake in Albania.

To mitigate corner failures, it is recommended to avoid the use of adobe or stone rubble in the construction of structural walls. Instead, hewn stone or brick materials should be employed, accompanied by the incorporation of reinforced concrete (RC) bond beams in both orthogonal directions. Adhering to modern seismic guidelines, it is crucial to maintain uniform thickness for these beams and walls, especially at the structure's edges. Fig. 8 illustrates the application of bond beams in masonry constructions as a preventive measure against corner damages.

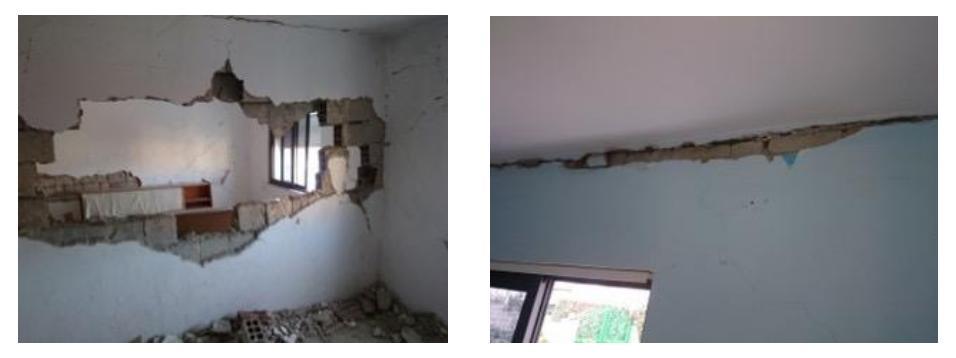
A significant contributor to out-of-plane mechanisms is the positioning of timber logs that bear the load of the building's floors in a single direction. This arrangement results in the transfer of earthquake loads from perpendicular walls to the timber logs, making walls without support from these logs susceptible to out-of-plane overturning. Fig. 9 schematically outlines various out-of-plane mechanisms, while Fig. 10 illustrates observed out-of-plane mechanisms in unreinforced masonry (URM) buildings across different villages following the November 26, 2019, earthquake in Albania.

Fig. 10. Observed out-of-plane collapses of walls

To prevent these mechanisms and ensure proper wall connection, it is crucial to establish a rigid diaphragm, particularly when structural walls lack reinforced concrete bond beams. Otherwise, partial or total failure mechanisms can occur.

To mitigate the occurrence of this out-of-plane mechanism, several measures can be taken. Firstly, it is crucial to limit the unsupported length of a load-bearing wall. Additionally, incorporate reinforced concrete horizontal and vertical bond beams into the construction, as illustrated in Fig. 11. Moreover, it is vital to ensure the presence of bearing walls in both the x- and y-directions, as recommended in reference [23].

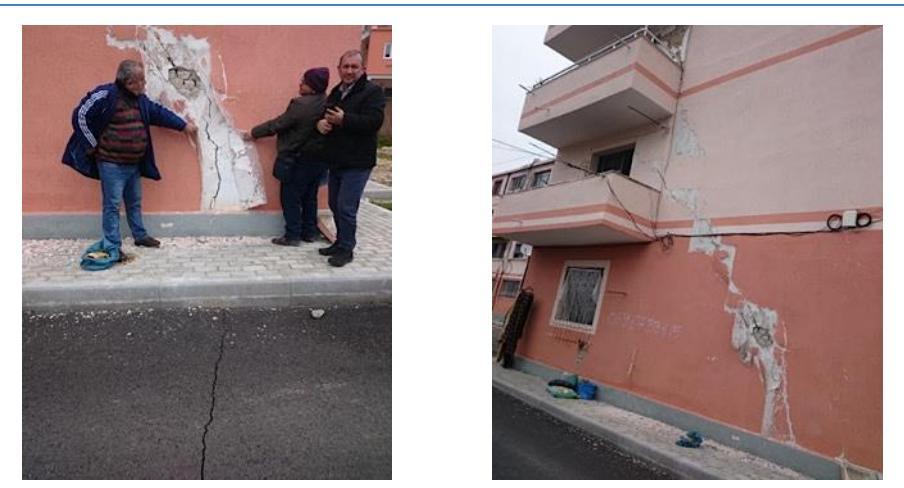
The prevalence of the in-plane mechanism involving sliding shear in masonry buildings can be attributed to the inadequate shear strength of the masonry walls and the absence of appropriate reinforced concrete (RC) bond beams. Fig. 15 visually presents examples of in-plane failures observed in masonry dwellings across various villages. This type of failure underscores the importance of reinforcing masonry structures to enhance their resilience during seismic events.

Fig. 15. Shear failure

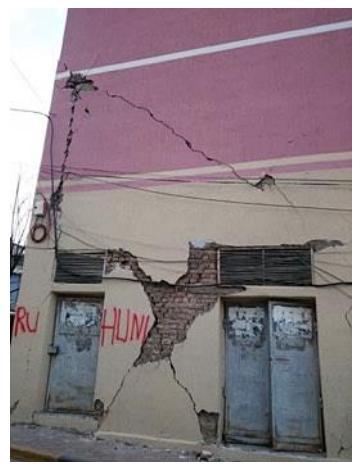
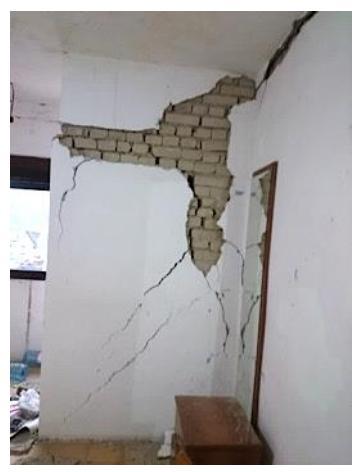
The existence of bond beams is essential for establishing structural integrity, but numerous masonry structures in the earthquake-affected villages lacked adequate and suitable bonding girders to enhance the complete horizontal shear capacity of their walls. Moreover, these structures featured sizable openings, which led to a reduction in wall stiffness and an amplification of shear effects. To mitigate this form of damage, it is advisable to incorporate reinforced concrete (RC) bond beams and decrease the size of openings in the load-bearing walls. Fig. 16 visually depicts this type of damage, emphasizing the significance of addressing these structural deficiencies to enhance the seismic resilience of masonry buildings.

Fig. 16. Shear effect in masonry buildings

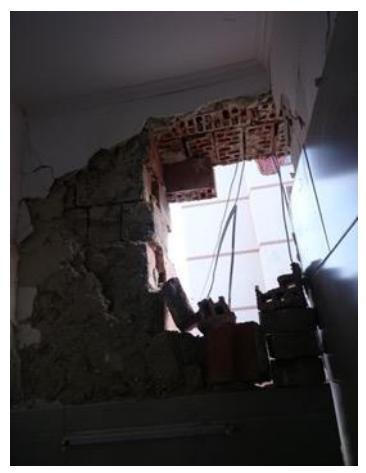
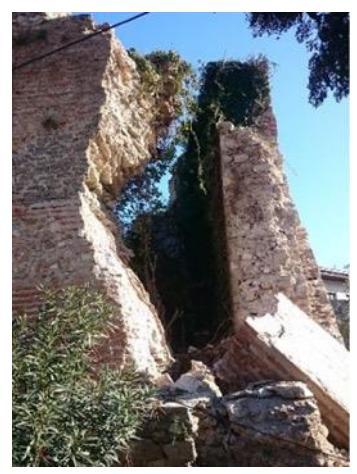
Crushing failure represents another type of in-plane failure, manifesting when the vertical part of earthquake motion is greater than the compressive strength of the load-bearing wall. Initially, vertical cracks propagate across the vertical transverse segment of the wall, followed by splitting along the longitudinal partition. Fig. 17 visually demonstrates the total loss of internal structural integrity in a masonry wall caused by crushing damage resulting from the dividing crash of the masonry segment.

Fig. 17. Crushing failure of the walls

This kind of damage is frequently witnessed in adobe and multi-leaf debris stone wall segments, mainly because of the absence of appropriate flat bonding planks. In other words, insufficient interlocking between connecting bearing walls at corners leads to the occurrence of this type of damage. To prevent this type of failure, it is essential to incorporate proper horizontal bond beams, which can enhance the seismic resilience of these structures.
