## Damage progression in rubble-mound breakwaters scale model tests, under a climate change storm sequence

This paper describes the two-dimensional (2D) physical model tests of a rock armor breakwater, performed at LNEC's experimental facilities, under the framework of the HYDRALAB+ project. The aim of the present work was to evaluate damage evolution under future climate change scenarios, by using different damage evaluation techniques. The tested wave conditions simulated a storm sequence where two water levels (low water and high water) were considered, as well as an increase of the wave height. The water levels and the wave heights were chosen to simulate extreme events forecasted on climate change scenarios. Damage evaluation was based on the traditional counting method and on stereo-photogrammetric techniques. Test results are presented in terms of the damage parameter  $S$  and in terms of the percentage of removed armor units. The analysis is focused on the damage progression during the scale model tests, for the imposed storm sequence. The damage presents an oscillating behavior with two main damage areas corresponding to the active zones for each level, due to the variat

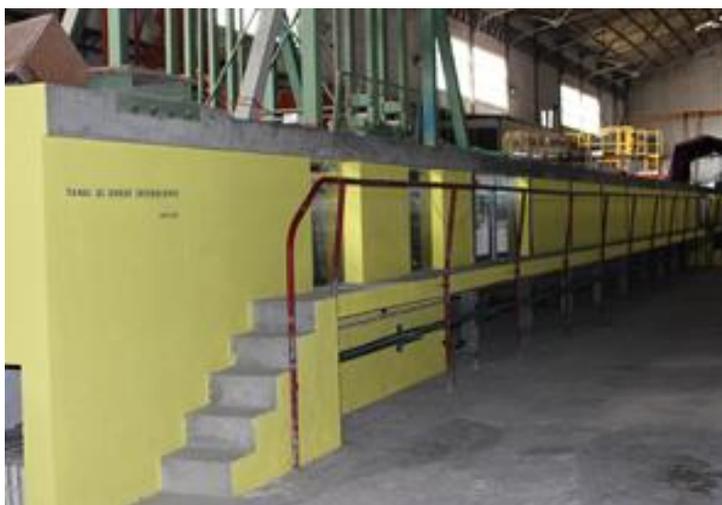
LNEC's experiments were performed at the Ports and Maritime Structures Unit (NPE) of the Hydraulics and Environment Department (DHA), in a wave flume (COI 1) approximately 50 m long, with an operating width and an operating water depth of 80 cm (Figure 2). The flume is equipped with a piston-type wave-maker that combines both irregular wave generation and dynamic absorption of reflected waves.

Fig. 2 COI1 wave flume

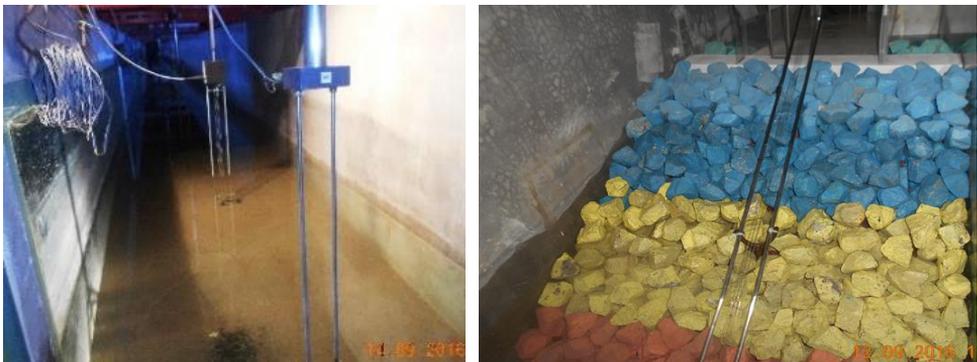
The flume was equipped with twelve resistive-type wave gauges deployed along the wave flume, to measure the free surface elevation (Figure 4, left). In order to measure run-up levels, an additional gauge was placed on the armor layer slope (Figure 4, right).

Fig. 4 . Measuring equipment. Left: wave gauges to measure free surface elevation; right: run-up wave gauge

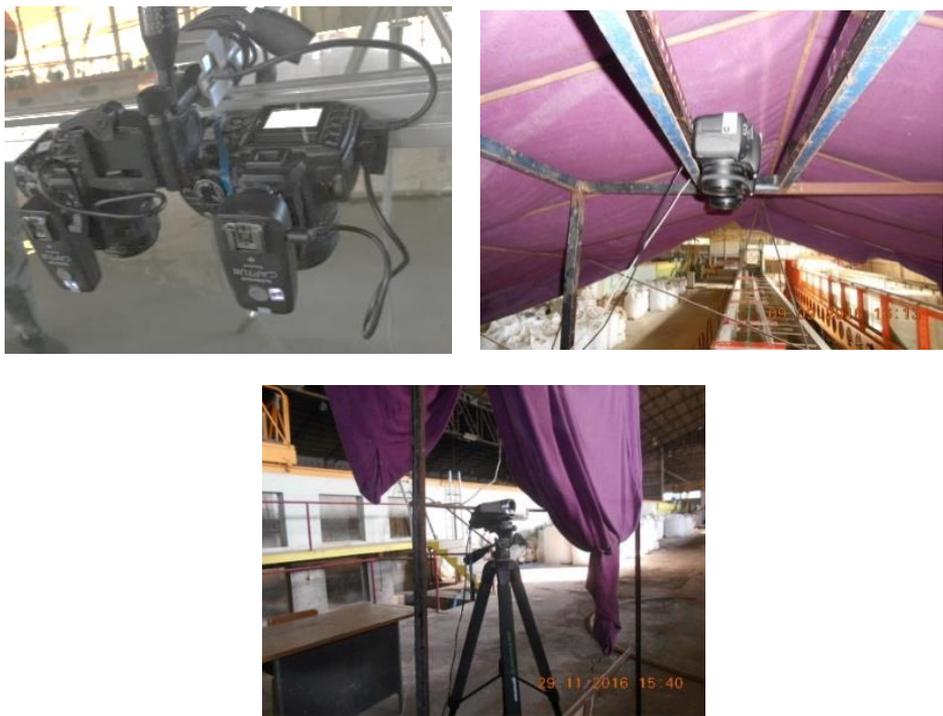
As referred previously, for damage assessment, two methods were used. The counting of falls and movements of the armor units was performed by visual observation and by taking some photos of the breakwater cross-section with a common camera. The stereophotogrammetric technique used two cameras mounted side by side in a support structure and able to photograph the same scene simultaneously (Figure 5, top). Throughout the tests herein described, two digital SLR cameras (Canon EOS 600D) were fitted with fixed focal length lenses (Canon EF 35mm f/2). This setup is capable of acquiring images ranging from 3.5 to 18 megapixel). All tests were filmed with 2 video cameras, one located above the model and the other placed next to the flume side wall (Figure 5, bottom). These cameras were used for run-up and damage measurements.

Fig. 5 Top: Photographic equipment. Bottom: Video camera for damage evaluation

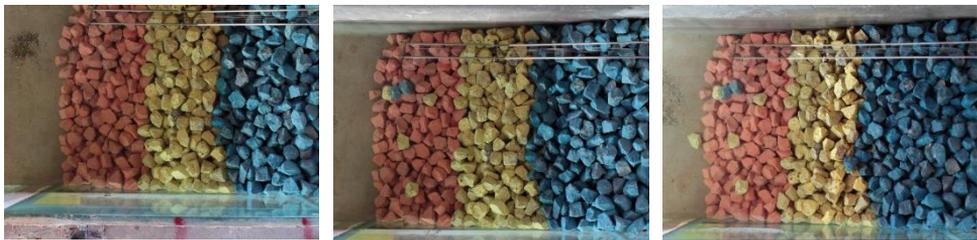
Figure 6 presents an overview of the cross-section before Test 10, after Test 16 and after Test 16Rep3, respectively.

Fig. 6 Overview of the cross-section before Test 10 (left), after Test 16 (center) and after Test16Rep3 (right)
