Influence of interventions on the seismic performance of URM buildings designed according to pre-modern codes

Neritan Shkodrani, Huseyin Bilgin, Marjo Hysenlliu

Journal Abbreviation: *Res. Eng. Struct. Mater.*

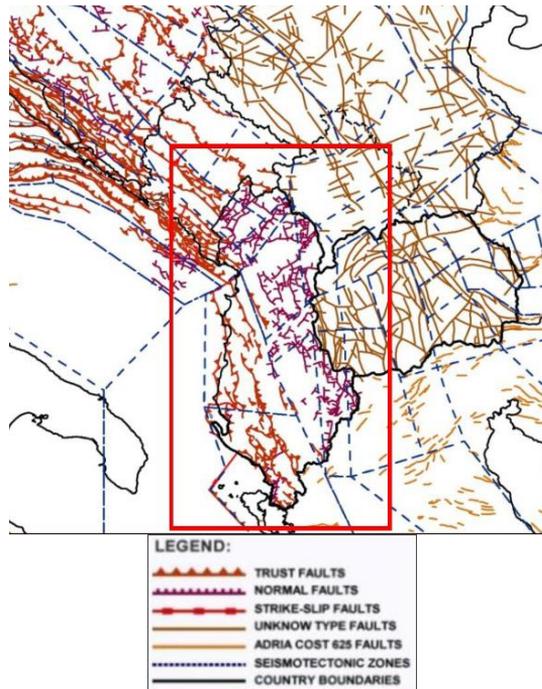
Fig. 1 Types of faults affecting the region [20]

Two transverse and three longitudinal active fault zones are evidenced into the Albanian orogen (Fig. 1). It has been concluded that the major seismic activity is located along the following seismic belts [21]:

- The NW up to nearly NNW trending Ionian-Adriatic thrust fault zone,
- The NW trending Shkodra-Mati-Librazhd graben fault zone,
- The N-S trending Peshkopi-Korça graben fault zone,
- The NE trending Shkodra-Tropoja normal fault zone,
- The NE trending Elbasan-Dibra normal fault zone.

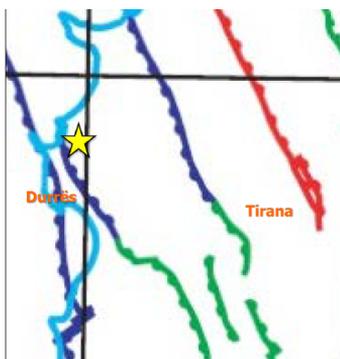
Fig. 2 Active fault zones and faults of the November 26, 2019 affected area

The 2019 earthquake affected area is dominated by NW-SE striking reverse active faults. Blue lines correspond to faults triggered during Middle Pleistocene-Holocene, the green lines to faults triggered during Pliocene-Lower Pleistocene and the red lines to faults activated during Pre-Pliocene period (Fig. 2). The star corresponds to the epicenter of the Mw 6.4 Durrës earthquake occurred on November 26, 2019.

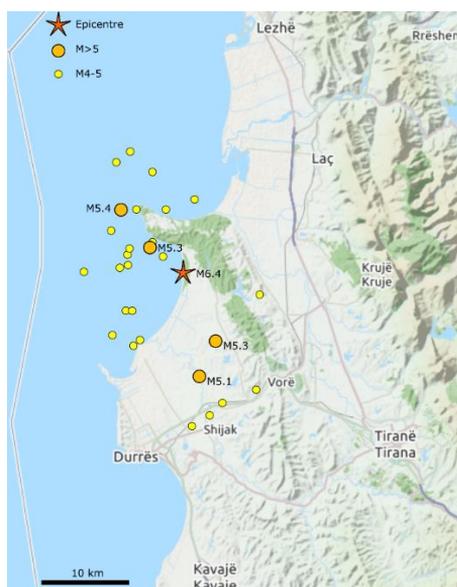
Fig. 3 The epicenter and location of aftershocks in the first month of the 26 November 2019 earthquake

An earthquake hit the central western part of Albanian territory on November 26, 2019. It was evaluated as Mw 6.4 (Fig. 3). Its focal depth was about 10 km [USGS, 2019]. According to the several seismological institutes and observations, the main shock was caused by the activation of a NW-SE striking reverse fault. The main shock was felt in the neighboring countries.

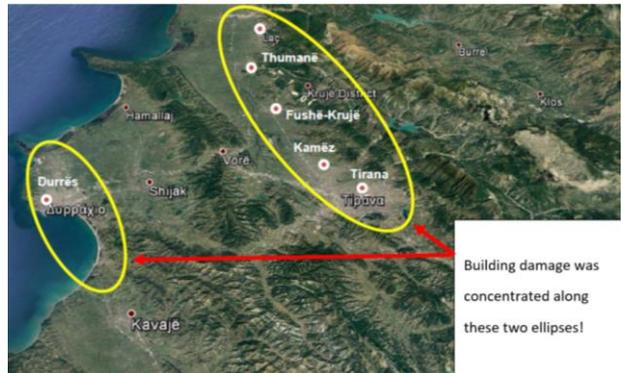
Fig. 4 Earthquake-affected region of 2019 Durrës (Albania) earthquake

The main shock and the aftershocks caused damage to buildings of Durrës, Tirana and several settlements of the wider area. Building damage was distributed along an elliptical

region (Fig. 4). This area coincides with the strike of the seismogenic fault as it is derived from the fault plane solutions provided by several seismological institutes and observatories [INGV, 2019 and USGS, 2019]. This area could be characterized as macroseismic epicenters as the result of the interaction between the seismotectonic setting and the local soil conditions and as the result of several reflections, refractions, directivity phenomena of seismic waves and resonance resulting in destruction in the earthquake-affected regions.

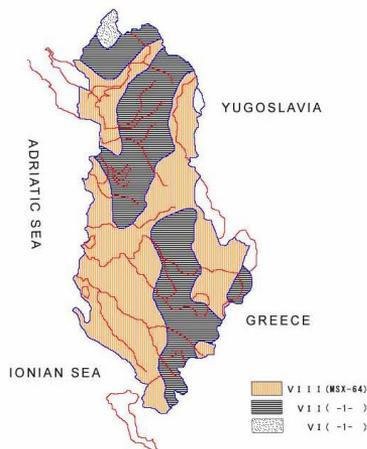
Fig. 5 Seismic intensity zonation map of Albania [22]

Based on the seismic map of Albania, published by Ministry of Construction (1989), it can be observed that the resulted intensities from this earthquake, are within the boundaries suggested in the Seismic Zonation Map (Fig. 5)

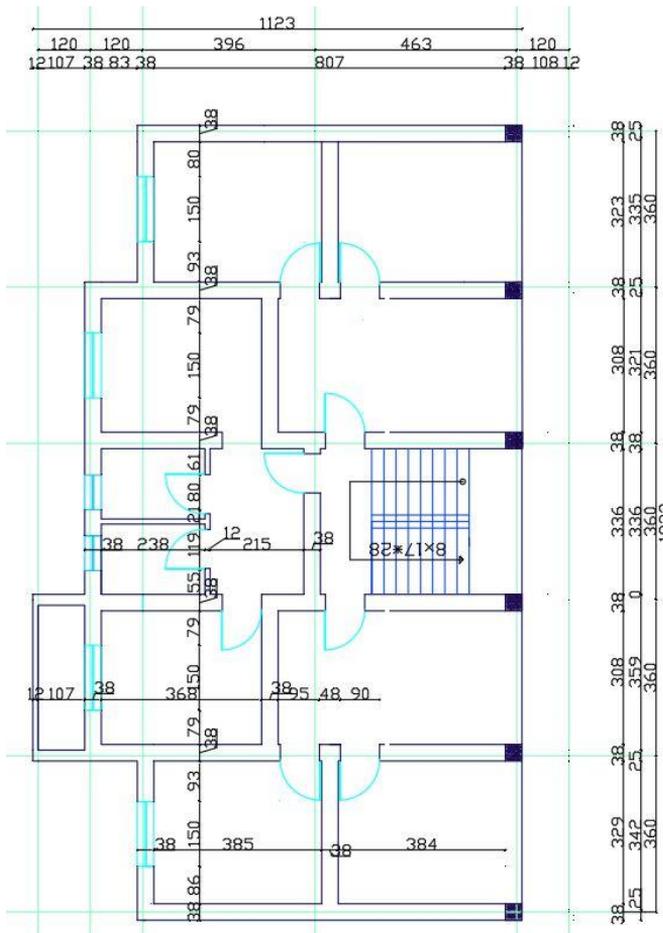
This template is of year 1972, referred as 72/1 in the manual of Albanian Construction Institute. This building has plan dimensions of (18.32x12.43) m. It has 5 story high with 285cm height for each story. The load bearing walls are built with clay bricks M75 (strength 7.5 MPa). The mortar is M25 of strength 2.5MPa. The wall thickness is 38cm in the first and second floor, then 25cm on the remaining. The partition walls are with hollow clay bricks. The concrete corner columns and slabs are constructed with M150 concrete. There are two buildings of this template, 5 floors each but in one intervention is done on the first floor (Fig. 6-7). In one side of the first story, walls are replaced with reinforced concrete frames, with 5 openings as shown (Fig. 7). Columns are of reinforced concrete C20/25 with dimensions of (40x40) cm² and steel reinforcement B400 with $A_s = A'_s = 12.56 \text{ cm}^2$ and stirrups $\phi 8$ every 15 cm. Beams are also of reinforced concrete C20/25 with dimensions of (30x50) cm² and steel reinforcement B400 with $A_s = A'_s = 3.14 \text{ cm}^2$ and stirrups $\phi 8$ every 20cm.

Fig. 7 Typical plan view of the selected masonry building after intervention in the 1st story

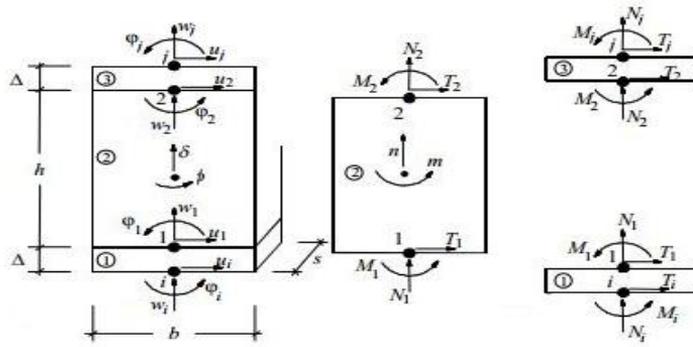
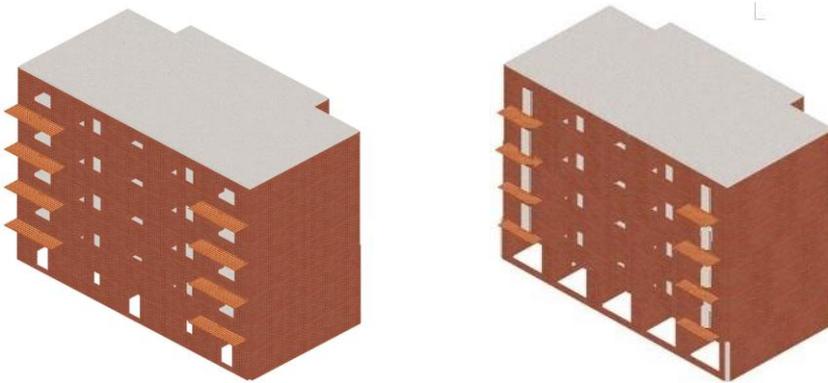
The conventional macro-element used for nonlinear static analyses is sketched with the kinematic model depicted in Fig. 8a. The 3D model of the examined masonry buildings, where it is apparent that masonry walls are modelled through a mesh of masonry piers and spandrels, is depicted in Fig. 8b.

Fig. 8 a) The macro-element kinematic model; b) the 3D building model with (right) and without (left) interventions setup through the TREMURI software.

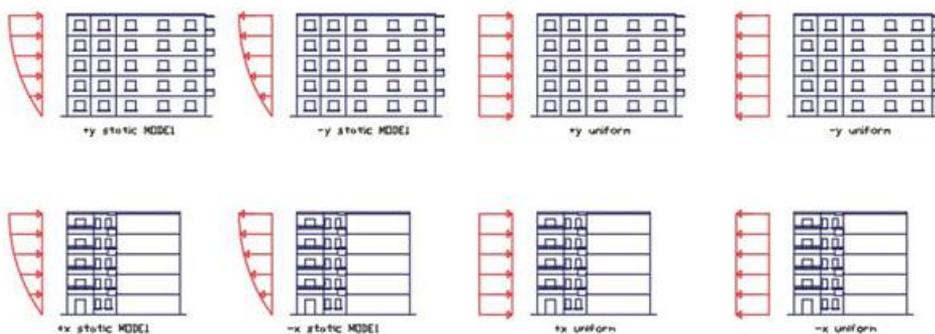
In the TREMURI, two load patterns are deployed: proportional with the 1st mode shape, based on the fundamental mode shape of the building, and a uniform load distribution to all stories. The two are performed in two orthogonal directions x- and y- and with positive and negative values. So, in total eight analysis: +x MF1, +x uniform, -x MF1, -x uniform, +y MF1, +y uniform, -y MF1, -y uniform (Fig. 9). These analyses are repeated for each combination. Without eccentricity of gravity load and with eccentricity of two different levels. For both simulations representing the original and intervened building are computed 24 analyses, for all load combinations, earthquake direction, with and without eccentricity. The numbers shown in the legend of capacity curves (Fig. 10-11) represents the eccentricity of the load application point.

Fig. 9 Load patterns used of pushover analyses

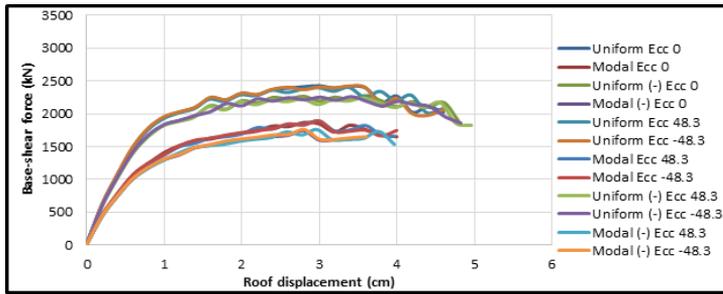
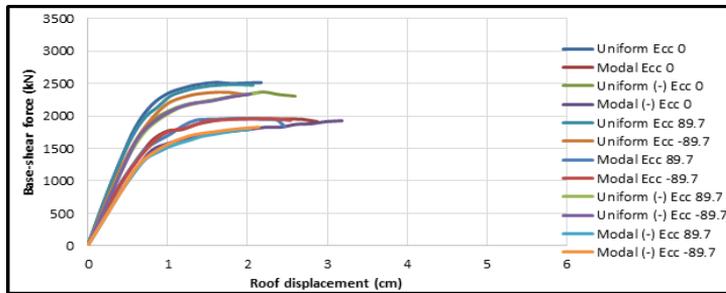
Upon finishing the modeling, the capacity curves of both buildings were estimated by carrying out nonlinear static analysis in TREMURI (Fig. 10-11). Gravity load of the buildings were evaluated by considering the combination of Dead and Live loads.

Fig. 10 Capacity curves of the URM building without intervention

From the comparison of the pushover curves of both buildings, in the x- direction is viewed a decrease in stiffness and max base shear force, but a slight increase in displacement and ductility (Table 4). It must be said that this value is close, and the difference is at levels of 8.35% for stiffness, 5.1% for max force, and 6% in ductility. Since the demolished walls were in this direction, the load bearing capacity has slightly decreased. Meanwhile, in y- direction happens the opposite. Since the walls in this direction are the same, but also columns had been added in first floor, the stiffness and maximum force, slightly increases, while ductility levels remain almost the same, with some little decrease. The values of initial stiffness change at a ratio of 6.6%, the values of max force change at a ratio of 2.1% and the value of ductility at a ratio of 5.9%.

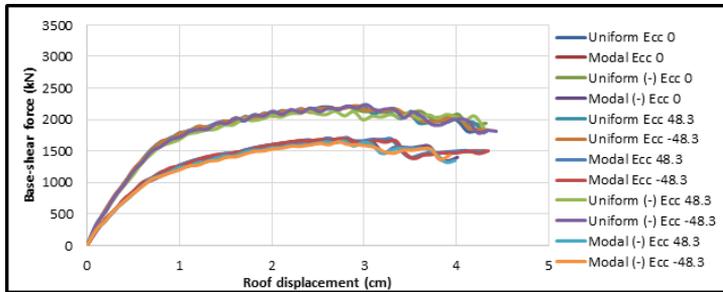
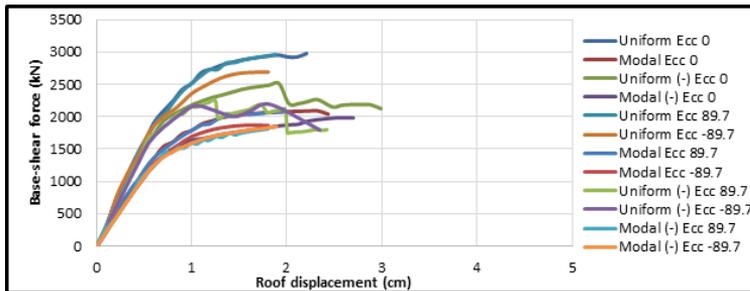
Fig. 11 Capacity curves of the URM building with intervention

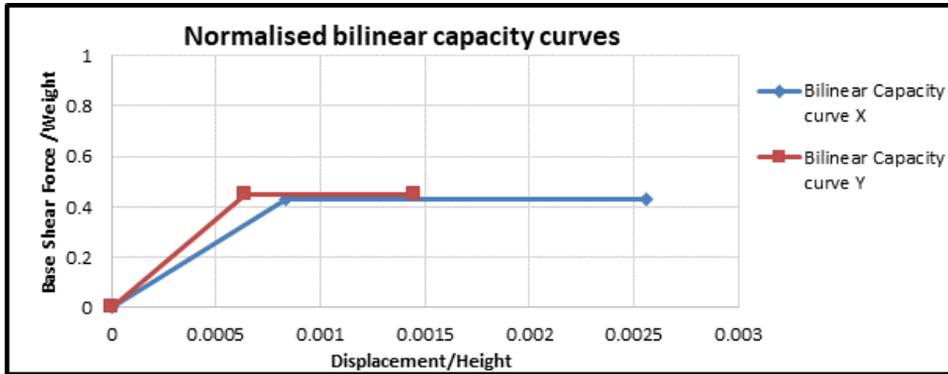
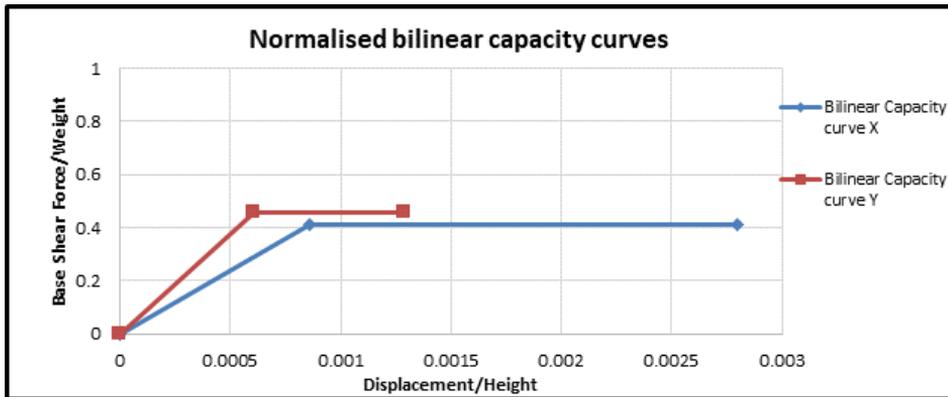
The worst cases were taken as the representative pushover curves for both x- and y-directions of the buildings. Normalized values of bilinear capacity curves are shown below (Fig. 12).

Fig. 12 Normalized bilinear capacity curves; a) Original building, b) Building with intervention
