Case study of the Beirut port explosion using 3D laser scan and nonlinear finite element model

Analysis of the structural failure of the Beirut port silos by the August 4, 2020 explosion is presented in this paper. The structural response of the silos due to the blast loading imposed by the explosion was assessed using 3D laser scan. Then, the silos were modeled using three-dimensional finite element models using Abaqus explicit. The silos' damage and failure were investigated to estimate the blast magnitude and to check the silos structural response against the silos' concrete strength and additional reinforcement and concrete coating added to the silos in 2000. In addition to the effects of reinforcing the ribs between the silos as well as the soil and foundation. Therefore, these parameters were tested after estimating the blast magnitude to check the structural status of the remaining part of the Beirut port silos (if they can be reusable), the role played by the foundation and soil and if the silos' response would have changed if certain parameters were taken differently in the design. In this article, the damage and silos' displacement obtained from the numerical models were

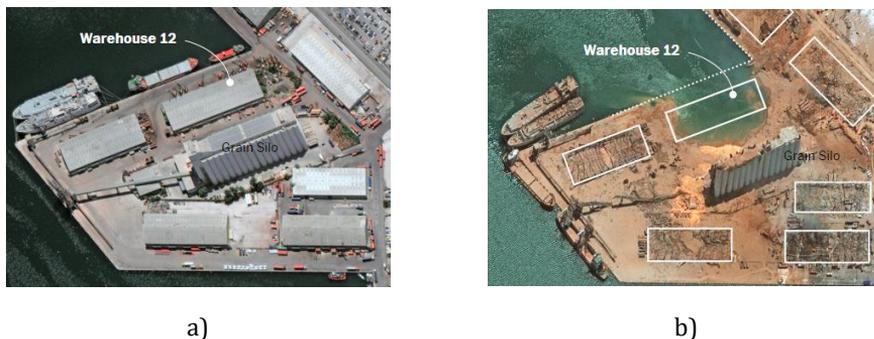
Fig. 1 The Beirut port silos, a) before August 4, 2020 blast and b) after August 4, 2020 blast [10]

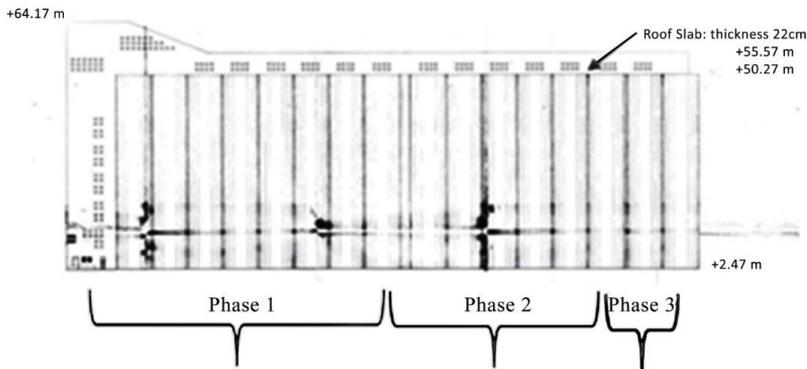
Fig. 3 The construction phases of the Beirut port silos

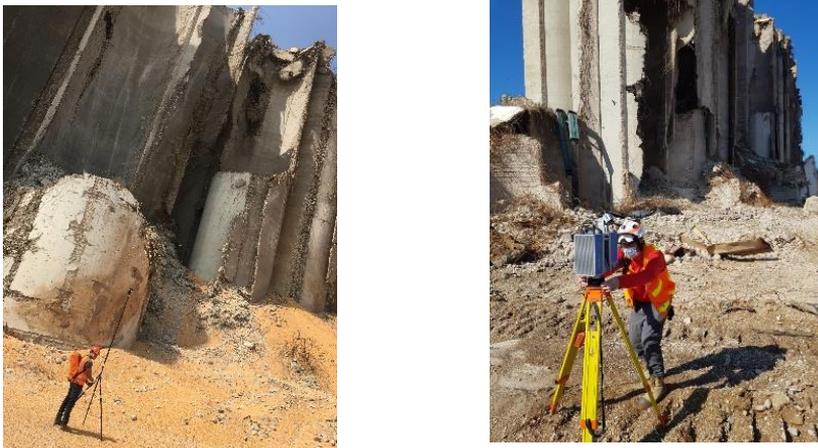
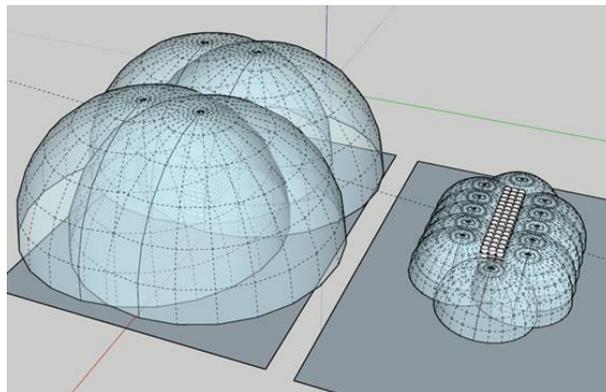
Fig. 4 Scanning the Beirut port silos using a) LEICA BLK 360 and b) Z + F Imager 5010 X Imaging scanner and c) Comparing the scope of silos' 3D scan (the left picture concerns the Z+F scope and the right, the Leica scope)

Another difference is the scope range captured by each piece of equipment; i.e the panoramic and thermal camera. The LEICA BLK360 imaging scanner forced the team to stand far from the silos to capture the total silos' height and not be in danger. Whereas the Z+F Imager 5010X allowed the team to sweep a volume 27 times larger per scan in a smaller amount of time since it has a larger scope range than the LEICA BLK360. The Z+F Imager is much more efficient in terms of color rendering as well as calibration between the laser device and the camera. Therefore, the use of the Z+F Imager 5010X in the second phase allowed for a better final 3D scan result. Fig. 4(c) presents a comparison of the scope of the silos' 3D scan using the above equipment. The LEICA BLK360 completes full-dome scan, spherical and thermal 3D images with 6 mm at 10 m and 8 mm at 20 m point accuracy in less than 3 minutes using Waveform Digitizing (WFD) distance measurement system technology. In addition, the camera system is formed of a 15 Mpixel camera system, 150 Mpixel full-dome capture, HDR, LED flash Calibrated 360° X 300° spherical image. While the thermal camera FLIR technology is based on a longwave infrared camera with thermal 360° X 70° panoramic image. The Z+F Imager 5010X scanner comes with an external

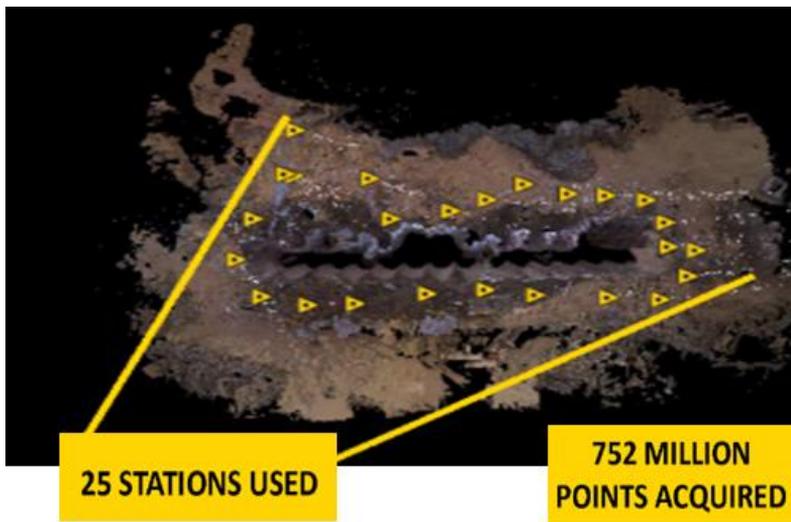
Fig. 5 The Beirut port silos 3D scan, points acquired, and stations used

As shown in Fig. 5, 752 million points of measure in three dimensions using 25 stations in 360° panorama infrared images were obtained. Therefore, a full panoramic picture of the silos was acquired using the LEICA BLK360 as well as the Z+F Imager 5010X (Fig. 6 and 7 (the video)). The obtained results show that the silos exhibit a general tilt of 20 to 30 cm in the direction of the blast. It should be noted that this tilt is not related to the original silos' construction. The silos, in their current state, do not pass the silos' design codes. The damage in the silos can be explained as follows: either the inner part (inside half cylinder) is damaged and/or the pile head is deformed beyond the elastic range and therefore broken (Fig. 8).

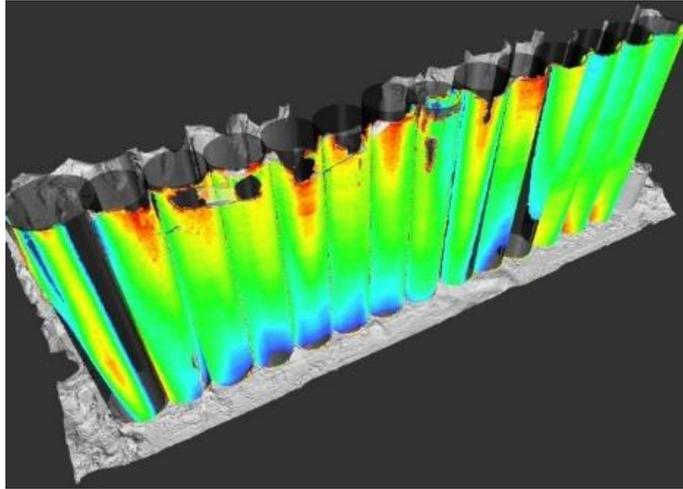
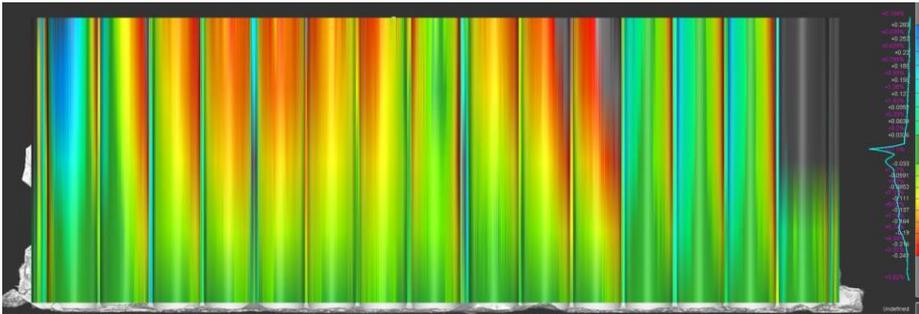
Fig. 6 The Beirut port silos 3D scan (the color shadings red, green and blue refer to a 20, 10 and 0 cm displacement in the direction of the explosion)

Comparing the results of Fig. 6 (3D scan) to Fig. 14 and 17 (FE results), we obtain that blast magnitudes of 550, 875 and 1100 tons TNT do not compare favorably to the results obtained from the 3D scan. A blast magnitude of 337.5 tons TNT (938 tons of Ammonium Nitrate) is found to best capture the 3D scan results and therefore, the real silos' displacement and damage. This is clearly illustrated in Tables 4 and 5 and Fig. 6 where silos 2 to 10 present a permanent displacement of around 20 cm while silos 11 to 14 present a permanent displacement of around 10 cm. For example, for silos 4, 5 and 9, the difference between the FE and 3D scan results is equal to 22, 14 and 3% for the estimated 337.5 tons TNT case while it is equal 52, 49 and 39 % for the 1100 tons TNT case. It should be noted that Rigby et al. [46], using empirical formula estimated the magnitude of the blast to an equivalent mass between 550 to 1100 tons TNT. In addition, Diaz [47] using images and videos' recordings of the explosion posted on social media, estimated the magnitude of the blast to be in the order of 1100 tons TNT while Aouad et al. [48] using fireball analysis, estimated the magnitude of the blast to be equivalent to 810 tons TNT. Also, Stennett et al. [49] and Pisman et al. [50] using videos posted on social media in addition to analyzing

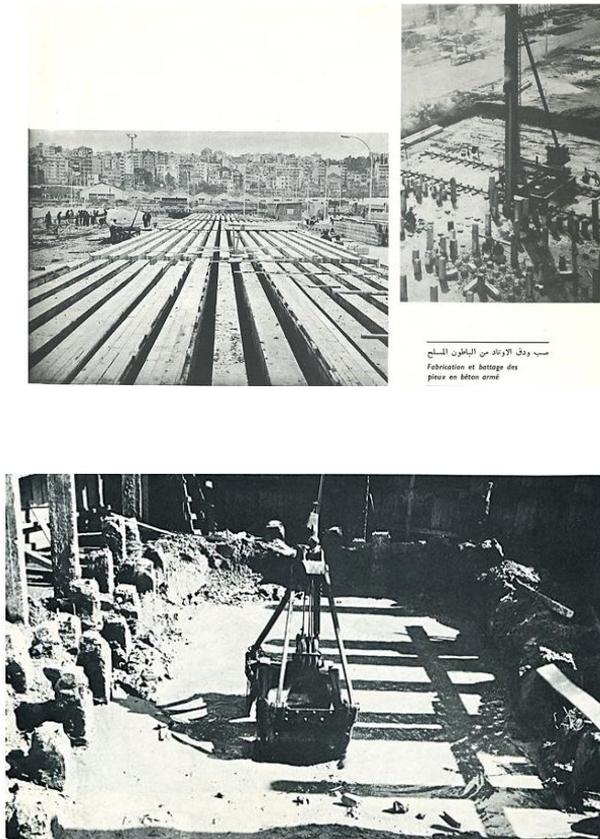
Fig. 8 Grain silos' foundation construction (pile cap and driven piles) and excavation for the base slabs as well exposing the piles head before casting the pile cap (GEER report [32])

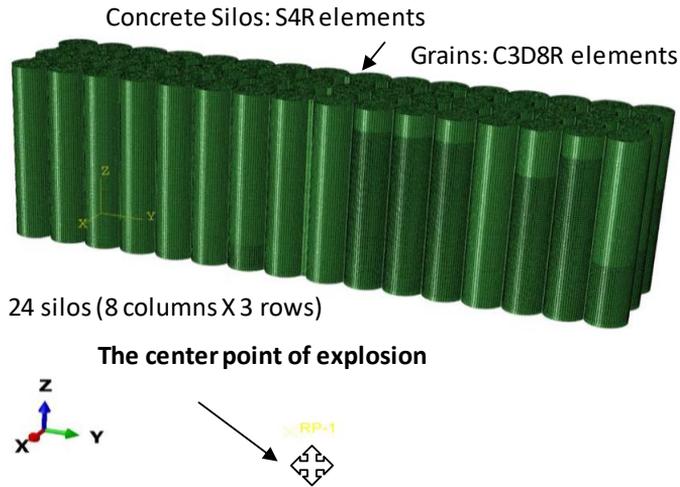
Fig. 9 The FE model

3D Finite Element model was built to simulate the blast of the Beirut port silos using the FE software Abaqus explicit. The analyses were performed using large strain formulations while incorporating geometric nonlinearity. The simulated 3D models consisted of the reinforcement concrete silos and the grains (Fig. 9). The silos were built using 313 741 4-node doubly curved shell, reduced integration, hourglass control, finite membrane strains S4R shell elements, as detailed in Table 2. In addition, the silos steel reinforcement was defined as layers of reinforcement as part of the silos' shell elements using the rebar command (rebars' layers option) available in Abaqus. The grains: wheat and corn, available at the time of the explosion (Fig. 10) were built using 529 678 8-node linear brick, reduced integration, hourglass control C3D8R solid elements (Table 2).

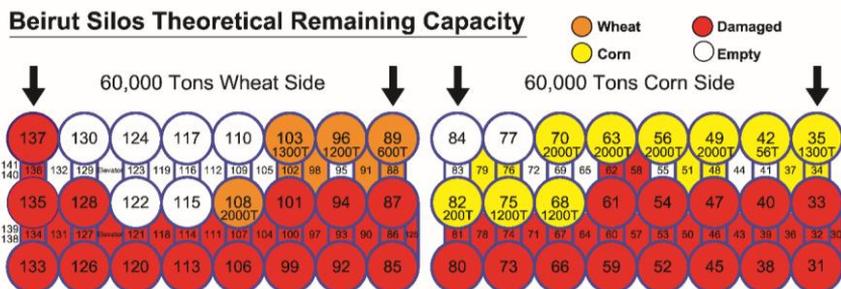
Fig. 10 Beirut silos grains capacity at the time of the blast

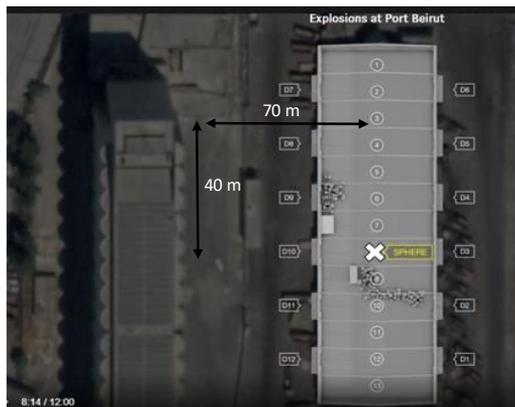
Fig. 12 The center point of explosion in warehouse number 12

To determine the center point of explosion, i.e. the detonation center point, the aerial photos captured by the Lebanese Army forces as well as the investigation done by Forensic Architecture [35] were used. As shown in Fig. 12, the center point of explosion was located, at about 70 m in front of the silos and 40 m from the side of the silos, in warehouse number 12 which contained the explosive materials.

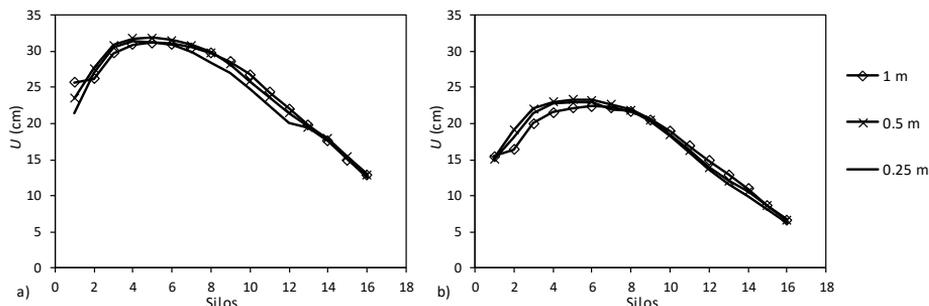
Fig. 13 a) Maximum displacement and b) permanent displacement in the direction of the blast at the head of the silos for different mesh sensitivity analysis

Finally, to make sure accurate and stable results are obtained in the FE simulations while minimizing the computational speed, a mesh sensitivity analysis was performed in Abaqus. Different meshing options were adopted for the shell silos and the solid grains: 0.25, 0.5 and 1 m, to check the maximum amount of deformation in the least damaged row of silos (row number 3), occurring at the head. The results of the mesh sensitivity analysis, as shown in Fig. 13, indicate that at the head of the third row of silos, the maximum displacement varies on average 3.1 and 2.62% while the permanent displacement varies on average 3.19 and 4.43% between the 0.25 and 0.5 m and between the 0.5 and 1 m cases respectively. Since the computational time of the 0.25 m case is 45 hours while the computational time of the 0.5 m is 23 hours and the deformations at the head of the silos only varies by about 3% between the 0.25 and 0.5 m, the 0.5 m mesh size was adopted in the FE analysis in this article. Also, to validate the FE model and to make sure the model is working correctly, first the artificial energy history was compared to the total energy. The results show that the artificial energy is significantly lower than the total internal energy.

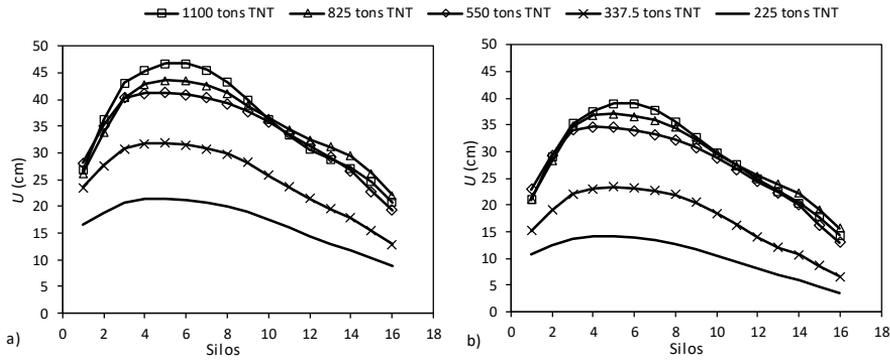
Fig. 14 a) Maximum displacement and b) permanent displacement in the direction of the blast at the head of the silos for different blast magnitudes (baseline case)

For example, in silo 4, as shown in Fig. 14 and 16 and Table 4, the maximum displacement increases from 21.3 to 45.4 cm while the permanent displacement increases from 14.2 to 37.6 cm as the blast magnitude is increased from 225 to 1100 tons TNT. Based on the above, the FE results were henceforth compared to the 3D scan results. Fig. 16 compares the displacement of the silos in the direction of the blast based on the 3D scan and the FE result. The results show that the first silo in the third row (the least damaged row), has lost its geometry. Whereas the other silos in this row have pertained their geometry and their 8.5 m diameter; nevertheless, they tilted around 20 cm. Therefore, the silos in their current state, do not pass the limits set by design codes such as Eurocode [45]. The results of the 3D scan, presented in Fig. 6, points out to a displacement of 20 cm (in red), 10 cm (in green) and 0 cm (in blue) in the direction of the explosion.

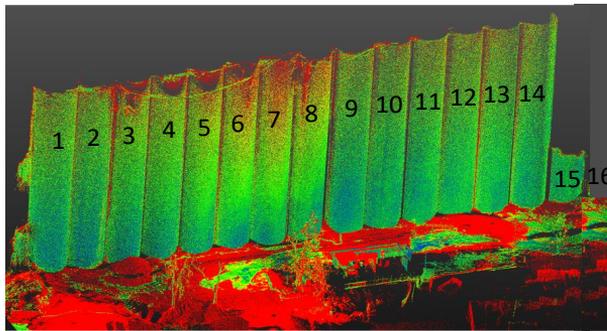
Fig. 15 Silos 1 to 16 in the third row

To check the structural status of the remaining part of the Beirut port silos (if they can be reusable) and if the silos' response would have changed if certain parameters were taken differently in the design, an estimation of the blast magnitude was first performed. Thus, magnitudes of the blast, expressed in terms of equivalent masses of TNT, of 225, 337.5, 550, 875 and 1100 tons (563, 938, 1375, 2188 and 2750 tons of Ammonium Nitrate) were considered/varied from the baseline case. The baseline case accounts for a mean concrete compressive strength of 30 MPa with all additional concrete coating and steel reinforcement added in 2000 and includes all grains available at the time of the explosion, as described in section 2. Moreover, the blast loading was applied at the silos' surface facing the explosion with the detonation center point as indicated in Fig. 12 in the warehouse which contained the explosive materials. The displacements in the direction of the explosion at the head of the silos in the third row, shown in Fig. 14, clearly demonstrate the significant contribution of the magnitude of the blast. It should be noted that a maximum and a permanent displacement were obtained for each silo. Since a permanent displacement was exceeded, then yield strength was exceeded. Note that the third-row silos' numbering in is indicated in Fig. 15.

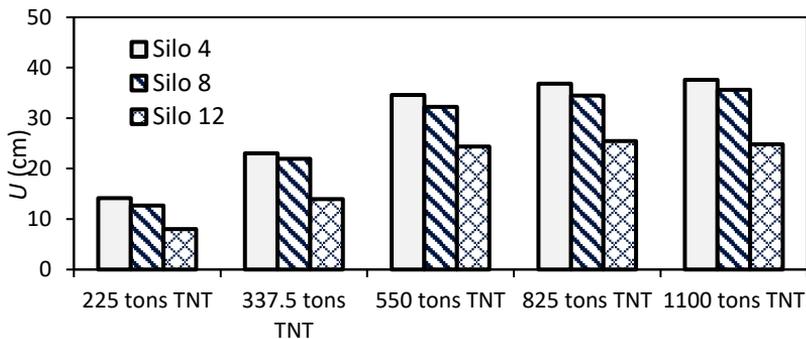
Fig. 16 Maximum permanent displacement in silos 4, 8 and 12 for the different blast magnitudes

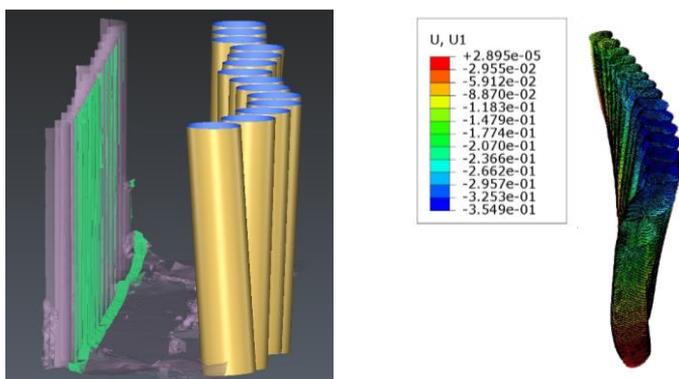
Fig. 17 Displacement of the silos in the direction of the blast a) 3D scan and b) FE results (in m)

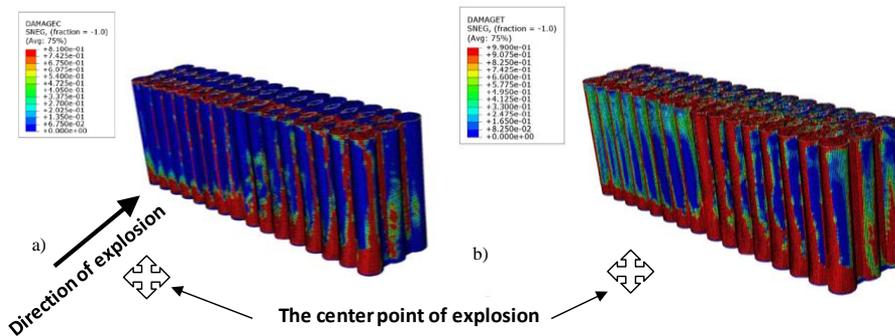
Fig. 18 Damage in a) compression and b) tension- 337.5 tons TNT baseline case (FE) (Damage variables range from 0 (no damage) to 1 (destruction))

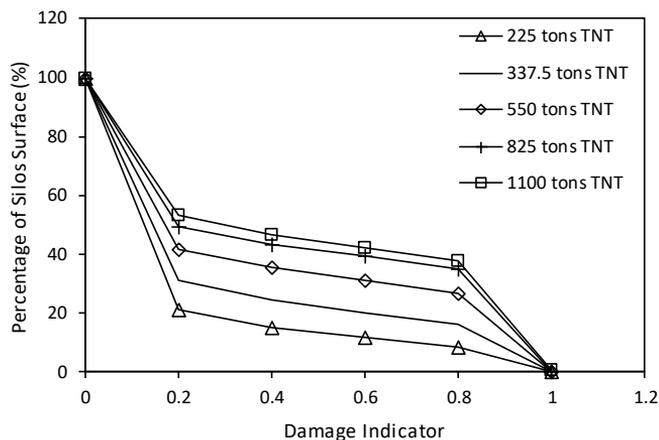
Fig. 19 The cumulative surface damage rate curve

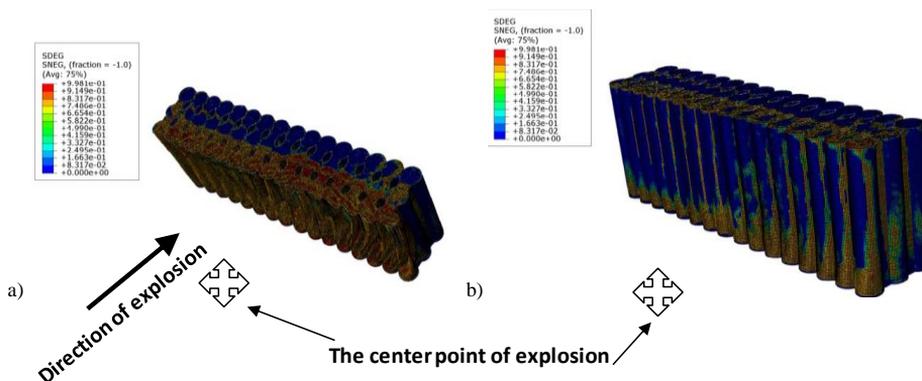
Fig. 20 The SDEG output of the a) 1100 and b) 337.5 tons of TNT simulated cases (Damage variables range from 0 (no damage) to 1 (destruction))

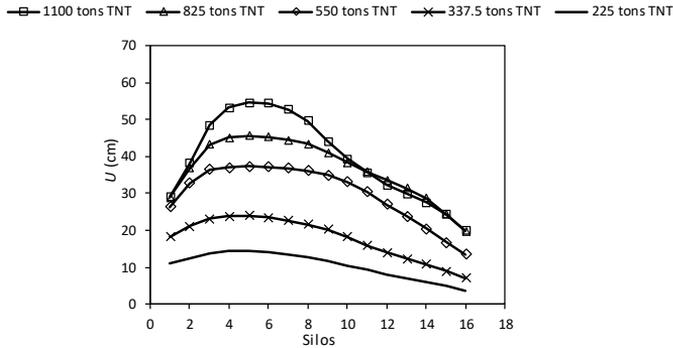
Fig. 21 Permanent displacement in the direction of the blast at the head of the silos for different blast magnitudes in the case of $f'_{c,m}=40$ MPa

To study the effect of concrete strength, the displacement response of Beirut port silos was investigated for concrete compressive strengths $f_{c,m}$: 30 and 40 MPa starting from the baseline scenario. The results obtained and presented in Fig. 14, 21 and 22 indicate that for low levels of blast magnitude (225 tons and 337.5 tons TNT), $f_{c,m}$ does not affect the silos' displacement. The average ratio of permanent displacement at the head of the silos for the case of $f_{c,m}=40$ MPa to $f_{c,m}=30$ MPa in the direction of the explosion is around 1.00 and 1.03 for 225 tons and 337.5 tons TNT respectively. However, as the magnitude of the blast increases from 550 tons to 1100 tons TNT, this ratio increases from 1.09 to 1.36 for the case of $f_{c,m}=40$ MPa to $f_{c,m}=30$ MPa.

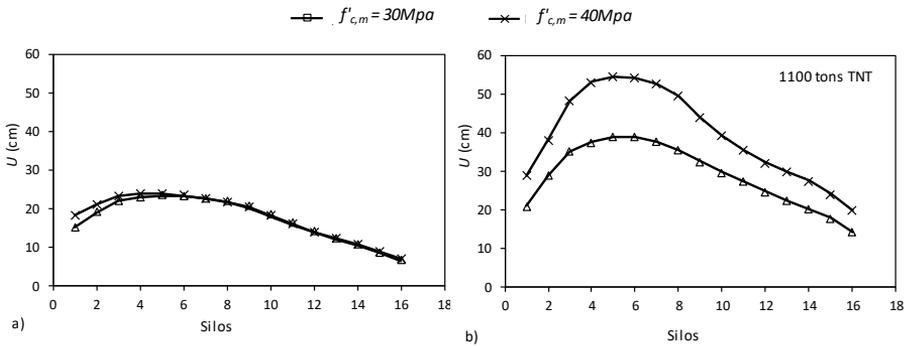
Fig. 22 Permanent displacement in the direction of the blast at the head of the silos for different concrete strength for a blast magnitude of a) 337.5 tons TNT and b) 1100 tons TNT

The significant contribution of concrete compressive strength as the magnitude of the blast increases may be due to the improvement of concrete shear resistance that leads to a reduction in the absorbing capacity of the blast energy. In general, the concrete shear strength increases with the increase in compressive strength. In addition, concrete with higher compressive strengths has greater resistance to blast loading [52]. Therefore, as the compressive strength increases, the concrete becomes stronger and able to withstand more load; in other words, it can withstand more permanent deformation. Noting that the increase in concrete compressive strength makes the latter more ductile, causing the failure of the structure in a brittle manner. This is manifested by the decrease not only in the amount of energies stored in the model under the blast model (the strain energies) but also in a decrease in the total and kinetic energies. For example, as the concrete compressive strength increases from 30 to 40 MPa for the 1100 tons cases, the strain energy decreases from 480.29 to 395.50 MJ and the total energy decreases from 29.60 to 26.14 MJ. The increase in concrete compressive strength also causes a decrease in the amount/level of silos' damage. Nevertheless, for the low level 337.5 tons of TNT estimated blast magnitude, designing silos with higher compressive strength would not have affected the damage obtained in Beirut port silos.

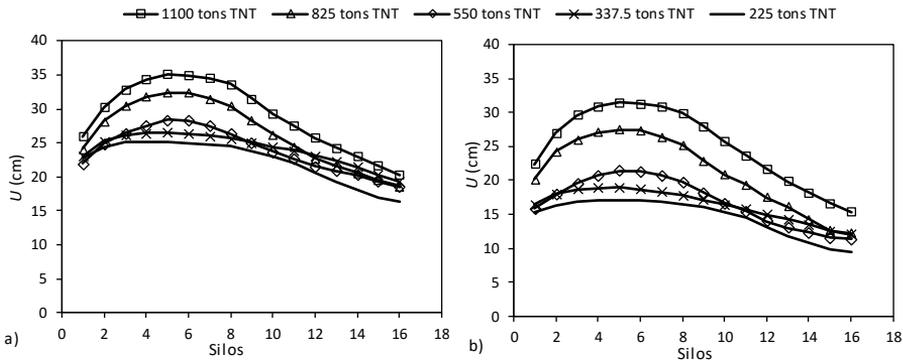
Fig. 23 a) Maximum displacement and b) permanent displacement in the direction of the blast at the head of the silos for different blast magnitudes in the case of no ARC

To assess the contribution of the additional reinforcement and concrete coating (ARC), added from 2000 to 2002 to the outer silos, the damage and displacement behavior of the silos in the case of “no ARC” was compared to the case of “with ARC” (baseline case) for the different blast magnitudes. In the restoration work, the internal wall of the outer rows of the silos was increased by 12 cm and an extra layer of steel reinforcement was added as shown in Fig. 11. The results, presented in Fig. 23 and Table 6, show that the silos with “no ARC” exhibit lower tilting/displacement but a higher amount of damage (in compression and tension) for blast magnitudes greater than 337.5 tons TNT compared to the “with ARC” cases. For example, the ratio of permanent displacement in the direction of the blast for the case “with ARC” compared to the “no ARC” case in silo number 1 is equal to 0.75 for 225 tons TNT, while it is equal to 0.97 and 1.09 for 337.5 tons TNT and 882.5 tons TNT respectively. Similarly, this ratio in silo number 6 is equal to 0.82 for 225 tons TNT, while it is equal to 1.25 and 1.35 for 337.5 tons TNT and 882.5 tons TNT respectively. Therefore, for the estimated blast magnitude 337.5 tons TNT, the case “with ARC” (baseline case) exhibits on average a 5 % greater amount of displacement compared to the “no ARC” case. It should be noted that silos 15 and 16 were destroyed in the blast. For the estimated blast case (337.5 tons TNT), the amount of damage in compression and tension exhibited in the silos is greater in the case of “no ARC” (Fig. 24) compared to the “with ARC” case (Fig. 18). As a result, the FE results indicate that reinforcing the outer silos from 2000 to 2002 played a positive role in the blast by decreasing the amount of the silos’ damage.

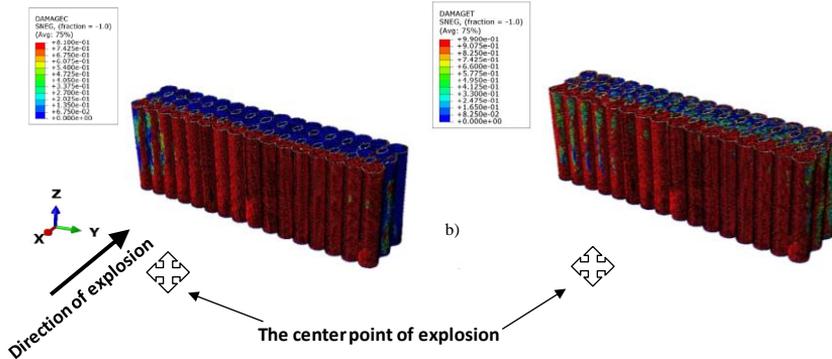
Fig. 24 Damage in a) compression and b) tension 337.5 tons TNT with no ARC (FE)

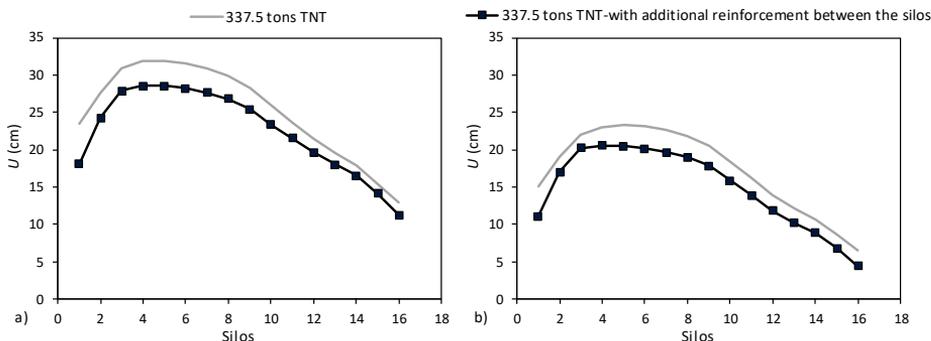
Fig. 25 a) Maximum and b) Permanent displacement in the direction of the blast for the 337.5 tons TNT without and with additional reinforcement in the ribs between the silos

To check if reinforcing the ribs between the silos, such as the ARC performed from 2000 to 2002, would have decreased the damage of Beirut port silos, the estimated blast magnitude 337.5 tons of TNT case was simulated for the case without and with additional reinforcement in the ribs. The numerical results, presented in Fig. 25 and 26, show that if the ribs were reinforced, they would have played a significant role in the blast by decreasing the silos displacement as well as damage amount. At the head of the silos and in the direction of the explosion, the maximum and permanent displacements decrease on average by 12% and 20%, respectively for the case with to without additional reinforcement in the ribs. For example, in silos 4 and 5, that exhibit the maximum displacement and damage amount in the direction of the explosion, the permanent displacement decreases from 23.02 and 23.35 cm to 20.60 and 20.49 cm when reinforcing the ribs. As a result, the FE results indicate that reinforcing the ribs would have not only decreased the silos' displacement, but it would have played a positive role in the explosion by absorbing a small part of the released energy. The strain energy (the energy stored in the model under the blast loading), the dissipated energy (the wasted energy outside the model) and the total energy (the sum of all potential energies in the system) released from

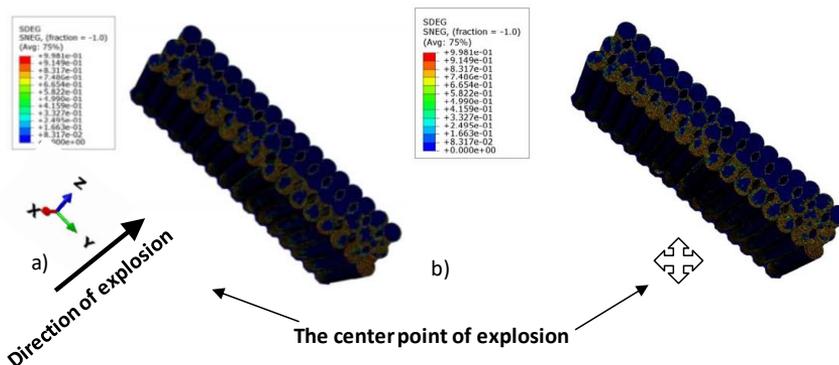
Fig. 26 The SDEG output of the 337.5 tons of TNT simulated cases a) without additional reinforcement and b) with additional reinforcement in the ribs between the silos

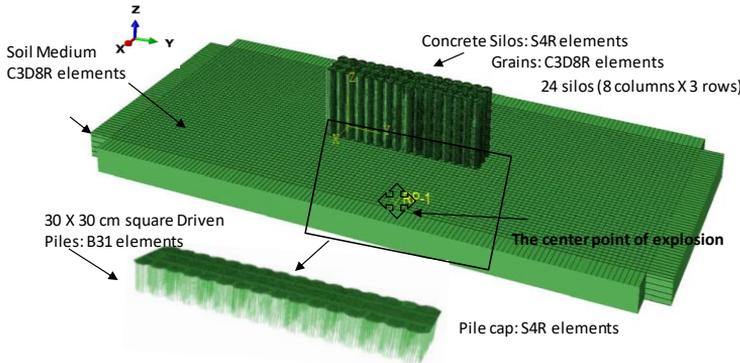
Fig. 27 The FE model (flexible-based model)

The August 4, 2020 explosion released rapid hot gases and produced high temperature and pressure, i.e. enormous amount of energy in only milliseconds. It formed of a blast wave that not only radiated throughout the city, but it radiated in the unbounded soil domain in a form of spherical type wave. Therefore, to check the contribution of the soil and foundation, an extra simulation consisting of the silos, the pile cap, pile foundation as well as the soil medium was simulated for the estimated 337.5 tons TNT blast magnitude (938 tons of Ammonium Nitrate). The displacements at the head, intermediate and near-bottom of the silos were extracted from the FE model. The geometry and properties of the soil and foundation were extracted from the real 1960s plans and designs (Fig. 11). Fig. 27 shows the FE model in flexible-based condition, consisting of the silos, the grains, the 140 X 30 m pile cap, the 2500 30 X 30 cm driven square 15 m length piles as well as the 460 X 200 X 17 m soil medium. In the FE model, and as detailed in Table 2, the pile cap was built using S4R shell elements formed using 7902 elements. Moreover, the pile cap's steel reinforcements were defined as layers of reinforcement as part of the pile cap's shell elements using the rebars command available in Abaqus. Finally, the piles were built using

B31 beam elements using 17868 elements while the soil medium was built using C3D8R solid elements using 30400 elements (Table 2). The typical Mohr-Coulomb model was used to define the plasticity behavior of the soil medium that is formed of a 2 m miscellaneous backfill sand material and 15 m sandy material that presents some levels of gravel and clay (Table 7). In addition, the concrete and steel reinforcements in the silos and pile cap were tied using the tie command in ABAQUS while the silos and the pile cap as well as the pile cap and the piles' interface were modeled by tying the different parts together.

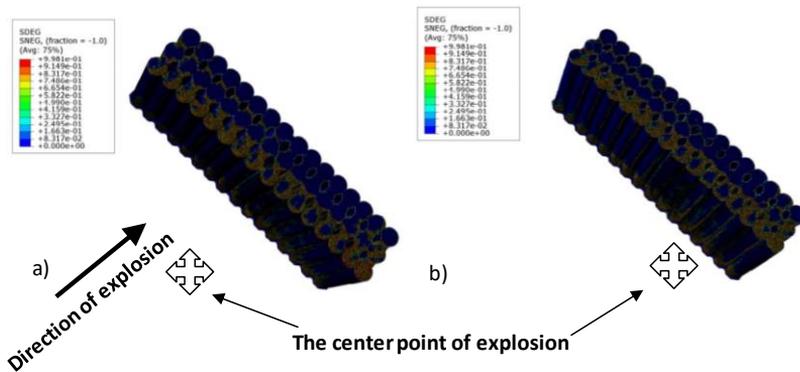
Fig. 28 The SDEG output of the a) fixed and b) flexible-based 337.5 tons of TNT simulated cases

As shown in Fig. 28, that presents the amount of damage the silos exhibited after the blast loading, the numerical results show that in both fixed and flexible-based cases, the first and second row of silos are destroyed while the third row of silos is damaged. Noting that in this row, the last two silos are destroyed (silos 15 and 16). Also, as shown in Fig. 29, silos 4 and 5 exhibit the highest amount of displacement and damage. Therefore, silos 4 and 5 will be used as reference silos in the analysis. The results indicate that, in silos 4 and 5, the maximum relative displacement (head with respect to bottom) only decreases by a ratio of 0.99 while the permanent relative displacement decreases by a ratio of 0.78 from the fixed to the flexible 337.5 tons TNT case. In addition, the average ratio of the maximum and relative displacement from the fixed to the flexible 337.5 tons TNT case at the head level is equal to 1.0 and 0.77, respectively. The increase in silos displacement is also detected at the intermediate level. For example, in silos 4 and 5, the maximum relative displacement (intermediate with respect to the bottom) increases by a small ratio of 1.06 while the permanent relative displacement decreases significantly by a ratio of 0.73 from the fixed to the flexible 337.5 tons TNT case. In addition, at the intermediate level for the 337.5 tons TNT, the average ratio of the maximum and relative silos' displacement fixed to the flexible-based cases is equal to 1.06 and 0.71, respectively.

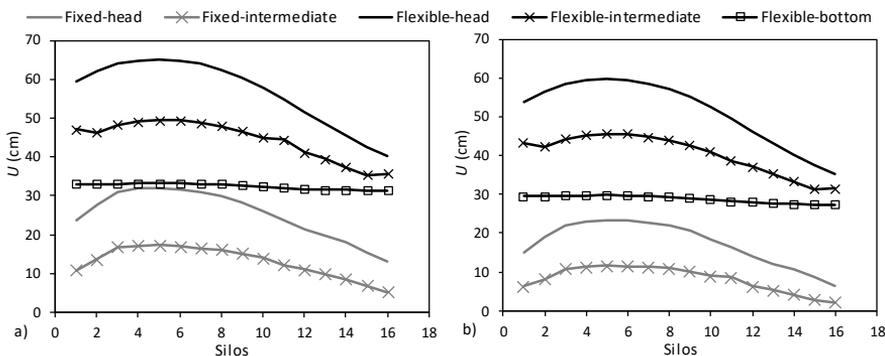
Fig. 29 a) Maximum and b) permanent displacement in the direction of the blast for the 337.5 tons TNT fixed and flexible-based cases

This increase in silos' displacement is caused by the contribution/role played by the soil medium and the pile foundation. Therefore, to examine this contribution, the fixed and flexible numerical models' different types of energies were extracted and compared. The results show that, the decrease in silos' displacement is manifested by a decrease in the amount of strain and damage dissipated energies. These energies decrease by a ratio of 0.82 and 0.78 from the fixed to the flexible-based case, respectively. The strain energy refers to the energy stored in the model while the damage dissipated energy refers to the wasted energy outside the model caused by the blast loading. On the other hand, the total energy released by the model increases by a ratio of 1.32 from the fixed to the flexible-based case while the internal energy, external work and kinetic energy remain almost the same under both models. As a result, even though the silos exhibit a higher amount of displacement when considering the soil and the foundation, the level of damage is very close compared to the fixed-based modeled case. Therefore, the results indicate that the soil and the foundation played a positive role in the explosion by storing more while dissipating less amount of energies. The flexible model absorbed part of the released energy, which only accounts for 0.033% of the total energy released by the August 4, 2021 explosion. The total energy released by the explosion is equal to 1.84×10^{12} J (every 1 ton of TNT releases 4.184×10^9 J) while the external work exhibited by the fixed and flexible-based 337.5 tons TNT case is equal to 590×10^6 J. This value was calculated by dividing the external work exhibited by the FE model to the explosion released energy. The obtained
