## Assessment of properties of rubble masonry used in heritage structure

Online Publication Date: 10 December 2023

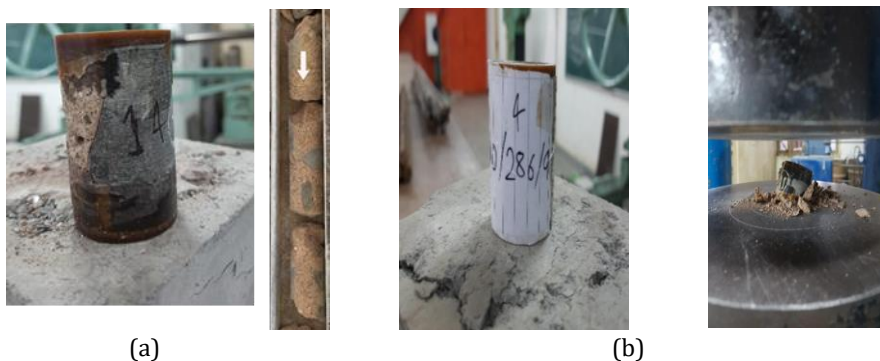
Fig. 2. (a)Core samples before and after capping, (b)Testing of core in CTM

This study examined three core samples as per IS: 456-2000 and IS 516 (Part 4). These standards provide guidelines for core testing to assess masonry quality. The cores were considered acceptable if their average strength met at least 85% of the required masonry strength, and no individual core had a strength below 75%. The study tested 16 cores for various properties, such as strength, water absorption, density, and specific gravity. These properties were compared with the percentage of basalt in the cores and the core's strength.

The core's strength was calculated using methods specified in IS: 14858, and the results were expressed in  $N/mm^2$ . Additionally, a correction factor based on the length-to-diameter ratio of the core specimen after capping was applied, following IS 14858. The core's material composition included lime, surkhi, sand, and basalt, with the mix proportion following standards. The core specimens had a diameter of 50mm, and their average length was 60-80mm. Refer Figure 2(a) and 2(b) for details. A correction factor, represented as "F," was determined based on the length-to-diameter ratio ( $l/d$ ) of the core specimen after capping, using the equation  $F = 0.11N + 0.78$ , where "N" is the length/diameter ratio. This correction factor is used to adjust the cylinder strength, making it equivalent to the strength of a cylinder with a height/diameter ratio of 2. This adjusted cylinder strength is multiplied by 5/4 to estimate the concrete's equivalent cube strength.

In terms of core failure patterns, the samples primarily fail at the interface between the lime surkhi mortar and the basalt components, often in a shear failure pattern. Shear failure occurs when forces applied to the materials cause them to slide along the interface, resulting in material cracks. The comparison between core test values and the analysis-design report values is provided in Table 2, offering insights into how the core test results align with the expected values outlined in the design report.

The failure pattern (Fig. 6) of the samples is predominantly at the interface between the lime surkhi mortar and the basalt components. This type of failure pattern is called a "core cut failure," which arises when a core sample is extracted from a masonry structure to evaluate its strength characteristics. In this context, the interface between the lime surkhi mortar and the basalt is critical in determining the structural integrity. Failure can be a shear, tensile, compressive, and debonding failure. However, the failure pattern is attributed to shear failure in the test scenario under consideration. Shear failure occurs when the forces applied to the materials cause them to slide against each other along the interface, resulting in cracks in the material. Comparison between core test values and analysis–design report values are given in Table 2.

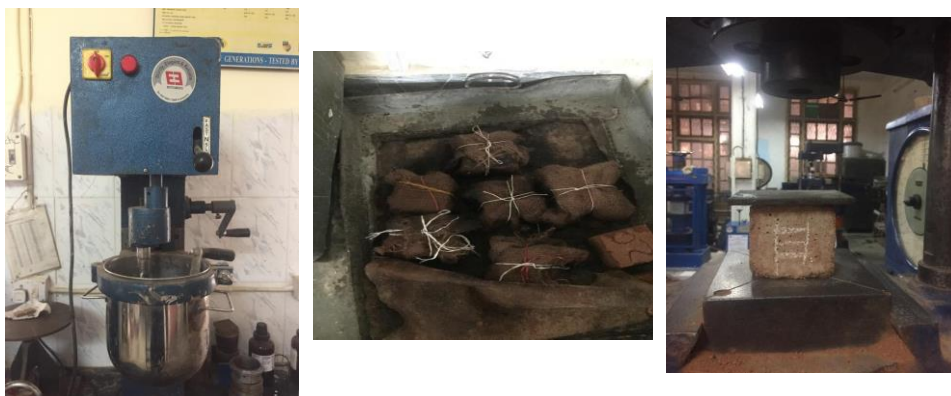
Fig. 3. (a) Mortar mixer, (b) curing of Lime mortar cube, and (c) UTM for compression test

- Lime slaking: Lime was slaked in water for seven days.
- Batching of materials: The materials were batched according to the mix design, which was 1:4:15 (Lime: Surkhi: Sand).
- Calculating lime density: The density of lime putty was calculated by measuring the weight of an empty vessel ( $w_1$ ) and the weight of the vessel filled with lime putty ( $w_2$ ). The density of lime putty was determined using a table from IS 712-1964.
- Mixing: Lime putty was added to a mixer and stirred to remove air bubbles. Dry surkhi was added, and the mixture was stirred for 5 to 7 minutes. Water was added as needed to make the mixture homogeneous. Finally, sand was added, and the mixer was operated until the mixture was properly homogeneous. (Figure 3 (a))

- Water absorption measurement: On the day of casting, the dry weight of the cubes was measured. The water absorption of the cubes was calculated by subtracting their dry weight from their saturated weight.
- These cubes were then tested in the universal testing machine (UTM) (Figure 3 (c)) for compression,
- and results were noted down

Nine cubes underwent testing, with each set of three cubes subjected to compression tests at 7, 14, and 28 days, respectively, using a Universal Testing Machine (UTM) as depicted in Figure 3(c). The corresponding compressive strength results for these durations are provided in Table 3, and a visual representation is presented in Figure 7. A notable trend is observed in the compressive strength, indicating a 54.025% increase from 7 to 14 days and a further 57.09% increase from 14 to 28 days. This suggests a linear increase in strength with the extension of curing time up to 28 days, as illustrated in Figure 7.

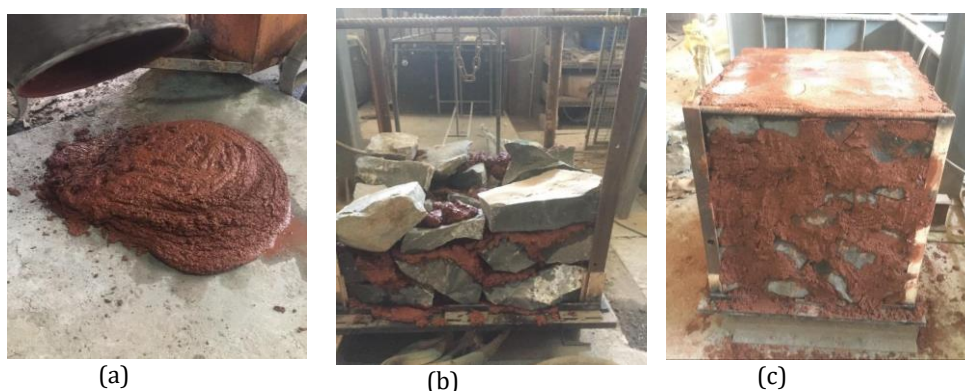
Fig 4. (a) Lime mortar, (b) Preparation of rubble masonry, and (c) final prepared rubble masonry cube

A specially fabricated 600x600x600mm test mould for rubble masonry was constructed, featuring a 20mm thick base plate and a 700x700mm height. An angle section was added at the corner to create a square cage, offering support and defining the mould's size boundary (See Fig 4©). Compression testing machine (CTM) with hydraulic lifting mechanism: A compression testing machine of 400 tones capacity was used to apply load on rubble masonry. Lime mortar preparation and arranging rubble masonry in layers can be seen in Fig 4(a) and Fig 4(b) respectively.

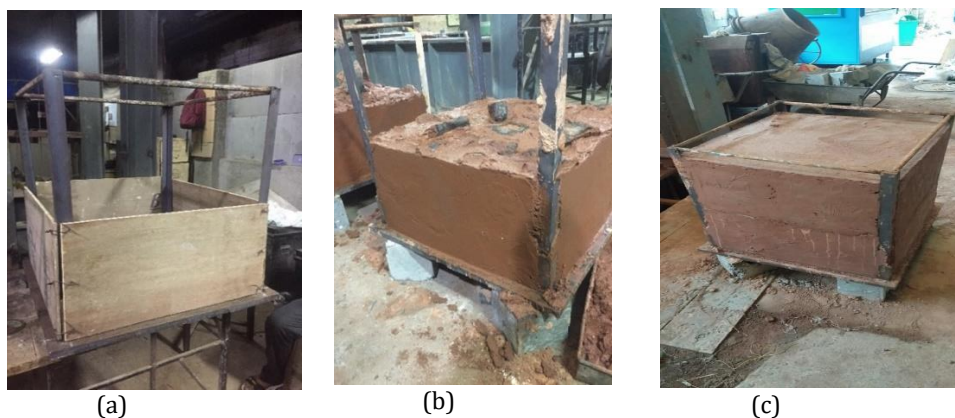
Fig. 5. (a) Wooden shuttering of mould, (b) 1<sup>st</sup> phase casting of cube, and (c) final rubble masonry cube after phase 2

To prepare three rubble masonry cubes of size (600x600x600mm), same as above, three moulds of cubes with wooden shuttering were designed (Figure 5(a, b)). Wooden shuttering helps with the smooth finishing of rubble masonry cubes with mortar. It also allows for the confinement of the mould. Wooden shuttering of mould is shown in Figure 5(a). Casting of the cube is done in 2 phases. In 1<sup>st</sup> phase, 50% casting of 3 cubes is done. i.e., up to a height of 300mm. In 2<sup>nd</sup> phase, on the next day, the remaining casting is done.

For casting, mortar volume was considered 30% of the total volume of 3 molds. The remaining 70 % of the volume was occupied by basalt stone sizes ranging from 5cms to 30cms, see Fig. 5(b). Rubble masonry cube was cast in 2 phases. In 1<sup>st</sup> phase, 50% of casting up to a height of 300mm was done, as shown in the figure. During casting, initially, a layer of lime mortar was placed at the bottom of the mould. Stones of sizes ranging from from 5cms to 30cms were used. A skilled mason did the placing of stones with experience in this field. All the gaps between these stones were filled by prepared lime mortar. The workability of mortar should be such that it should fill all the voids between stones. The same procedure was repeated as above for 2<sup>nd</sup> phase of casting(Fig 5(c)), which should be done on the 2<sup>nd</sup> day of 1<sup>st</sup> phase. After the construction of both phases, wooden shuttering was removed and kept from curing, as shown in the figure below. The curing of the cube was done by sprinkling water regularly.

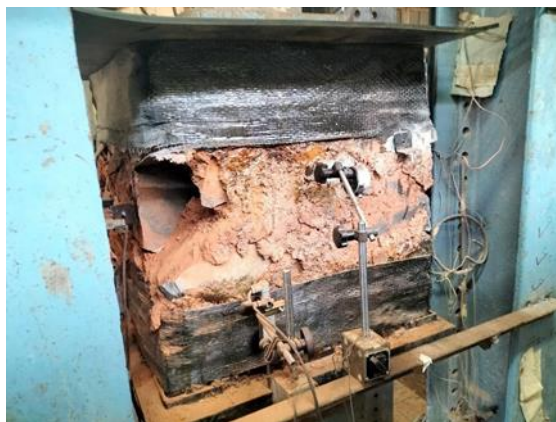
Fig 8 Failure of cube

After applying load in CTM, the cube failed at 38 tonnes, equivalent to 1.034 Mpa. Failure of the cube is shown in Figure 8. The reason for this failure can be attributed to factors like the composition and quality of the materials used in the cube's construction, the curing

conditions, and the structural integrity of the cube itself. The cube's breaking load and its conversion to stress provide valuable insights into its compressive strength, which is a critical parameter in assessing the performance of masonry materials and structures under load-bearing conditions.

From the failure of the cube, it is observed that mortar strength is the governing factor for the strength of rubble masonry, as the failure strength of rubble masonry cube closely resembles the strength of lime mortar cubes. (1 MPa).

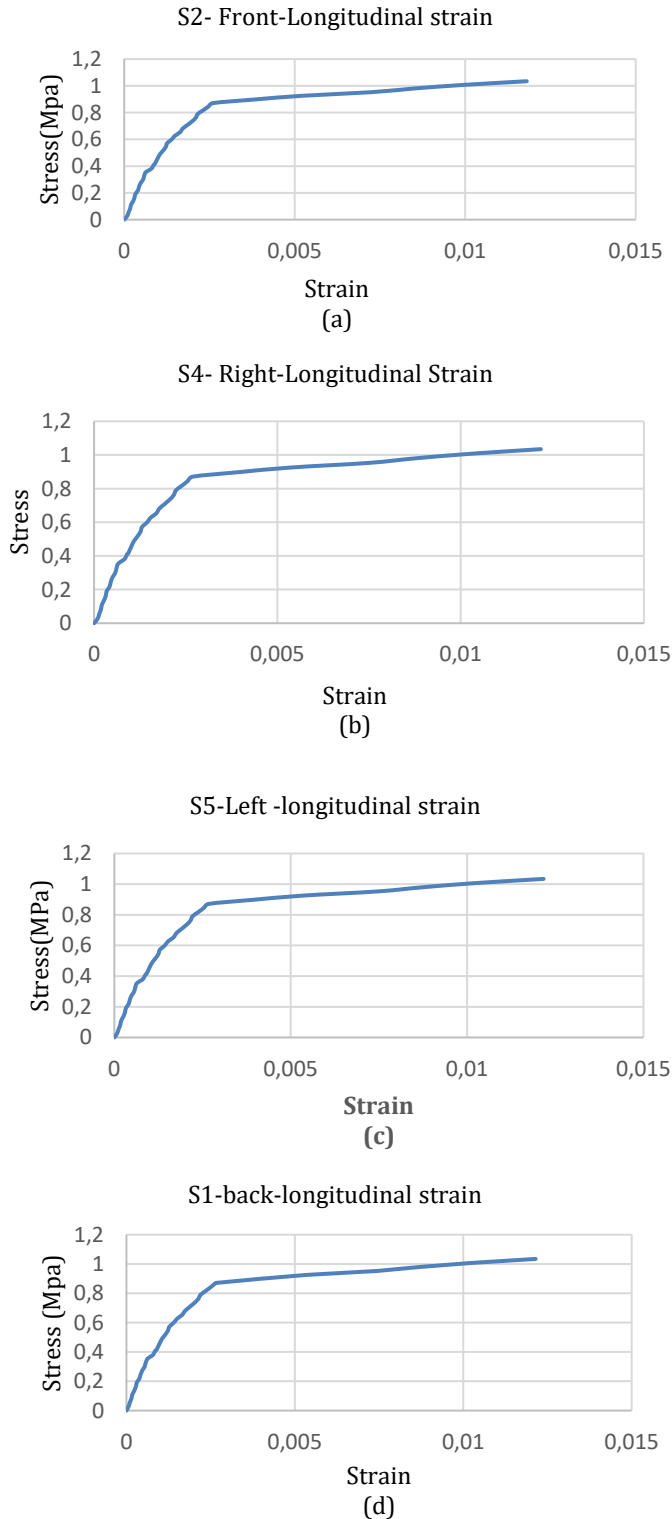
Fig. 9. Stress vs strain (a), (b), (c) and (d)

From the stress vs strain graph as shown in Fig.9 (a-d), it is observed that for all the strain gauges, nonlinear behaviour is observed till the visible peak point of strain value of 0.0026 at 0.87MPa and after that, strain continuously increases from 0.0026 to 0.012 with an increase in strength from 0.87MPa to 1.03MPa. Later behaviour resembles linear behaviour. From LVDT readings, the average modulus of elasticity(E) is 458.4427109 Mpa, and the Poisson's ratio( $\mu$ ) is 0.211.

The stress-strain graph of rubble masonry exhibits a distinctive pattern: initially, the graph follows a parabolic shape, signifying a nonlinear stress response. As the strain increases, the curve transitions into a more linear trajectory. This behaviour suggests that at lower stress levels, the material undergoes deformation with a nonlinear relationship between stress and strain. However, as the stress increases, the response becomes more consistent and linear, indicating a more predictable deformation pattern. This observation shows the complex mechanical behaviour of rubble masonry, highlighting the need to consider its nonlinear and linear aspects for accurate structural analysis and design. From LVDT readings, we can conclude that the average modulus of elasticity (E) is 483.54 MPa, and the Poisson's ratio ( $\mu$ ) is 0.225 (Refer Table 5). This modulus of elasticity signifies the material's ability to deform elastically under an

applied load and return to its original shape once removed. A higher modulus of elasticity indicates a stiffer material that undergoes minimal deformation. A Poisson's ratio of 0.225 suggests that the material experiences a relatively small lateral expansion when subjected to axial compression or tension. This value aids in understanding the material's deformation behaviour and is crucial for accurate structural analyses and design considerations. From the failure of the cube, it is observed that mortar strength will govern the strength of rubble masonry, as the failure strength of rubble masonry cube closely resembles the strength of lime mortar cubes. (1 MPa).
