## Stress analysis of aircraft tow hook using non-destructive testing techniques and numerical simulation

Ömer Kurt, Mesut Uyaner

Aircraft tow hook;  
Non-destructive testing techniques;  
AISI 4130 alloy steel;  
Finite Element Method;  
Stress analysis;  
Safety factor

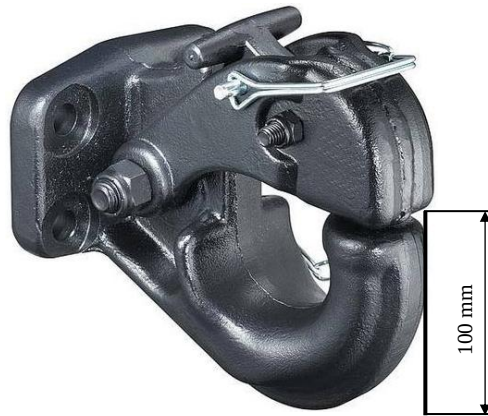
Fig. 1. Aircraft tow hook

Forged components made of AISI 4130 alloy steel are widely used in the oil and gas, aerospace, agricultural, and defense industries, where reliable strength and toughness are required. Typical applications include forged valve bodies, pumps, and other medium- to low-stress structural parts. Fig. 1 shows the aircraft tow hook examined in this study, which was manufactured from AISI 4130 steel by hot forging at approximately 1000 °C. After forging, the hooks were oil-quenched from 850

°C and subsequently double-tempered at 560 °C and 530 °C, respectively, to achieve a balanced combination of strength and ductility.

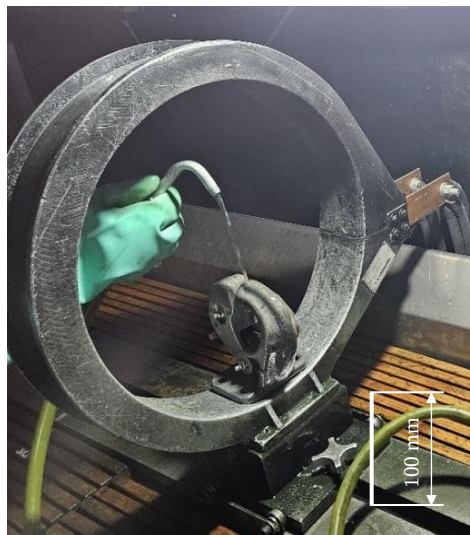
Fig. 2. Aircraft tow hook sample washing with magnetic particle testing solution

Prior to testing, the hook was thoroughly cleaned to remove all grease and contaminants. The main purpose of this cleaning was to prevent any residual substances from concealing potential discontinuities. It was then positioned within a device equipped with a five-turn coil (Fig. 2).

Magnetic particle inspection was performed according to ASTM E1444/E1444M-25 and ISO 9934-1/-3 using a Magnaflux ZA-1633 wet horizontal bench unit. The tow hook was magnetized circularly by-passing current through a five-turn coil, inducing circumferential fields across the hook section. ASTM-E1444 refers to ASTM-E709-21 for calculation. The magnetizing current was calculated utilizing Eq (2) [23].
