Effects of elevated temperatures on the stress-strain behavior and microstructure of normal and high-strength concrete

Amenah M. Abdulrazzaq, Haider A. Abdulhameed, Maan S. Hassan

Journal Abbreviation: *Res. Eng. Struct. Mater.*

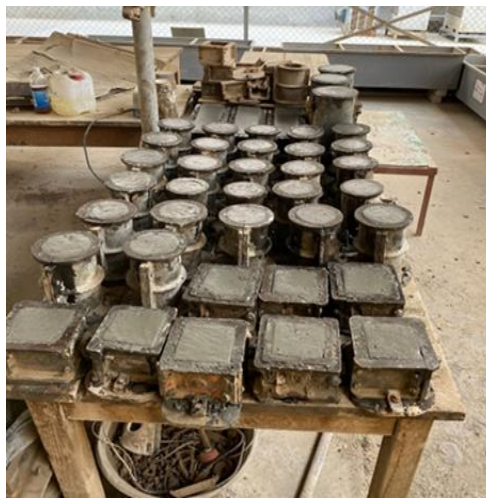
Fig. 1. Concrete specimens' preparation

In order to attain the required compressive strengths of 35 MPa and 55 MPa after 28 days of curing, the concrete mixes were made in compliance with ACI 211.1 criteria. An electric mixer was used to create homogenous concrete mixtures at the ratios [1:2.1:2.16:0.4+1.2 L/100kg of cement admixture] and [1:1.68:1.72:0.3+1.8 L/100kg of cement] [cement fine aggregate: coarse aggregate: W/C ratio admixture] for C-35 and C-55, respectively. To increase the concrete's water content efficiency, a chemical addition based on polycarboxylic polymers was used, which produced a slump of 19.5 cm. In order to remove air spaces and ensure adequate compaction, specimens were cast in two layers using steel molds and then compressed using vibrating tables. Before being demolded, the specimens' upper surfaces were polished with a trowel and covered with sheets of polyethylene for a whole day. The samples were then submerged in a tank of water for 28 days to cure before to the incineration process.

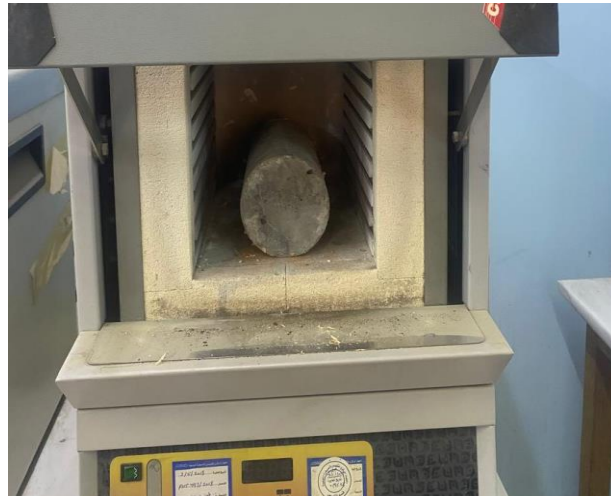
Fig. 2. Electric furnace used to expose the specimens to elevated temperature

In an electrical furnace, the cured concrete cylinders were heated to 400°C, 600°C, and 800°C for two hours at a rate of five degrees Celsius per minute. When the furnace reached the desired temperature, the retention time began. Following the heating phase, the furnace was switched off, and the specimens were left to cool within the furnace for 24 hours prior to reaching room temperature by air cooling [24,36].

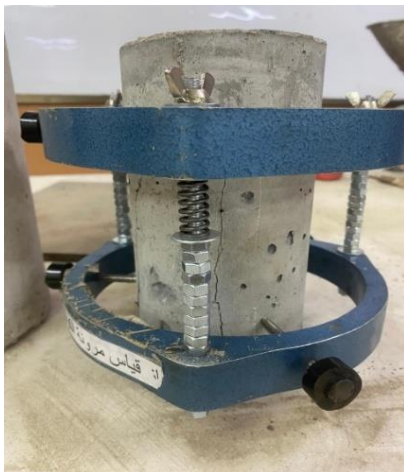
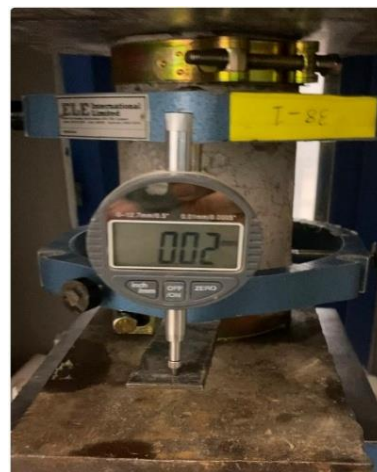
Fig. 3. Testing setup for the uniaxial compressive strength test

All post-cooled concrete cylinders were tested under uniaxial compression stress at the compression machine with a 2000 kN capacity, used to test the load capacity and stress-strain performance. All concrete cylinders were tested under uniaxial compression to measure the load capacity and stress-strain performance of the concrete columns. A compression testing machine was used to apply loads on the specimen, with the setup including a specialized ring for measuring the Modulus of Elasticity. This ring was equipped with a gauge to record lateral deformations. The test bolts were installed on the specimen at a height of 10 cm from the top and 10 cm from the bottom. Fig. 3 illustrates how the testing procedure is set up. In order to prevent premature collapse in the areas next to their ends, the columns were also constrained by steel rings at both ends.

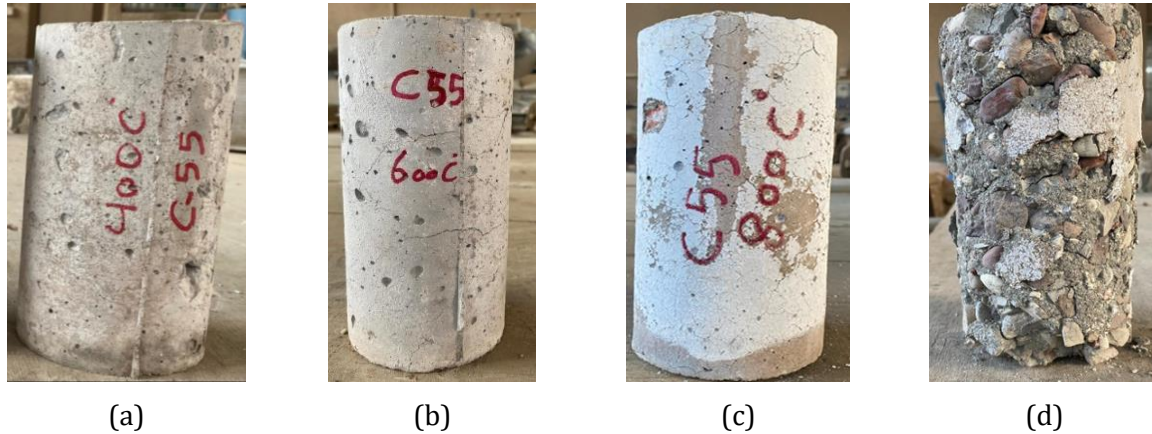
Fig. 5. Compressive strength tested specimens of C-55 cylinders after heating: (a)T400, (b) T600, (c) T800 before aging, (d) T800 after aging
