## Evaluation of runways for Al-Habbaniya air base in Iraq

Mustafa Imad Ahmed, Alaa H. Abed

Civil Engineering Department, AL- Nahrain University, Baghdad, Iraq

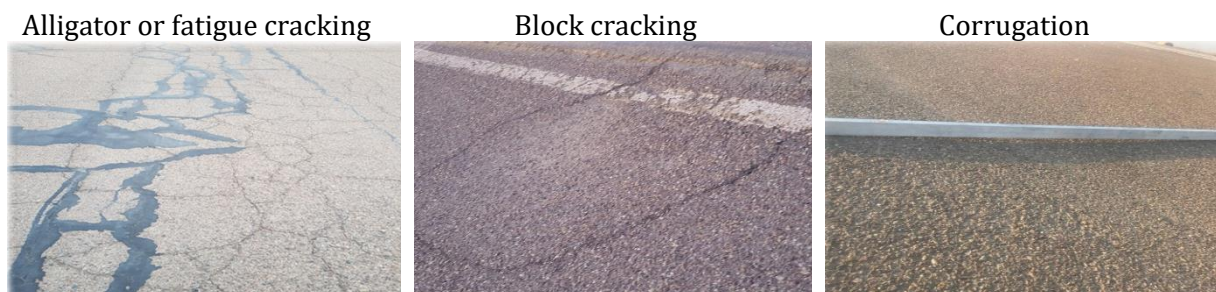
The evaluation revealed significant distress in the asphalt layers, including alligator or fatigue cracking, characterized by interconnected cracks resembling alligator skin caused by repeated traffic loading. These cracks, originating from the bottom layer and extending to the surface, often require reconstruction in severe cases [11]. Block cracking, another common defect, is primarily caused by asphalt shrinkage and temperature fluctuations, resulting in rectangular patterns unrelated to traffic loads but varying in severity. Corrugation, or wash boarding, was identified as closely spaced ridges and valleys perpendicular to traffic direction, caused by unstable pavement or subbase layers. Reconstruction is necessary to meet ASTM standards, Figure 2.

Fig. 2. Asphalt pavements distresses

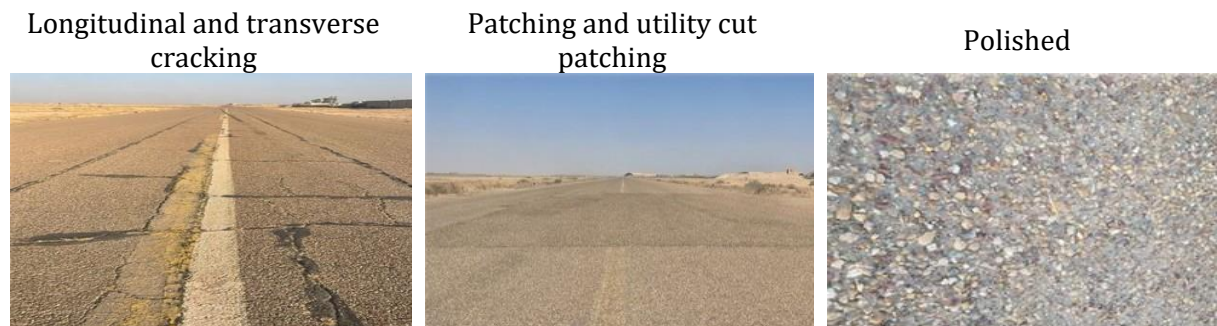
Longitudinal and transverse cracks, indicative of sub-structural concerns, were noted. Potential longitudinal cracks are appearing along the direction of the pavements which are connected to bad quality in construction or material deterioration, while transverse cracks where emerged induced by temperature stress. Other repairs, like patching and utility cut patching, are all noted as defects,

since they generally show roughness and will deteriorate much faster than the original pavement, which has an impact on ride quality. Traffic wear results in polished aggregate, creating a smooth surface that decreases skid resistance and decreases vehicle traction, Figure 3.

Fig. 3. Problems of asphalt runways

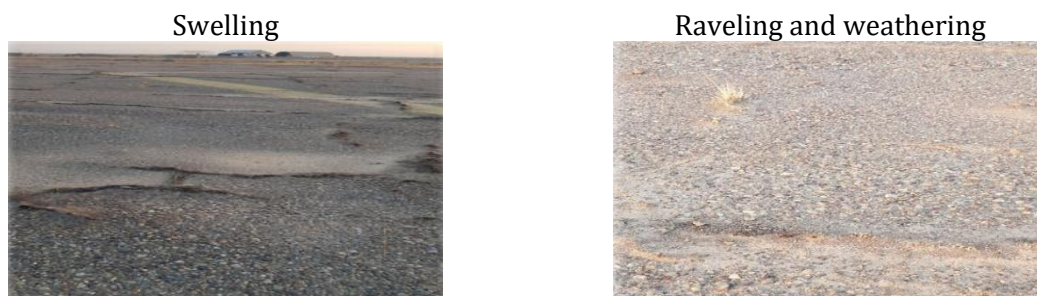
Swelling, identified by upward bulges in the pavement, is caused by swelling soil, leading to surface deformation and cracking. Lastly, raveling and weathering were prevalent, with surface degradation attributed to asphalt aging, poor-quality mixtures, or environmental factors like oil spills, resulting in the loss of aggregate particles and compromised pavement performance, Figure 4.

Fig. 4. Soil and weather problems

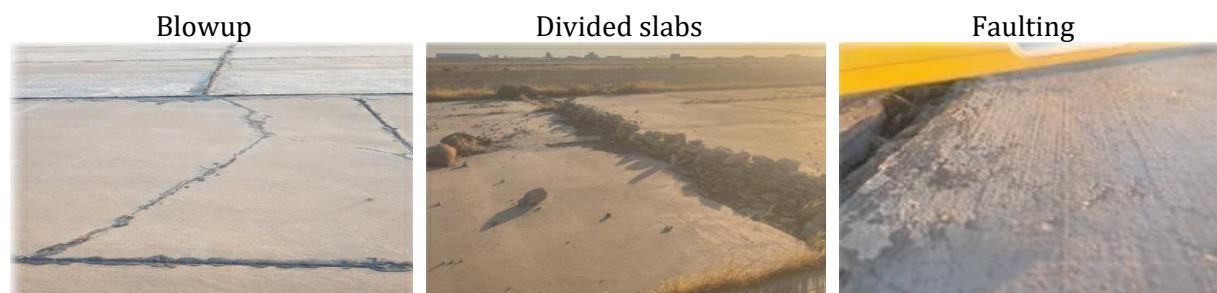
The evaluation of concrete pavements at the runway revealed several significant defects [12]. Instances of blowup or buckling were observed, particularly during hot weather, caused by insufficient expansion space due to incompressible materials infiltrating joints. This results in upward slab movement and deformation, requiring immediate intervention. Divided slabs were another common defect, where slabs fractured into multiple pieces due to overloading or inadequate support. Repairs ranged from sealing cracks to full slab replacement. Faulting was identified across several joints, characterized by elevation differences between slabs, caused by foundation settlement or erosion. Slabs with significant elevation differences require recasting, Figure 5.

Fig. 5. Concrete pavement distresses

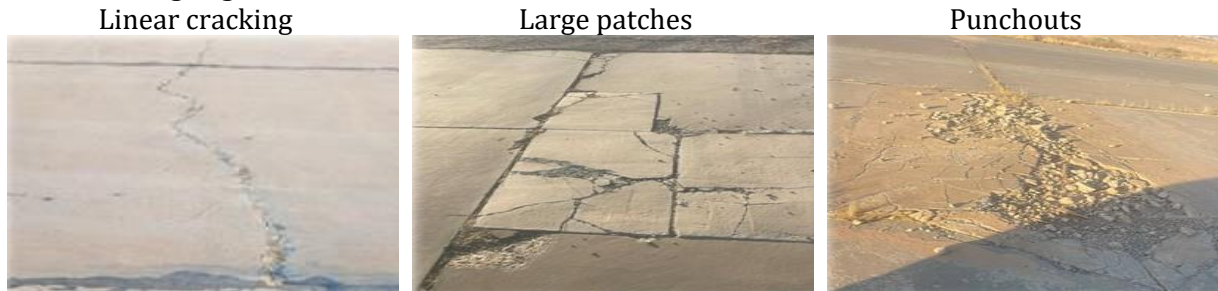
- Linear cracking in the form of longitudinal, transverse, and diagonal cracks was observed, often caused by repeated loads, thermal gradients, and moisture. Low-severity cracks posed minimal risks, but medium-to-high severity cracks were structurally significant.

- Large patches and utility cut repairs exceeding 5 square feet were found, often deteriorating faster than original pavement. Severe cases require recasting to meet ASTM standards.
- Punchouts, or localized slab fragmentations were common near cracks and joints, often resulting from repeated heavy loads and insufficient slab thickness. These necessitate recasting, Figure 6.

Fig. 6. Types of cracks and patches in runway slab

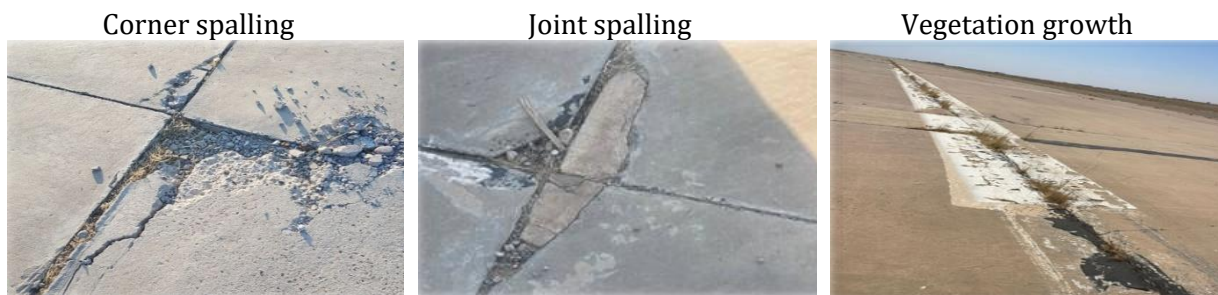
Corner spalling was identified as deterioration near slab corners due to stress and material degradation. Partial-depth patching was recommended for minor cases. Similarly, joint spalling, occurring along slab edges, was caused by traffic stresses, material infiltration, with repairs ranging from patching to joint reconstruction. Lastly, vegetation growth in cracks indicated possible water infiltration and soil salinity issues, suggesting inadequate drainage and potential structural instability. Comprehensive repairs and preventive measures are recommended to mitigate these distresses, Figure 7.

Fig.7. Stress and material

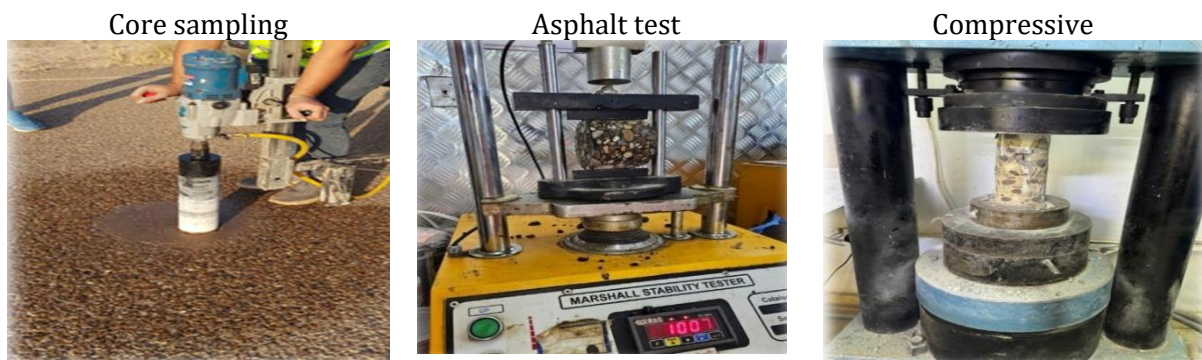
These tests are essential for evaluating the structural integrity and quality of the pavement [13]. The data provides insights into the core samples' condition, helping us assess whether the pavement meets the required standards, in regarding the asphalt, 18 cores were extracted from the main runways, taxiways, and branch runways as shown in Figure 8.

Fig. 8. Sampling and tests

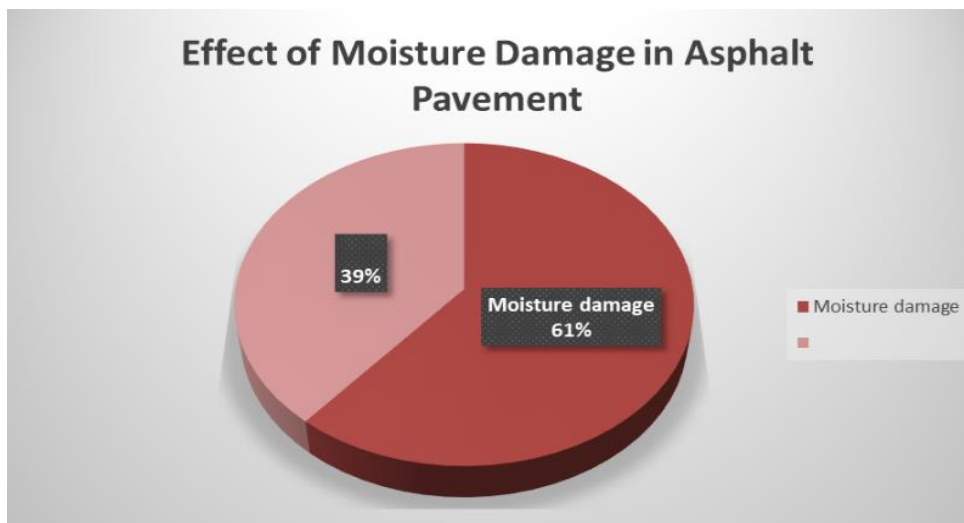
Fig. 10. The effect of moisture damage in asphalt pavement

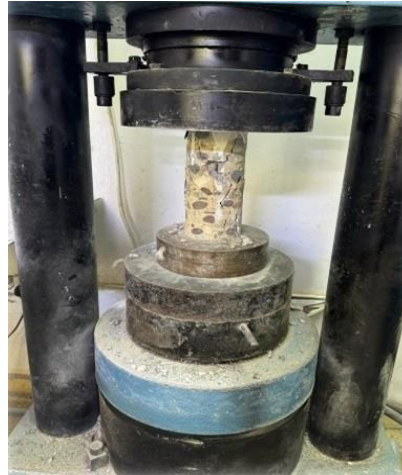
In regarding the concrete, 12 cores were extracted from the main runways, taxiways, and branch runways. Concrete core sampling test was conducted as well, it involved extracting cylindrical samples to analyze the material composition and condition and for further laboratory analysis to assess material quality and perform the necessary physical and chemical laboratory test, Figure 11 [14]. The compressive strength results shown in Table (3), which range from 11.95 MPa to 29.01 MPa, indicate that most of the samples do not meet the required standards for concrete used in runway construction. The majority of the values fall below the acceptable threshold, suggesting that the concrete is generally weak.

Fig. 11. Cores are being tested
