In-situ investigation of earthen building materials in the Ksour of the Ziban region, Algeria: A comparative study between Chetma and Lichana

Amdjed Islam Dali ^{*,1,2,a}, Sami Zerari ^{2,b}, David Gandreau ^{1,c}

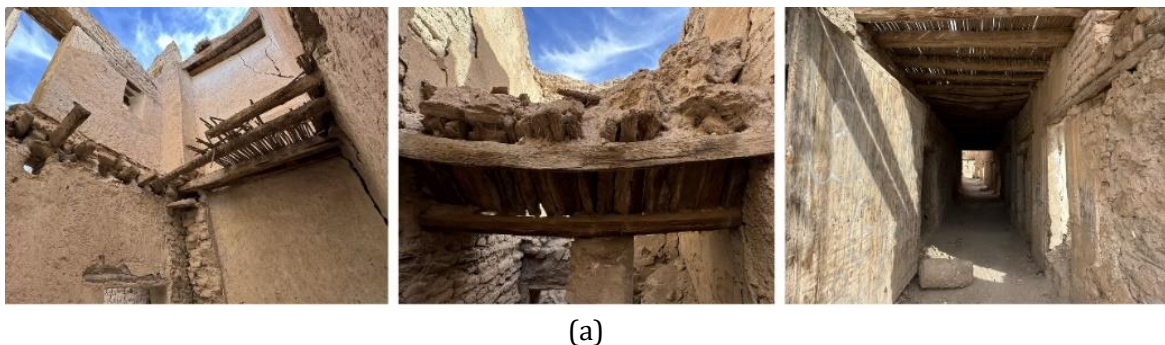
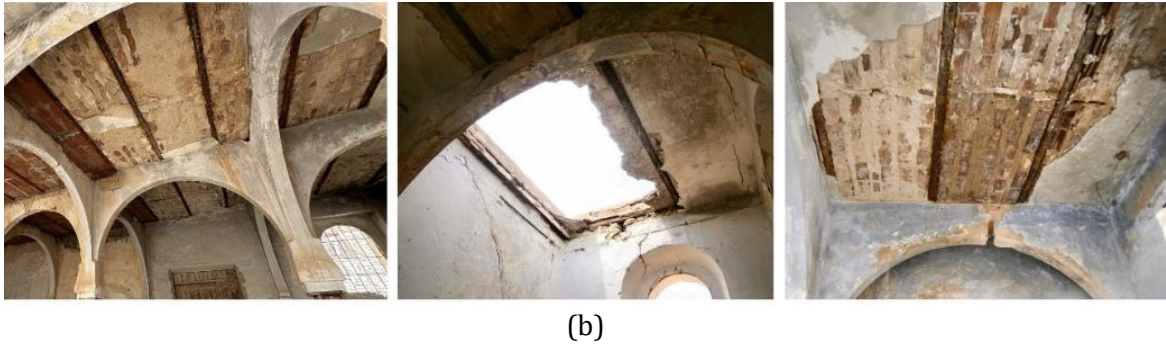
Fig. 7. Views of the roof structures in the ksar of Lichana: palm wood post-and-beam; b) IPN joists of the mosque. Photos by authors, 2024

The mosque of Lichana features a distinctive building element: its roof was constructed using IPN joists (I-beams) filled with fired hollow bricks, a building technique that reflects French colonial influences (Fig. 7), as stated by Dali and Belakehal [20]. However, the locals have managed to preserve the authenticity of the two ksour, as no significant changes in construction techniques or new materials have been observed. This resilience is primarily attributed to *Touisa*, an ancestral

In the ksar of Lichana and Chetma, the load-bearing walls were built in an English bonding pattern (in French: *Appareillage debout*) and coated on both the outside and inside with an earth-based plaster, giving the walls a harsh texture (Fig. 6 and Fig. 8). In addition, the mud bricks used are rectangular with dimensions of 40x20x10 cm. However, it is possible to find mud bricks 36 or 37 cm long. Palm trunks are utilised for vertical and horizontal structural elements like pillars, beams, and joists (Fig. 7 and Fig. 9).

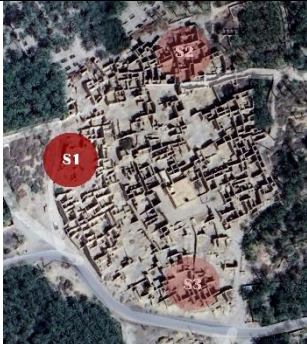
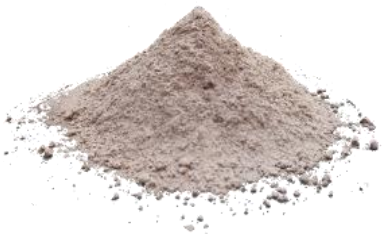
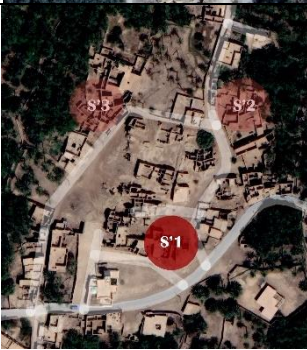
Table 1. Collection and preparation of mud brick samples (S1 and S'1) for testing. Elaborated by authors, 2024

Field tests were carried out on two samples: one taken from the ksar of Lichana (S1), specifically a piece of mud brick that was retrieved from a ruined house near the western gate of the ksar. Despite the deterioration of its original structure, the piece of brick appeared in relatively good condition, making it a viable specimen for detailed earth analysis (Table 1). The second sample (S'1), concerning the ksar of Chetma, was taken from a ruined property between the two mosques of the

ksar. According to the local people's oral history, the brick-making earth originated from Ouldja, north of the ksar, and was transported by donkeys. The mud bricks appeared in relatively good condition, making them viable specimens for detailed earth analysis (

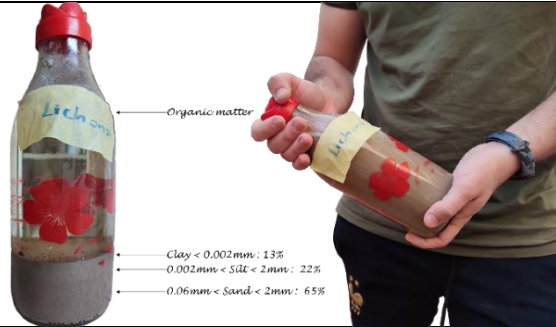
Tests	Observation and interpretation	Tests' illustrations
Sedimentation in bottle	This earth comprises grains of different sizes (clay 13%, silt 22%, and sand 65%). The test indicates a sandy earth with probably some clay and silt.

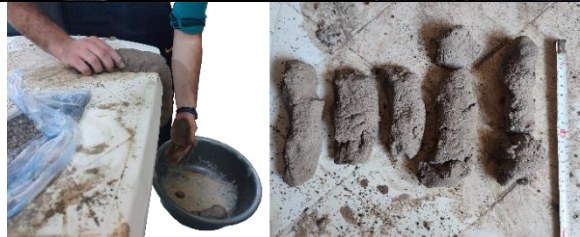
Cigar test	The cigar is cut to an average length of 11.73 cm, indicating a significant level of earth cohesiveness.

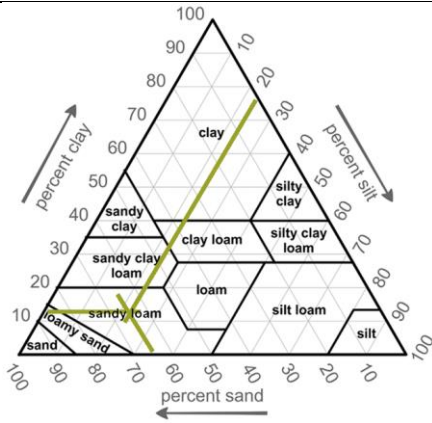
Soil Texture Triangle	The earth is a balanced mixture of sand (65%), silt (22%), and clay (13%), which means it is a sandy loam earth.

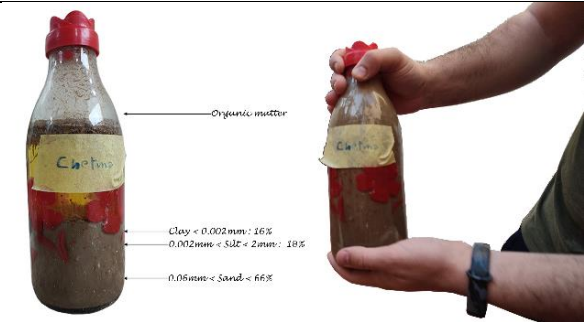
Tests	Observation and interpretation	Tests' illustrations
Sedimentation in bottle	This earth is a mixture of different grains (16% clay, 18% silt, and 66% sand). The test conducted indicates that it is sandy in nature.

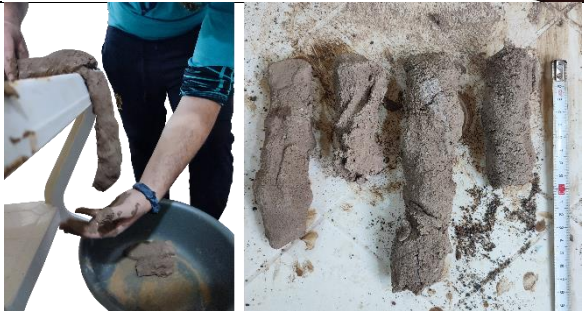
Cigar test	The cigar is cut to an average length of 13.67 cm. This earth is more cohesive than the first sample from Lichana.

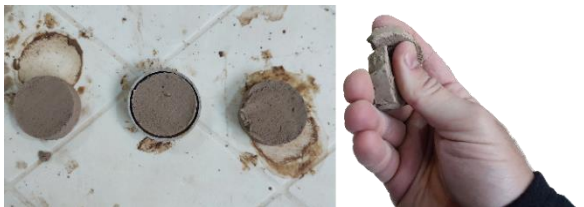
Pellet test	The shrinkage of the pallet was greater than 1 mm. Breaking it required significant force, and the sample was not very friable. This demonstrates the excellent cohesion of the clay in the earth.
