Blow-out analysis of head race tunnel: A case study of Solu Khola (Dudh Koshi) hydroelectric project, Nepal

This paper examines the analysis, rectification, and performance of the blowout that occurred at chainage 1+154.12 meters (critical section) in the Head Race Tunnel (HRT) of the Solu Khola Dudh Koshi Hydroelectric Project in Eastern Nepal. The Tunnelling Quality Index (Q) for the critical and adjacent to the collapsed section was derived using probe drilling results and face mapping. The rock support system was evaluated using the Q-system support chart and is validated with the finite element-based program Rocscience (Phase²). The parametric study was conducted to evaluate the support required for varying the overburden depth from 100m to 650m. The tunnel convergence at the critical section was observed almost for two years before application of final rock supports and was found to be a maximum of 4.277 mm at 27 days, which was quite low and within acceptable limits. The performance study has also been carried out for nearly two years and has been found to be in stable condition since its commissioning. This study presents practical rectification procedure for blowout analy

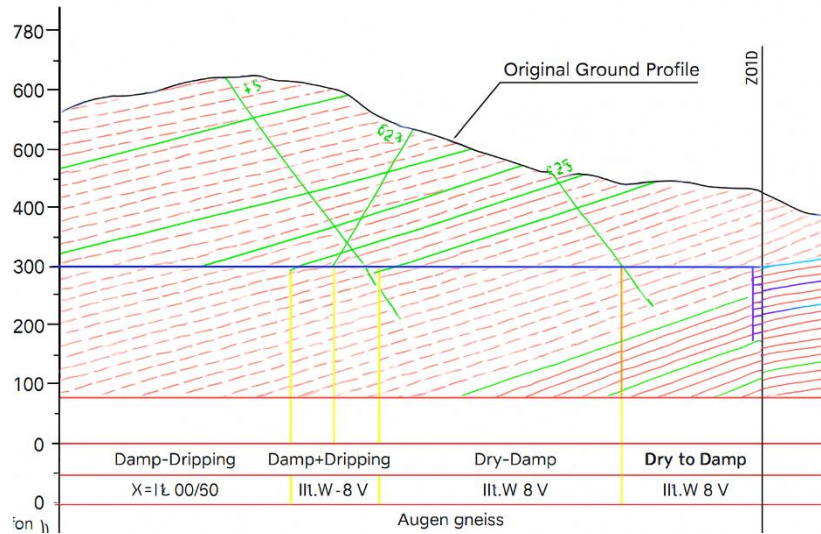
Fig. 3. Longitudinal profile of the project

vertical shafts and horizontal underground sections up to bifurcation that convey water to the 3-pelton runner (vertical axis) in the surface powerhouse located on the right bank of the Dudhkoshi River at Maikhu-Besi, in the foothills of the world's highest peak, Mount Everest.

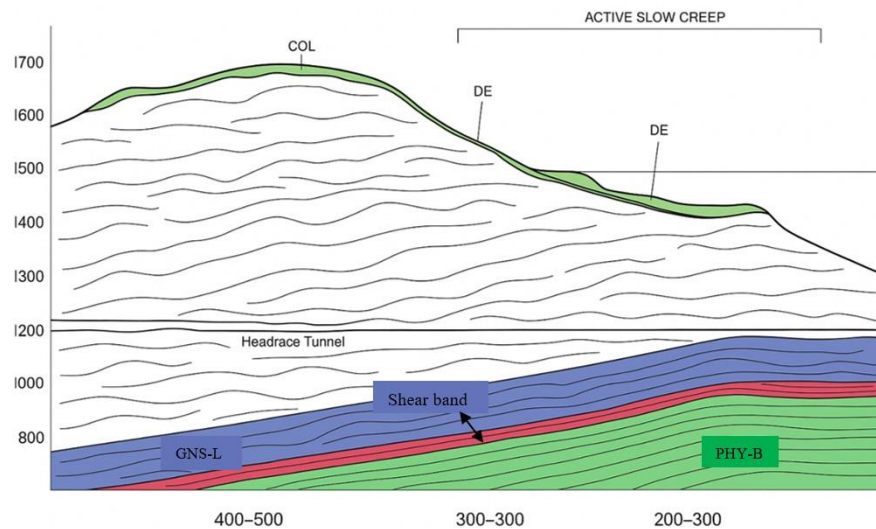
Fig. 5. Geological profile along the HRT

The project area is situated in the Kuncha formation, which consists of green phyllite of Precambrian age, metasandstone, and quartzite. The area also contains Palaeozoic-aged Augen gneiss. Along the MCT, the tectonic window is separated from the overlying higher Himalaya rock. It is a large dome-shaped anticline deeply cut by the major river, exposing a deep section of the Lesser Himalaya Sequence (LHS). Based on lithology, three stratigraphic sequences of the LHS have been identified in the Okhaldhunga Window, from bottom to top: Lower Nawakot Group, Upper Nawakot Group and Higher Himalaya. The geology along the headrace tunnel is also influenced by three vertical fault zones, 30-35m thick, formed by fractured, brecciated rocks with fine grained fault gouges at around Ch. 0+350 m, Ch. 2+450 m, and Ch. 3+600 m and could be encountered

locally for the presence of low angle weak schist bands (shear planes) parallel to foliation, see Figure 5.

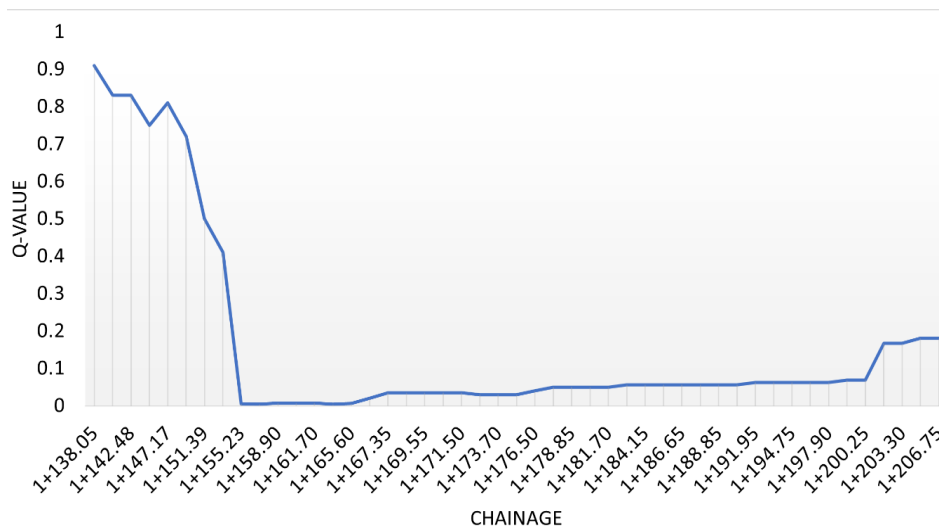
Fig. 10. Variation of Q-value in the problematic stretch

As demonstrated in Figure 10, the rock mass Q-value gradually decreases from 0.833 to 0.0042 (from Ch.1+42 m to 1+156 m), indicating exceptionally poor rock. This is due to the deterioration of rock mass characteristics. The rock mass quality assessment was carried out using geological face mapping with visual inspection and each discontinuity parameters are observed for the Ch.1+42 m to 1+156 m. Table 5 shows the rock mass quality assessment Ch.1+42 m to 1+156 m after post collapse.

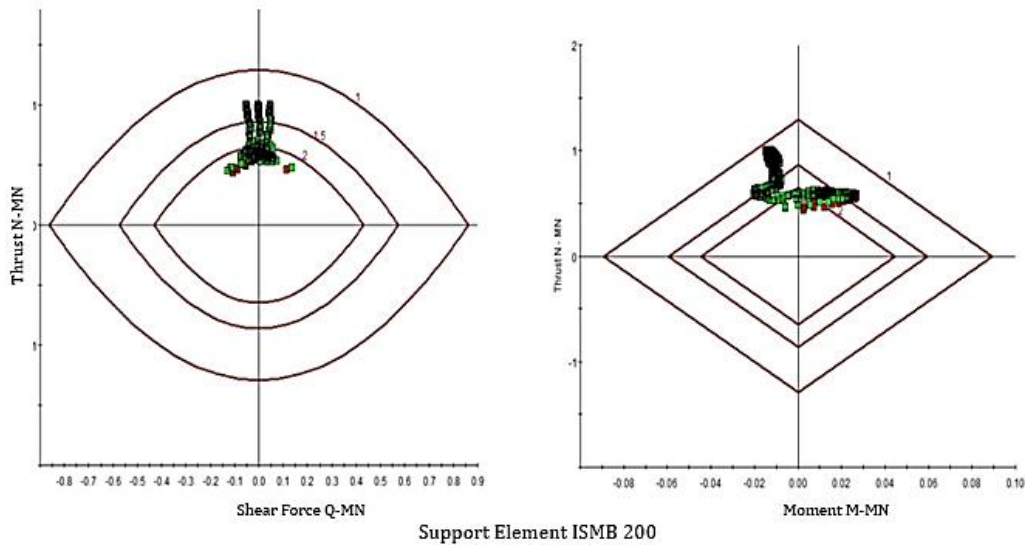
Fig. 16. Support capacity plot of ISMB 200 at 1m c/c spacing

Support capacity plots are used to check the stability of the applied supports, which includes envelopes of the lining support for different factors of safety and each support finite elements as points. Figure 16 indicate the support capacity plot of ISMB200 at 1m c/c spacing, whereas Figure 17 represent the plot for final concrete lining of 25cm thickness. The MN curve shows the relationship between applied bending moment and associated tensile capacity of the section.

The aforementioned figures shows that the support element of Rib fall inside the capacity plot of 1.0. It can be concluded that the use of ISMB 200 provided at 1m c/c meets the necessary safety factor in all conditions. Because the applied load does not follow the path where stiffness decreases, it remains within the elastic zone, where deformation does not increase the stresses and the risk of progressive deformation, such as development of shear zone or stiffness degradation, is low. The support capacity plot of concrete lining for overburden of 650 m falls slightly outside of the Factor of Safety 1.5 envelope, as shown in Figure 17, but this is only the case for the corner of the invert; this is due to stress concentration (idealized sharp corners), which may naturally put the structure back in to the stable loading zone. Although such sharp corners are not formed in the rock mass during actual construction, it is anticipated that this level of stress concentration will not occur. Overall, the displacement and support capacity curve reveal that the rock support system is stable and free from any progressive deformation. Some modifications to the rock supports were proposed for the “exceptionally poor rock mass” for overburden depths >350 m to 650 m, as shown below.

- Fiber reinforced sprayed concrete =20 cm and Rock Bolts= 2.5 m long (Ø 25 mm) @ 1.0 m spacing and Spilling bolt= 6m long (Ø25 mm) @ 0.4 m c/c spacing
- Steel Rib= ISMB 200 @ 1.0 m c/c spacing and Concrete Lining= 25 cm, Grade C25.

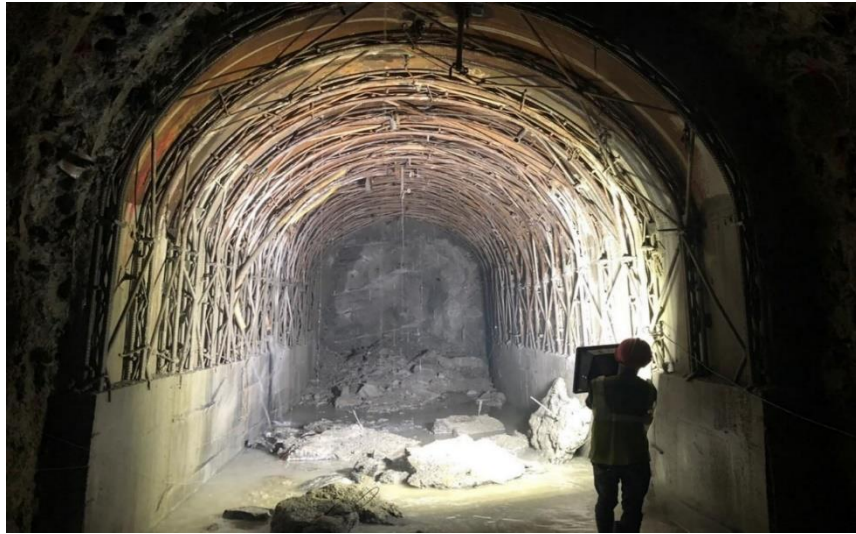
Fig. 18. Support at collapse section prior excavation resumes

The methodology adopted aim to address specific requirements, which included identifying the source, cause, location and extent of the cavity. The cavity that had formed remained unidentified at the time of blowout and was targeted with probing as suggested in [26], stabilization, and continuous monitoring while advancing the rectification procedure between February 4th and February 20th, 2020, muck and debris were cleared from Ch. 0+0840 m to Ch. 1+142 m, over 15 m behind the collapsed face. The face was sealed at Ch. 1+142 m to improve rock support prior to further muck cleaning and advancement. To resume further excavation work, as briefly described in in Table 8, additional 12 mm metal sheet lagging with voids between the applied rock supports and the steel liner filled with contact grouting. This was supported by additional lattice girders with concrete at the wall up to half of the spring line, as shown in Figure 18.

The tunnel width is reduced from 4.30 m/4.50 m to 3.55 m and was evaluated to have no significant hydraulic issues, assuming a 20 cm final lining at a later stage in addition to the initial rock support provided during the restoration operations. The hydraulic capacity for the reduced cross section was checked by comparing the flow velocity of the finished section to the permissible velocity suggested by P.J. Bier’s [27] equation and was found to be within the permissible limit.

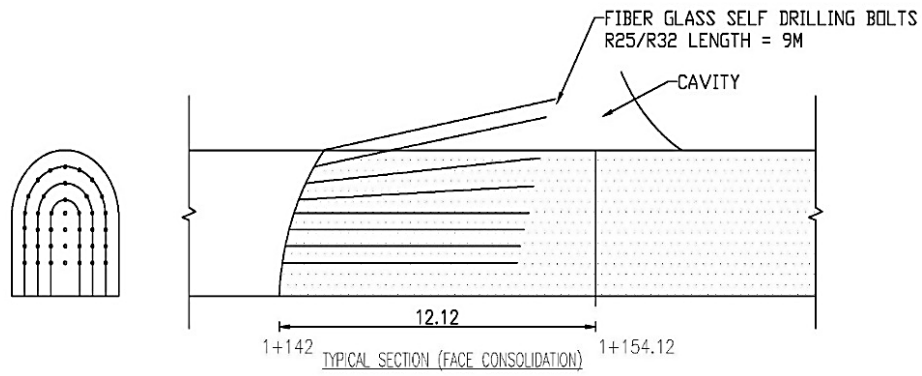
Fig. 20. (a-e). Work sequence for rectification of critical section (Ch.1+42 m to 1+156 m)

The methodology adopted to rectify the HRT from Ch. 1+142 m to Ch. 1+154 m and onwards is presented below. Prior to the rectification, the back chainage (Ch. 1+118.00 m to 1+142.00 m) also known as niche section was strengthened. This process includes installing a safety plug at Ch. 1+142.00 m and face stabilizing the muck using fibre glass SDRs. To increase stability, an additional 200mm of Fibre Shotcrete was applied. Longer rock bolts (4 to 5 m long, 25mm diameter) were installed in a staggered pattern, 2m apart. Finally, consolidation grouting was carried out. The work sequence for rectification from Ch. 1+142.00 m to Ch. 1+154.12 m and onwards is listed below in Table 8 and Figure 20 (a-e), shows the key action and the support elements/outcomes.

- A face Buttress was sufficiently kept at the centre of the face to prevent releasing thrust during heading and benching.
- Drilling for grouting and drainage was used for continuous probing and assessing the tunnel face and crown conditions.
- Water inflow was continuously monitored to prevent pressure buildup near and above the face. In addition to regular inspection and cleaning, any clogged or blocked holes had to be cleared to allow free passage of water and prevent pressure buildup.

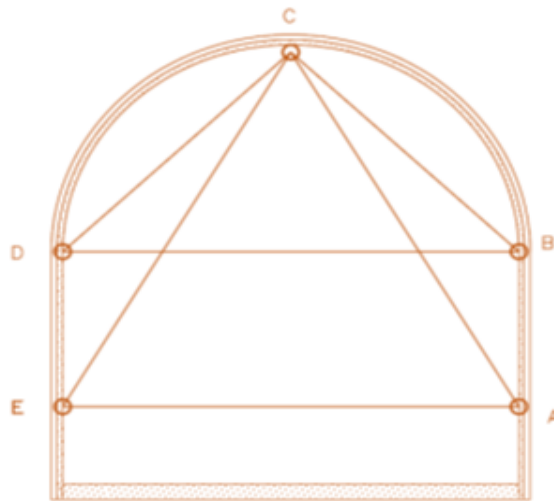
Fig. 21. Location of 5-points convergence monitoring system at Ch. 1+154.26 m

Tunnel convergence measurement is crucial in any type of tunnel excavation because it helps to ensure its long-term stability. For safety reasons, it is not recommended to carry out lining work in rocks where the loads and deformations do not attain stable values. If the final lining is installed after the tunnel has been stabilized by initial support, it will undergo very little additional loadings. Thus, in the present case study, the final deformation was closely monitored using a total station with one-second accuracy during the excavation process. The observation was monitored on daily for 44 days, then monthly for two years. Figure 21 shows the 5-point convergence monitoring system (A to E) at chainage 1+154.26 m, whereas Figure 22 show the variation of convergence over a period of days. The convergence was observed almost for two years before application of final rock supports (final lining). Figure 22 shows that the DC line prior to the final lining, which had a maximum convergence of magnitude 4.277 mm at 27 days, when the tunnel face was 144.79 m ahead of the chainage 1+154.26 m.

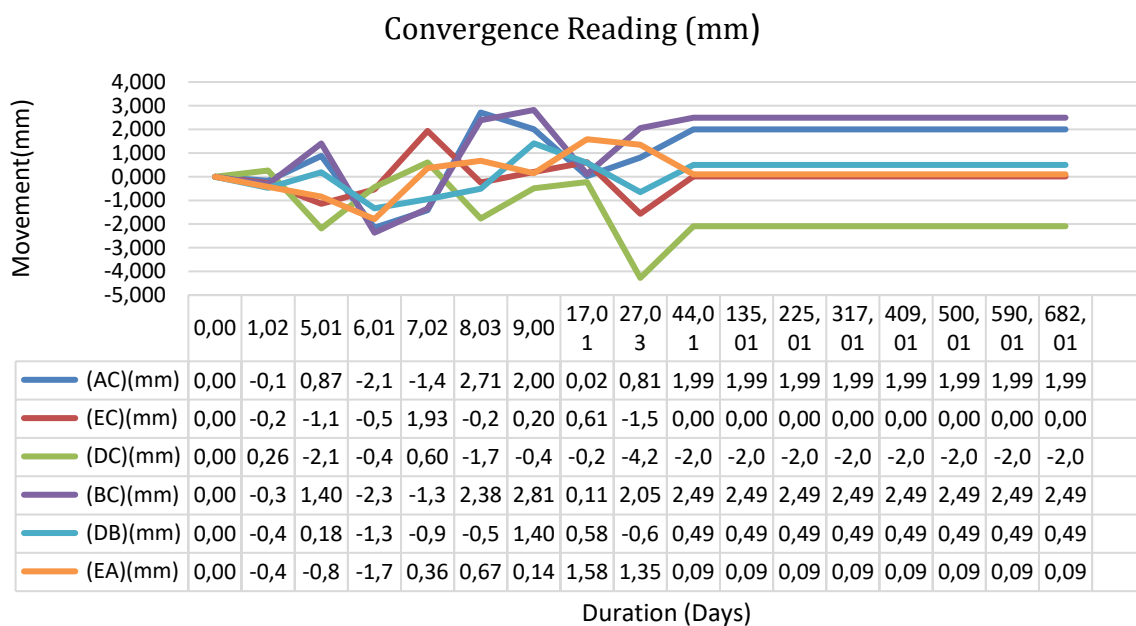
Fig. 22. Convergence reading at Ch. 1+154.26 when the tunnel face was 144.79 m front

At 44 days, the convergence was found to be 2.07 mm, which is almost 50% lower than at 27 days (At 27 days it is 4.277mm reducing to 2.07mm by day 44). It indicates that after 27 days, the stabilization phase begins and convergence decreases, however after 44 days, it is virtually an exponential decay, or implying that by 44 days, almost 95% stabilization has completed. This indicates that the surrounding geology almost completed the time -dependent deformation, ensuring that the final lining will be responsible for taking just the designed load and ensuring safety. Other convergence points, with the exception of the EA line, demonstrated a similar tendency. The observed convergence was quite low, being within an acceptable range for the stretch overburden of 495 m. The time-dependent convergence showed that the overall tunnel movement had stabilized, and no substantial movement would occur subsequently. The monitoring continued for nearly two years until final lining.

- The tunnel convergence at the critical section was observed almost for two years before application of final rock supports and was found to be a maximum of 4.277 mm at 27 days, which was quite low and within acceptable limits.

- At 44 days, the convergence was found to be 2.07 mm, which is almost 50% lower than at 27 days. It indicates that after 27 days, the stabilization phase begins and convergence decreases, while after 44 days, it is practically constant, indicating that the surrounding geology has almost completed the time -dependent deformation.

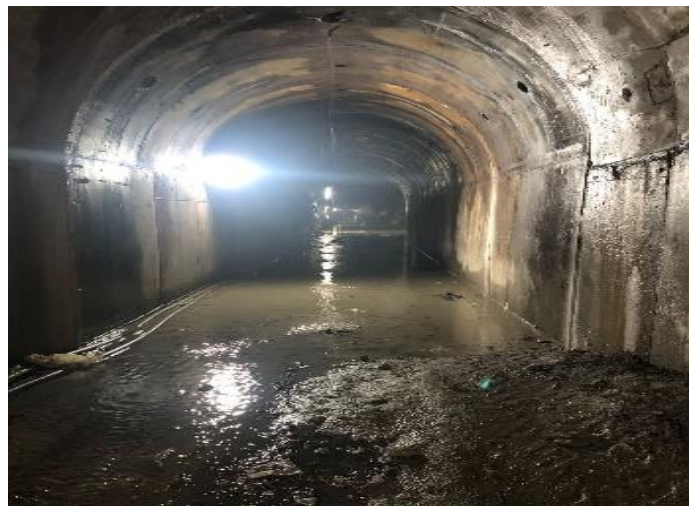
Fig. 23. Photograph of 12mm Thick Steel Liner (non-deformed)

After rectification, the rectified stretch was monitored for over two years before the final lining was applied, and the performance of the HRT collapsed section at Ch. 1+154.12 m was observed almost for two years after commissioning. According to the site data analysis and the 2023 project commissioning state of the HRT collapsed section at Ch. 1+154.12 m, neither deformation on the applied steel or concrete supports, nor buckling of metal sheets, was reported. The structural integrity of applied supports is observed. Figure 23 shows the photograph of a nondeformed 12mm thick steel liner. The proper usage of rock support in those regions resulted in stability along this length. The project has been running successfully for the last two years, and the stretch is trouble-free.
