# Research on Engineering Structures & Materials

## Strengthening of fire-damaged reinforced concrete columns under pre loading

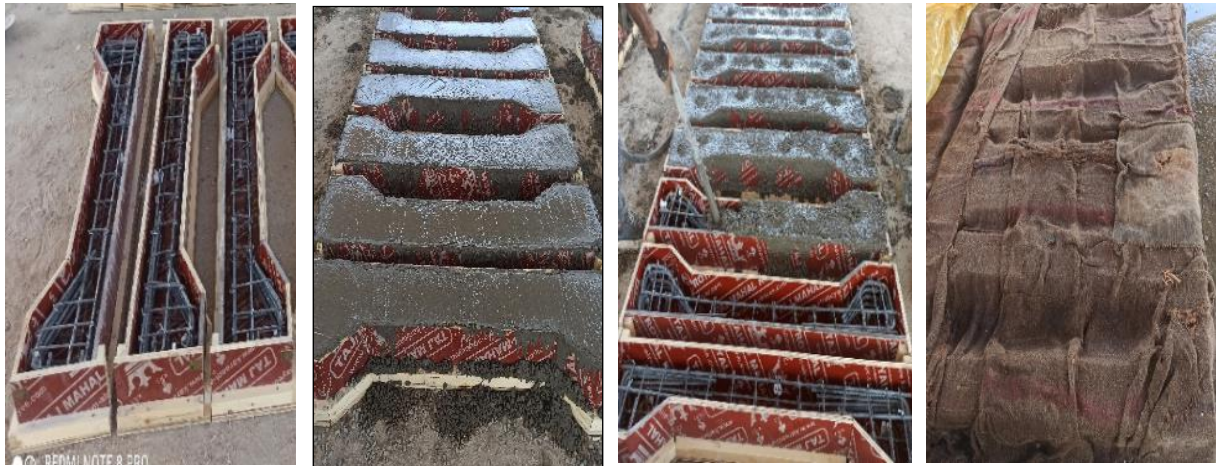
Fig. 2. Casting process phases

A central batching mixer with a capacity of 10 m<sup>3</sup>, supplied by Al-Mustaqbal Ready-Mix Concrete Company, was used for concrete mixing in this project. To prevent adhesion of hardened concrete, the internal surfaces of the cube and cylinder molds were thoroughly cleaned and properly lubricated prior to casting. Subsequently, each steel reinforcement cage designated for the column specimens was placed horizontally inside the wooden formwork and securely fixed in position. Concrete was poured into each mold in a single layer, followed by compaction and vibration using an internal vibrator. After casting, the specimens were water-cured for a period of 28 days. The casting and curing procedures are illustrated in (Fig. 2).

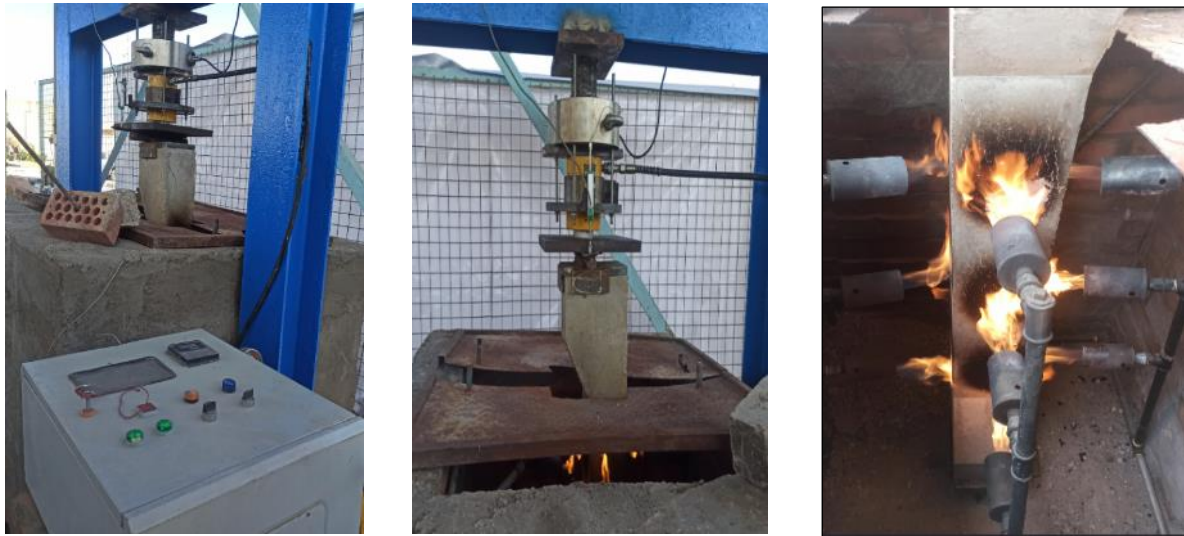
Fig. 5. Specimens subjected to fire exposure under pre-loading curve

Column  $C_1$  served as the unexposed control specimen. Columns  $C_2$  to  $C_9$  were subjected to a sustained eccentric axial load of 81.5 kN at an eccentricity of 90 mm prior to and during fire exposure, corresponding to 50% of the ultimate capacity determined from preliminary testing of the control column. The load was applied using a calibrated hydraulic jack and maintained

throughout the fire exposure period to simulate sustained service loading conditions during a fire event. The applied load was continuously monitored during fire exposure to ensure stability of the load magnitude. The loading frame was designed to preserve the predefined eccentricity throughout the fire exposure phase, minimizing potential load redistribution due to fire-induced material degradation and deformation.

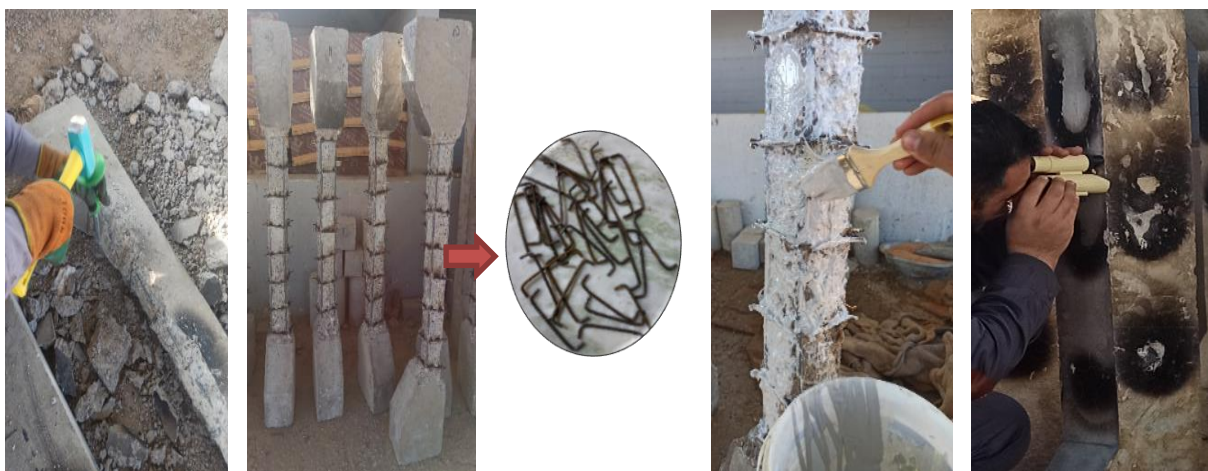
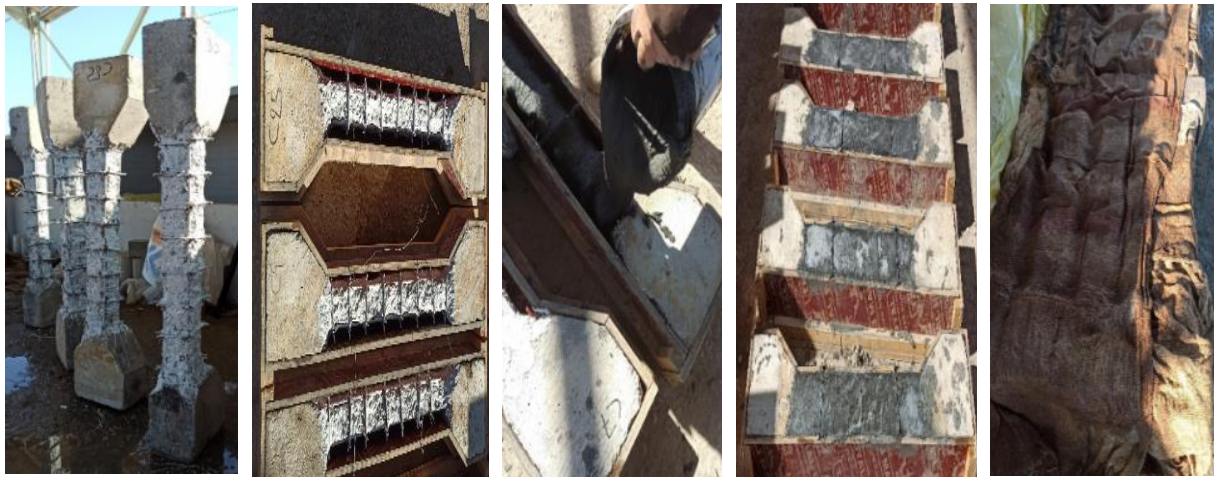
Fig. 6. Sequential steps of RC column repair

- **Removal of Damaged Concrete:** The deteriorated outer concrete cover was carefully removed manually until the longitudinal reinforcement was fully exposed. The average removal depth was approximately 20 mm, corresponding to the original concrete cover thickness. Mechanical methods were avoided to prevent dynamic vibrations that could weaken the elements. The removal depth was kept consistent for all repaired specimens to ensure uniform rehabilitation conditions.
- **Installation of Shear Connectors:** 4 mm-diameter shear connectors were horizontally fixed on all four sides of the stirrups to ensure a reliable bond between the existing concrete core and the new UHPC outer layer.

- **Epoxy Preparation and Application:** The epoxy resin (Sikadur ®-32 LP) was prepared by separately stirring the base and hardener, then mixing them thoroughly with a slow-speed drill for 2 minutes until a uniform color was achieved. The cleaned surface of the existing concrete core was coated with epoxy to enhance bonding between the old concrete and the UHPC layer.
- **Casting of UHPC Layer:** The removed concrete cover was replaced using Ultra-High-Performance Concrete (UHPC) with a uniform thickness of 20 mm, restoring the original cross-sectional dimensions of the columns (150 × 150 mm). No enlargement of the column cross-section was introduced during rehabilitation. All steps are illustrated in (Fig. 6).
