## An experimental study on consolidated sandstone by accelerated salt crystallization cycles: A case study of Dendera Temple, Qena, Egypt

Essam H. Mohamed

Online Publication Date: 20 April 2025

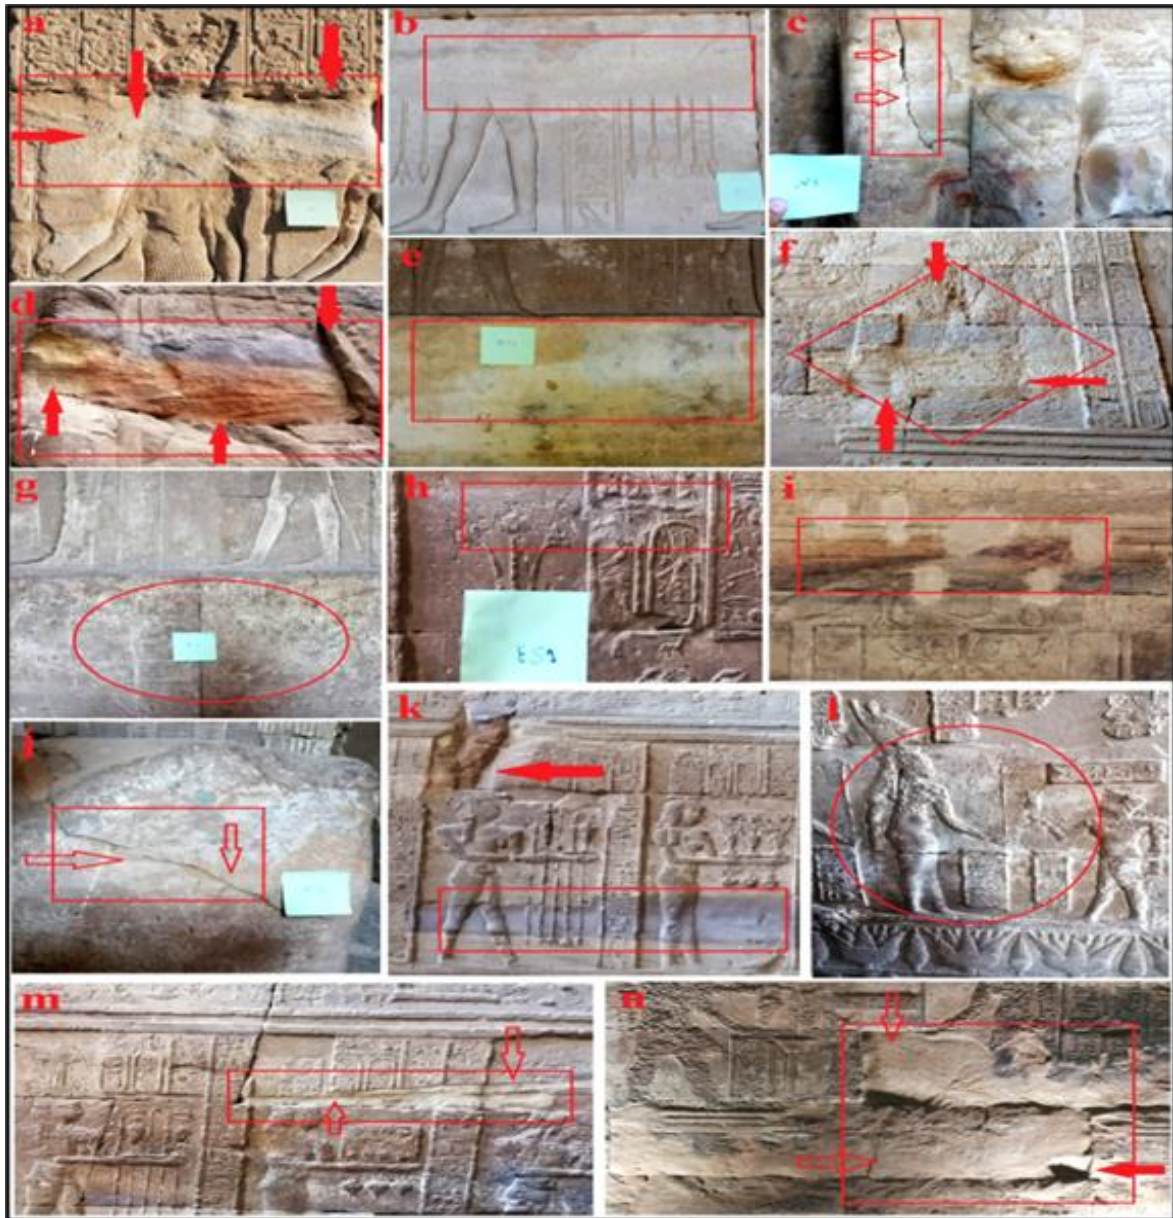
Fig. 2. (a), (b) Weathering out "granular disintegration into sand", (c) Efflorescence salts on stone surface and fissures, (d) Weathering out of stone components and coloration due to migration of iron oxides, (e)(h)(i) Efflorescence salts on stone surface, (f) Weathering out dependent on stone structure, g. Relief due to the effect of salts, (i) Coloration due to the effect of iron oxides, (j) Efflorescence salts and crack in the stone surface, (k) (m) The arrow indicates the loss of stone components and the rectangle indicates coloration due to migration of iron oxides, (n) Granular disintegration and scaling of the stone due to salt crystallization.

The sandstone that was used to build Dendera Temple has been exposed to variations in groundwater level and high temperatures, and infection of groundwater beneath the temple by salts. These factors combine to form a complex damage mechanism that negatively impacts the sandstone used in the temple. By studying the effect of salt weathering, as well as observing the deterioration patterns of the sandstone used in the Dendera Temple, it was found that it suffers from many different forms of deterioration, which are indicated in (Fig.2), and which include the following symptoms: efflorescence salts, granular disintegration into powder as a result of the effect of salt crystals, which led to the erosion of the inscriptions that were on the stone (Fig.2.a,b). Weathering out of stone components and multiple scaling were occurred, coloration due to migration of iron oxides. Weathering out occurred dependent on stone structure, separation of crusts or thin sheets of stone surface, loss of stone material, exfoliation, bleeding of stone, fissures, cracks and chipping of the stone to pieces.

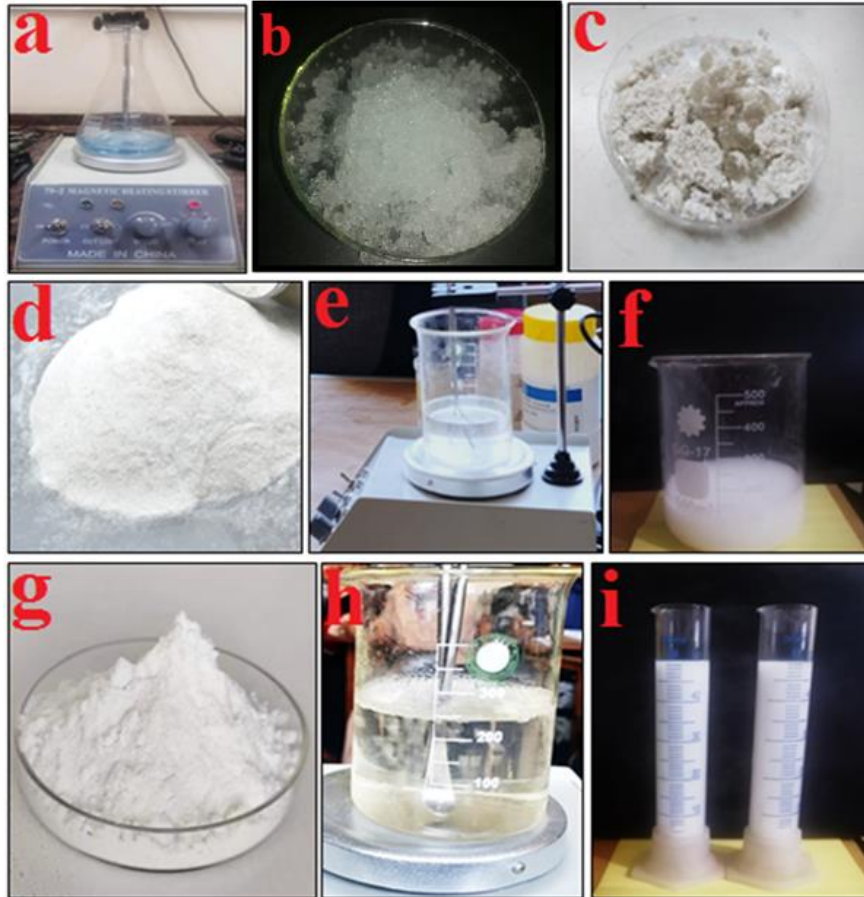
Fig. 5. (a) preparation of silica gel, (b)(c) silica gel, (d)  $\text{SiO}_2$  nanoparticles powder, (e)(f) Nanocomposite of  $\text{SiO}_2$  nanoparticles and paraloid B-72, (g)  $\text{Ca}(\text{OH})_2$  Nanoparticles, (h)(i) Nanocomposite of  $\text{Ca}(\text{OH})_2$  nanoparticles and paraloid B-72

A solution was prepared by dissolving 10 g of sodium silicate in 200 mL of deionized water, stirred for 30 minutes using a magnetic heating stirrer, then hydrochloric acid (HCl at concentration of 0.1-0.5 ml) is slowly added to the previous solution with continuous stirring. The previous solution was treated with 1 gram of 25% ammonia ( $\text{NH}_3$ ), added slowly, and then stirred for 3 hours at  $80^\circ\text{C}$  in a water bath. Following that, the white product was filtered and cleaned using alcohol and deionized water until  $\text{Cl}^-$  was found. Then, chlorotrimethylsilane was used to chemically alter the  $\text{SiO}_2$  nanoparticles [19]. After dissolving the white product and 0.05 moles of CTMS in 200 milliliters of alcohol, the resulting solution was heated to  $80^\circ\text{C}$  in a bath of water and stirring it for three hours. Following the reaction, the resultant product was filtered and vacuum-dried for 24 hours at room temperature to produce a powder of 40–50 nm-sized  $\text{SiO}_2$  nanoparticles. (Figure 4. a). 1.5 g of powdered  $\text{SiO}_2$  nanoparticles were mixed to paraloid B-72 (as a 70/30 co-polymer of methyl methacrylate/ethyl acrylate (MMA/EA) monomers). To create Nano composite, it was dissolved in 250 milliliters of acetone and then agitated with a magnetic stirrer set at 500 rpm for 30 minutes in a water bath at  $80^\circ\text{C}$  (Figure 5. a, b, c, d, e, f); Table 1 [20, 21].

The resulting product was filtered and dried in a vacuum at room temperature for 24 hours to obtain powder of  $\text{Ca}(\text{OH})_2$  nanoparticles (size 10- 40 nm) (Fig. 4. b). 1.5 g of  $\text{Ca}(\text{OH})_2$  nanoparticles powder added to paraloid B-72 (as a Co-polymer of methyl Methacrylate/ethyl acrylate (MMA/EA) monomers with a composition Ratio of 70/30) dissolved in 250 ml of acetone to prepare nanocomposite, the solution was mechanical stirred for 60 minutes at  $90^\circ\text{C}$  in a water bath using a magnetic stirrer (600 rpm) (Fig.5. g, h, i; Table 1).
