## **Constructional characteristics and restoration aspects of historic earth block structures**

Ioanna Papayianni, Vasiliki Pachta

Papayianni I, Pachta V. Constructional characteristics and restoration aspects of historic earth block structures. *Res. Eng. Struct. Mat.*, 2017; 3(2): 113-121

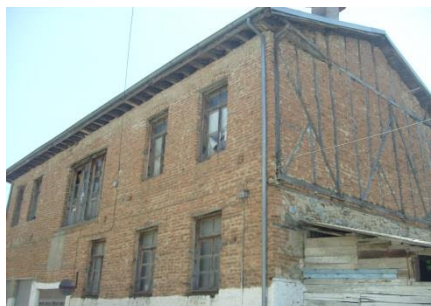
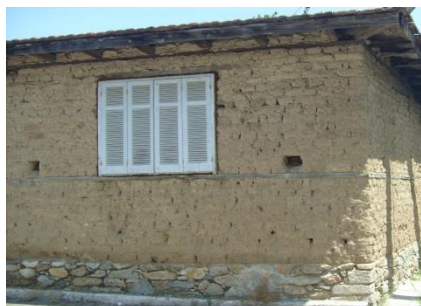
(1)

Figs. 1-2. Earth-block houses of N Greece (town of Goumenissa)

In SE Europe they are usually located in lowland villages and mountainous settlements. Some of them are still inhabited, others have been abandoned. They constitute characteristic examples of regional vernacular architecture, since they were constructed with local raw materials by using traditional constructional techniques (Figs.1-2).

Traditional earth-block houses were of one or two storey's (Figs. 1-2). Masonries were usually 50-100cm thick and were constructed with earth-blocks and mud mortars (structural mortars, renders, plasters) based on locally available clay. Wooden beams and conjunctions reinforced the structure by connecting the structural members and increased the bearing capacity (Fig. 3). Foundations were usually of stone masonry in order to be stable and resistant to humidity.

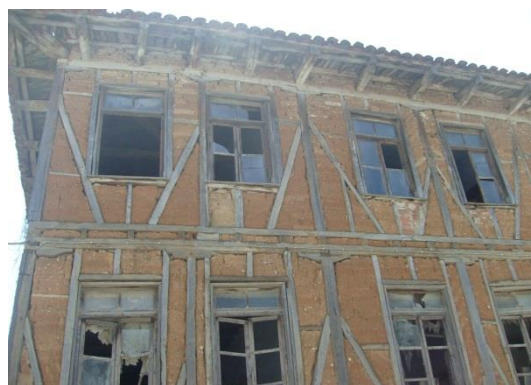
Fig. 3. Wooden beams and conjunctions of earth-block structure

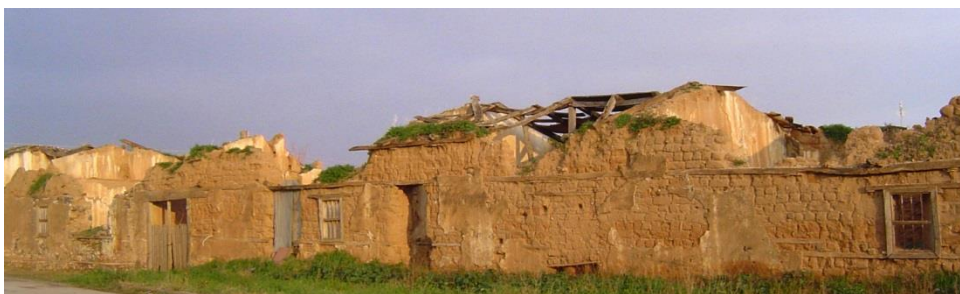
Fig. 4. In situ, macroscopic and microscopic figures of a traditional earth blocks

Research focused on the analysis of the building materials from a settlement of historic earth-block structures (Kolligospita, Zografou settlement), located in Chalkidiki peninsula, N. Greece and dated in 1845(Fig.4). The settlement is nowadays abandoned, while earth-block structures confront severe damages [6].

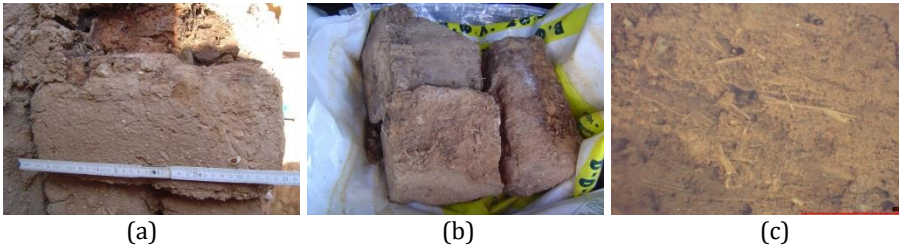
Earth blocks (Fig. 5) were compact, with dimensions 30x15x10cm, manufactured with clay of local origin. Inert material, such as fine aggregates, wooden fibers, straw, was added in order to increase their stability and flexural strength. Their compressive strength was low, around 0.5MPa, probably due to their extreme deterioration (cracking

and material detachments). Porosity was around 10% and apparent specific gravity 1.7. As expected, their water absorption and capillary sanction were high and led to material detachments.

Fig. 5. In situ, macroscopic and microscopic figures of a traditional earth blocks

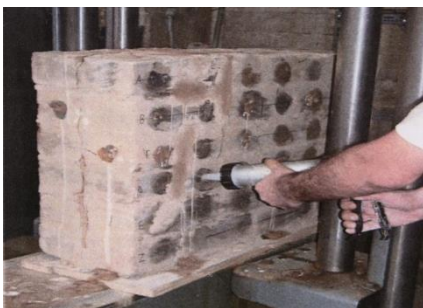
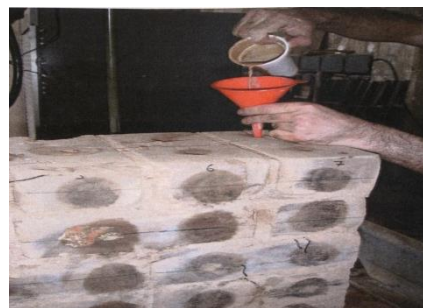
Fig. 8 Grouting earth block masonry models with soil based grouts, through syringe and gravity

The effectiveness of the grout mixtures was further studied. The grout mixtures that have exhibited the maximum mechanical strength, fluidity and volume stability were used for grouting earth block masonry walls that were previously loaded and crushed (Fig.8).

Before the grout penetration, the walls were subjected to pulse waves' velocity measurements made with sonometer, in order to estimate the cracks or discontinuities of the crushed masonry walls. After one month period of curing at room conditions the consolidated masonry models were crushed again (Table 4). Measurements of the pulse waves' velocity were also made before the appliance of compressive loads. An adequate number of earth block masonry walls were crushed.
