Fatigue behavior of flush reinforced welded hand-holes in aluminum light poles

Rusnak CR, Menzemer CC. Fatigue behavior of flush reinforced welded hand-holes in aluminum light poles. *Res. Eng. Struct. Mater.*, 2021; 7(3) 465-480.

Technical Note

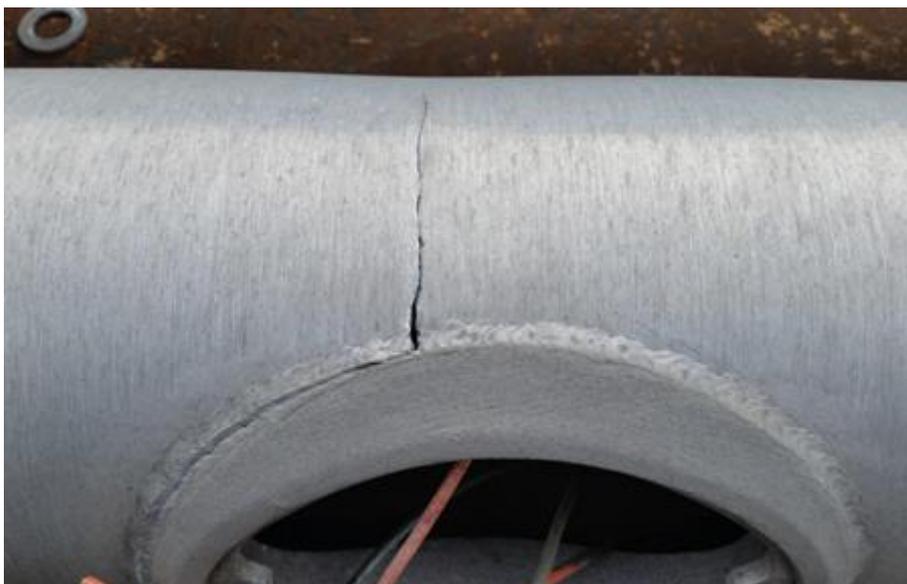
Fig. 1 Fatigue crack in welded aluminum light pole hand-hole in field

Fatigue cracking associated with hand-holes has been observed in the field. NCHRP report number 469 describes fatigue cracks that have occurred in welded steel structures near hand-hole details in multiple states. These include New York, New Mexico, California and Minnesota [7]. After the failure of a high-mast welded pole in Iowa, multiple inspections found cracks associated with a hand-hole at another location. Some fatigue cracks were found in welded aluminum light poles mounted on the Mullica River Bridge after a violent storm in New Jersey in 2011 [8]. A fatigue failure associated with a more typical (not flush) hand-hole reinforcement on an aluminum light pole can be seen in Figure 1.

The University of Akron (UA) conducted a study on twenty light-pole samples with “typical” hand-holes containing the cast reinforcement shown in Figure 1. The cast reinforcement is joined to the outside of the poles with fillet welds. In addition to fatigue tests, several static tests were conducted in order to gain insight into the strain distribution around the hand-hole. This study found that typical reinforced welded hand-hole fatigue test data fell above both the category D and E design S-N curves of the Aluminum Design

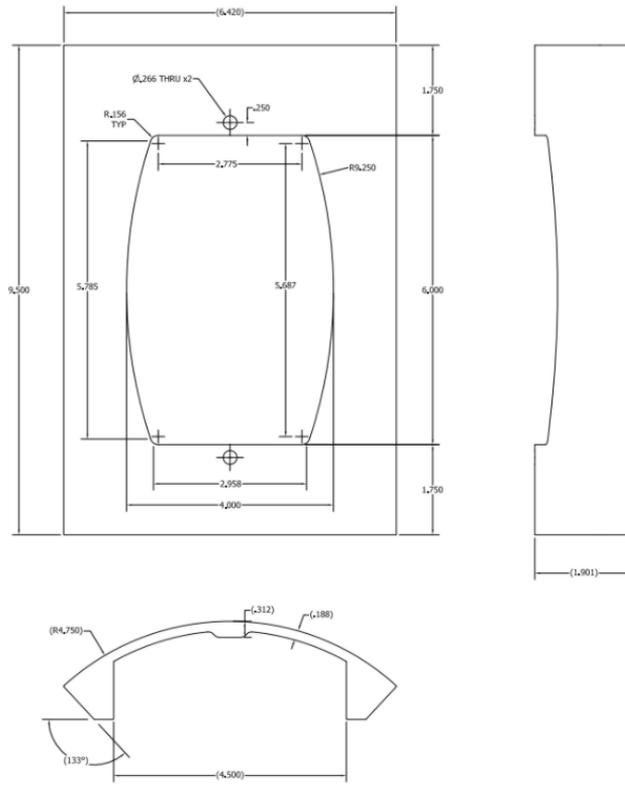
Fig. 2 Hand-hole reinforcement

Five aluminum specimens, with a total of ten details, were tested under cyclic loading to examine the fatigue behavior of the flush hand-holes. Each of the specimens were fabricated from 10 in (25.4 cm) diameter extruded 6063 aluminum alloy tubes with a $\frac{1}{4}$ in (0.635 cm) thick wall. Hand-holes measured 6 in (15 cm) in the longitudinal direction of the pole and 4 in (100 cm) in the transverse direction. Each hand-hole was reinforced on the inside of the pole with an extrusion that measured $9\frac{1}{2}$ in (24 cm) in the longitudinal direction and 6.42 in (16.3 cm) in the transverse direction. Figure 2 depicts the design of this extrusion and Figure 3 shows the connection that uses longitudinal fillet welds to join the reinforcement extrusion to the inside of the pole around the hand-hole opening. The final samples measured 144 in (3.66 m) in length with the hand-holes placed 54 in (1.37 m) in from each end respectively. Each specimen consisted of three separate pieces as shown in Figure 4. The central tube containing the hand holes measured 72 in (183 cm) in length and had pole bases welded on either end. Hand holes in the center pole section were located 18 in (457 cm) from either end which represents the largest distance a welder can comfortably work inside of the 10 in (254 cm) diameter tube. Stub poles measuring 36 in (91 cm) were welded to a base and bolted to the base on either end of the center section. The stub pole sections were designed to increase the moment arm from the point of specimen bearing to the hand hole. Support rollers for the specimens were placed 6 in (15.2 cm) from each end. All specimens were Post-Weld Heat Treated (PWHT) [14]. Table 1 provides properties of 6063-T6 extrusions and the 4043-filler wire material.

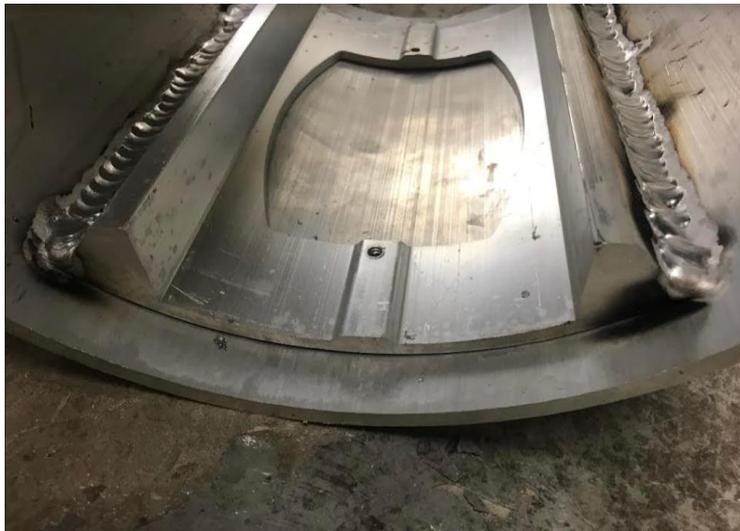
Fig. 3 Welded insert plate

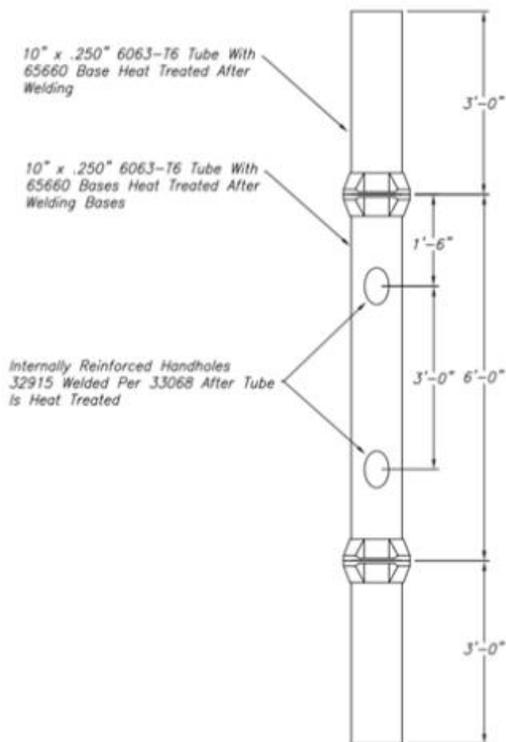
Fig. 4 Specimen design

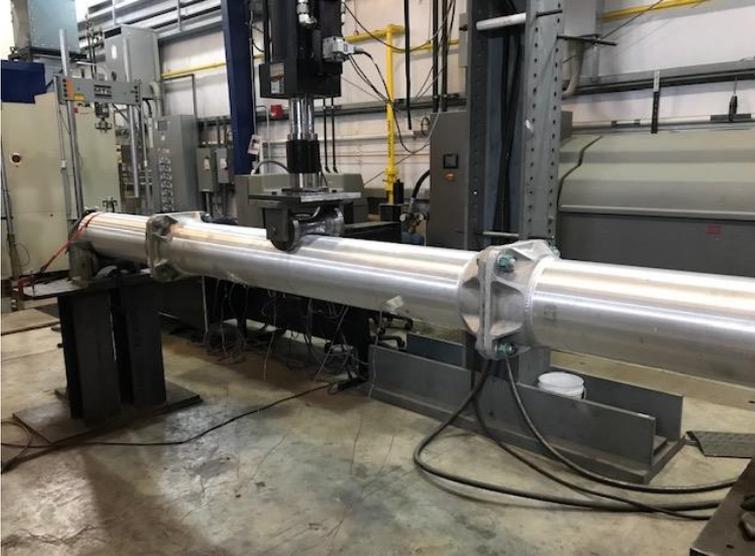
Figure 5 is a photograph of the three-point bending fatigue test setup in the Gas Turbine Testing Laboratory of The University of Akron. All of the earlier fatigue tests conducted at UA were in four-point bending. Three-point bending was used as the flush inserts were placed inside of the pole and limited the location of the hand hole to near the end of the specimens. Stub poles were added to increase the length and moment arm, but to ensure failure at the hand-hole required limiting the stress range at the base to tube connections.

A 55 kip (245 KN) MTS servo-hydraulic actuator and control system was used to apply the load to specimens. This actuator was mounted to a structural load frame that is capable of safely supporting 300 kips (1335 KN). Loads were applied to each of the specimens through a roller that was attached to the actuator. Supports consisted of rollers that were machined to fit the profile of the tubular specimens.

Fig. 5 Fatigue test set-up of flush welded aluminum hand-hole details

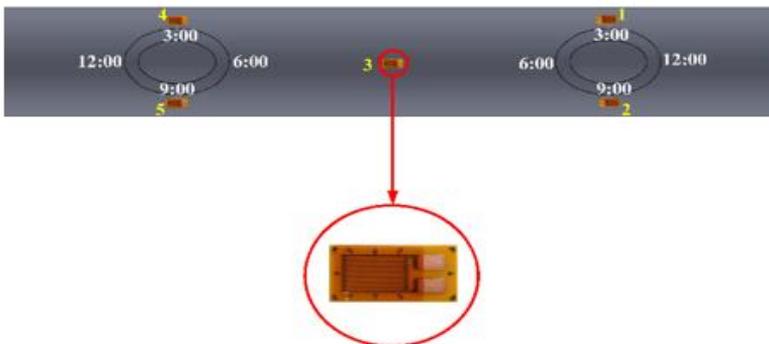
All the tests were conducted in load control, while strains were monitored using gages that were mounted around the hand-hole on the outside of the pole. Typical strain gage locations may be seen in Figure 6. On the first specimen tested, a strain gage was also placed at each 6 o'clock position and near each pole base respectively. Strain gages were $\frac{1}{8}$ in (3.175 mm) in length with a resistance of 350 ohms. Strain readings were taken every two hours for 10 seconds using a Micro-Measurements System 8000 data acquisition device.

Fig. 6 Typical strain gage location and position around hand-hole

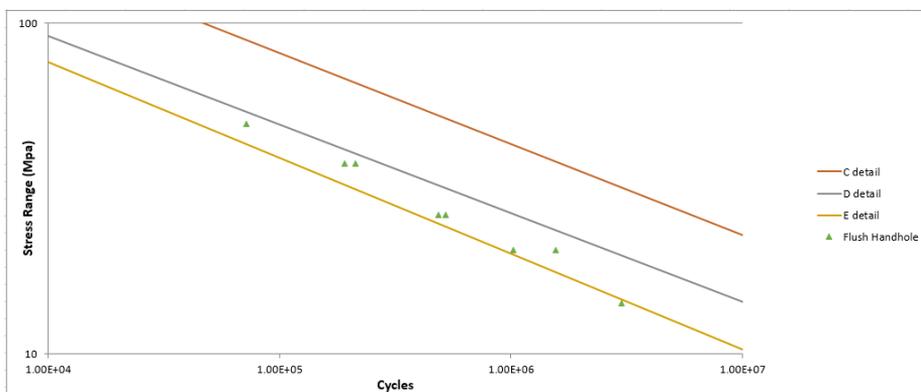
Fig. 7 Fatigue test results

The data collected from the fatigue tests can be seen in Figure 7 and tabulated results are available in Table 2. The stress range in Table 2 was calculated by subtracting the minimum stress in an average load cycle from the maximum stress in the same cycle. All of the data appears to follow the same trend, slightly above the “E detail” lower bound. Figure 8 shows a comparison between the flush details and a previous study conducted on 10in poles with a “typical” hand-hole detail. This figure shows that typical hand-hole details with reinforcement fillet welded to the outside of the tube (Figure 1) have a larger fatigue resistance as compared to flush hand-hole details.

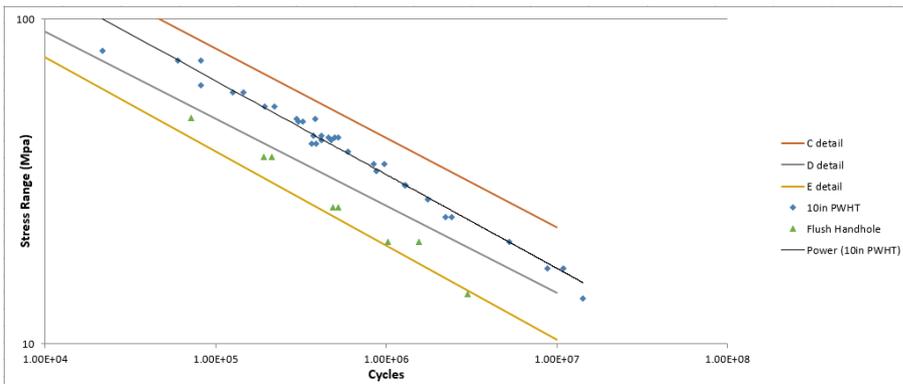
Fig. 8 Flush detail vs 10in poles with standard hand-hole reinforcement

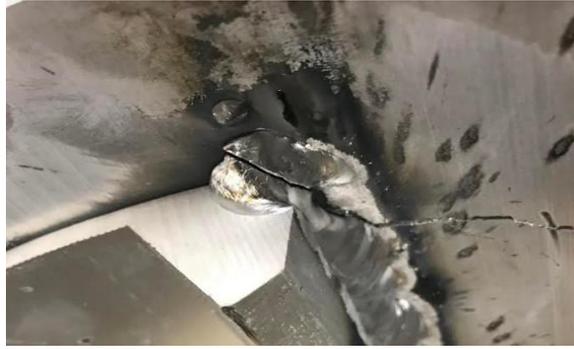
During fatigue testing, the appearance of cracking was soon followed by failure. After cutting open several failed specimens, it became apparent that the hand-holes experienced failure that initiated in the weld that joins the reinforcement extrusion to the inside of the pole (closer to the load). Figure 9 shows the nature of the crack on the inside of the pole and Figures 10 and 11 show the weld removed from the pole. These images show how “jagged” the break is after failure and how initiation appears to coincide with the fillet weld termination. Often, fillet weld terminations in aluminum will contain shrinkage defects unless properly “buttoned up”.

Fig. 9 Crack in weld

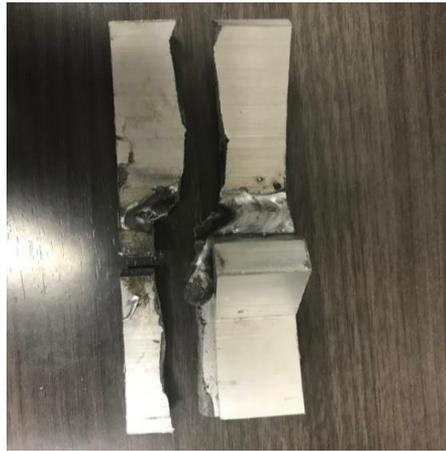
Fig. 10 Weld failure location

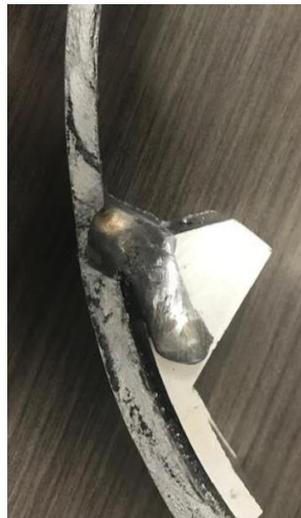
Fig. 11 Failure of pole sample

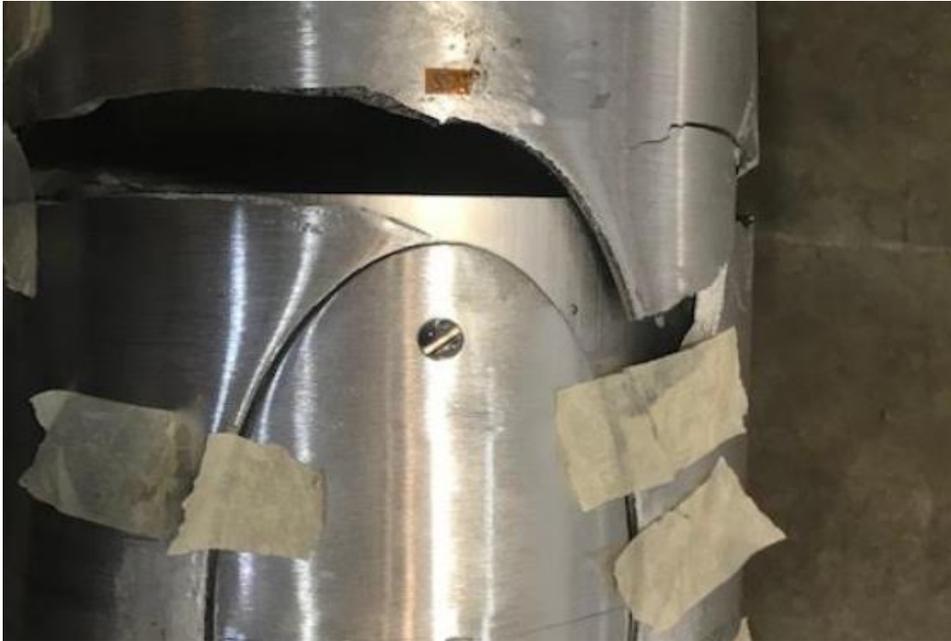
Final failure occurred as the crack broke through the surface of the tube, usually at the 6 o'clock position and propagated transversely in the pole until the displacement limit was reached and the test was stopped. In all of the specimens, initial cracking could not be observed due to the detail being inside of the pole. Figure 12 depicts a typical final failure. A few of the specimens contained a smaller crack, at about the 4 o'clock position. This still followed the same failure mode with the crack initiating within the weldment inside of the pole. Figure 13 shows an example of this type of cracking.

Fig. 12 Final failure

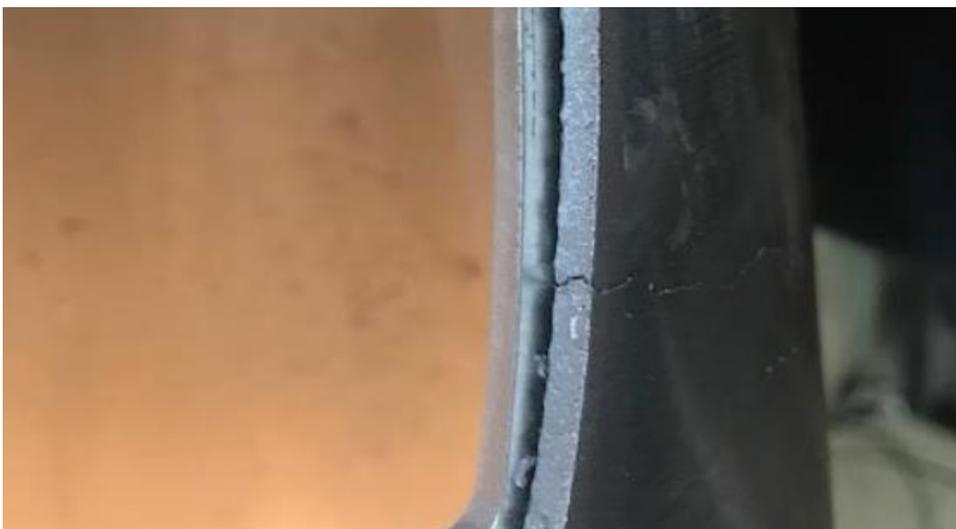
Fig. 13 Cracking in Pole Wall

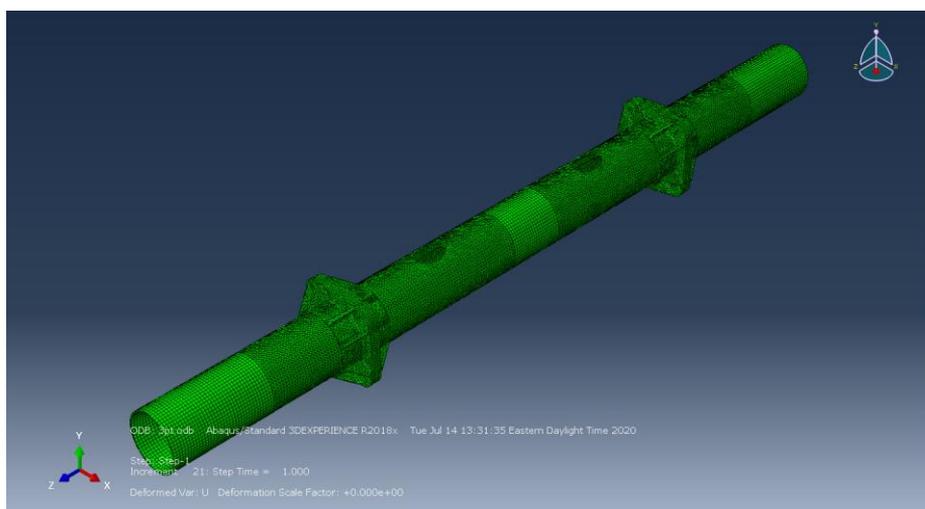
A finite element (FE) model was constructed of the three-point bending specimen to help understand the stress distribution around the hand-holes. The model was created to represent the geometry of the specimens as manufactured and to examine the local stresses associated with the flush hand-hole design as compared to the more typical hand-hole detail with reinforcement welded to the outside of the pole. Local stresses are generally mesh dependent. Finer mesh sizes usually increase stresses local to important geometric details, whereas a course mesh often results in a reduction in local stresses. Elements used in this model consisted of both tetrahedral and hexahedral element types. The mix of element types provided a fairly accurate model of the specimen and provided for reasonable run times. If the model had been constructed with hexahedral elements only, the open handholes would not have been meshed in a realistic manner. A full model consisting of tetrahedral elements would make nodal loading more complex than necessary. A global mesh size of 0.25 was used and the model consisted of 1,347,205 nodes. One hundred twenty-six nodes were used to apply the load, each with a concentrated force of 0.0558 N and was identical to the load used in a previous study and made for easy comparison. One hundred twenty-six nodes were used to represent each support and were restricted in three degrees of freedom and acted as the rollers at each end. Figure 14 depicts the mesh.

Fig. 14 Overall model

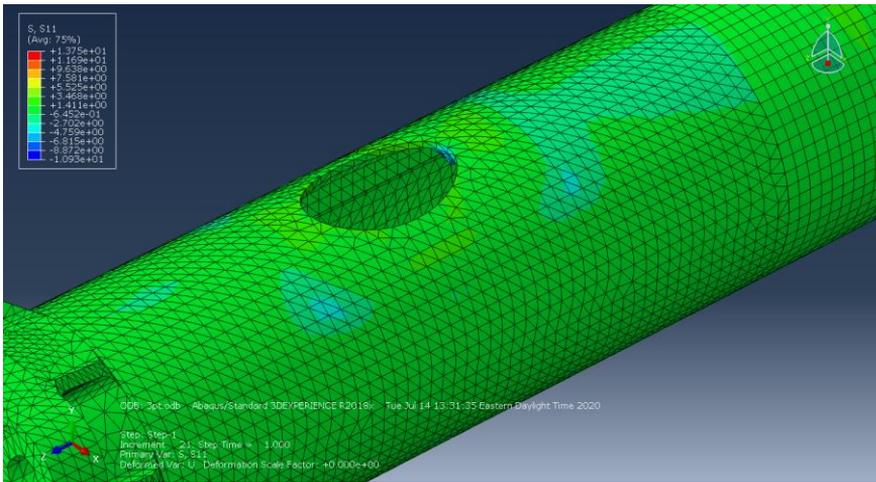
Stress “hot spots” indicate where fatigue cracking is likely to develop and where failure may occur. Figures 13-15 depict the stresses on the outside surface of the pole in X, Y, and Z directions respectively. The longitudinal stress corresponds to the Z axis and the transverse stress corresponds to the X axis. From Figure 13, there appears to be some concentration of stress around the reinforcement and at the corner of the reinforcement inside of the pole. Figure 14 shows how the stress formed around the reinforcement extrusion on the inside of the pole. Figure 15 depicts how the stress is transferred in the longitudinal direction.

Fig. 13 Stress map in transverse direction

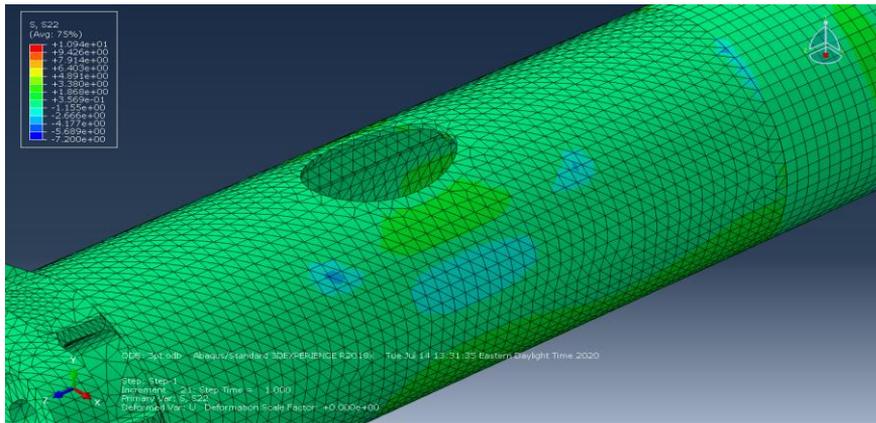
Fig.14 Stress map through the thickness of the pole

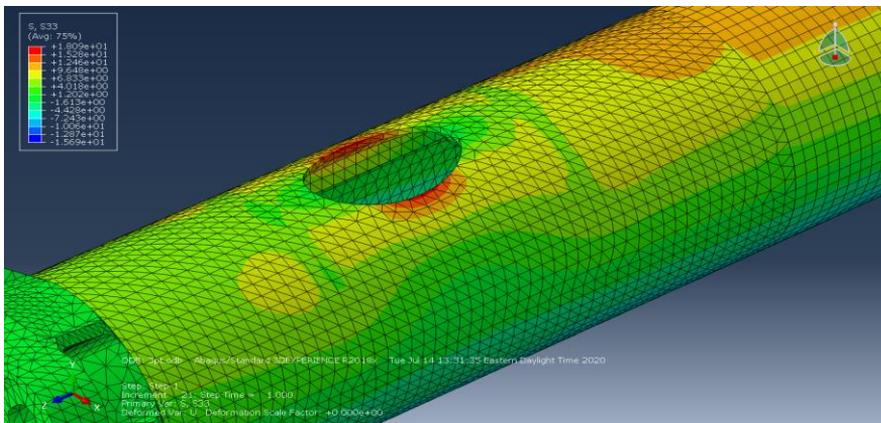
Fig. 15 Stress map in longitudinal direction

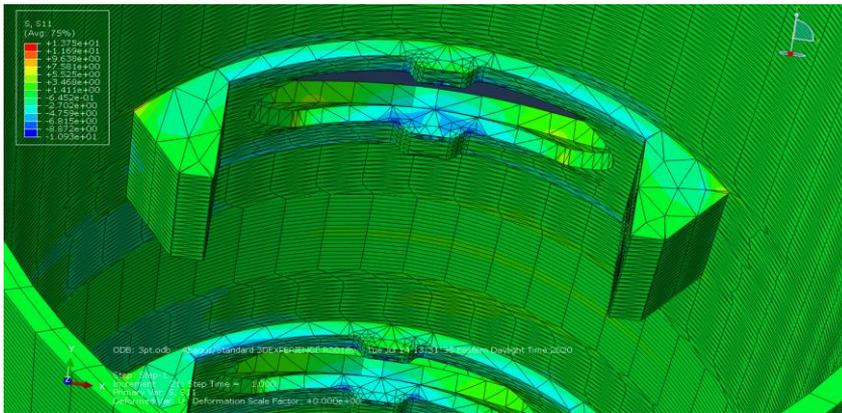
Figures 16-18 depict the same stress maps as Figures 13-15 but show the stresses on the inside of the pole. What was most interesting about these images is that one can see how the stress collected around the ends of the extruded reinforcement even without the weld being modeled. This was typically the initial point of cracking.

Fig. 16 Stress map in transverse direction inside pole

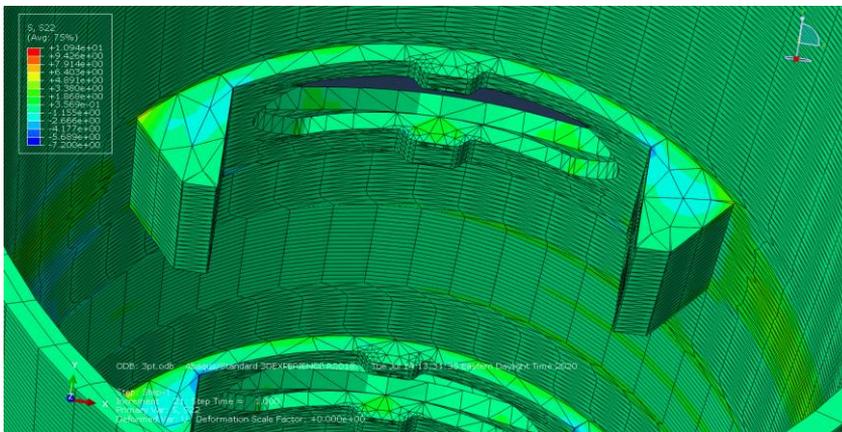
Fig. 17 Stress map through the thickness inside pole

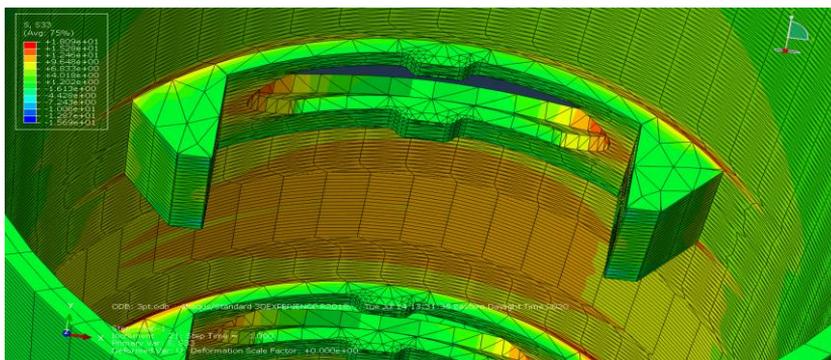
Fig. 18 Stress map in longitudinal direction inside pole

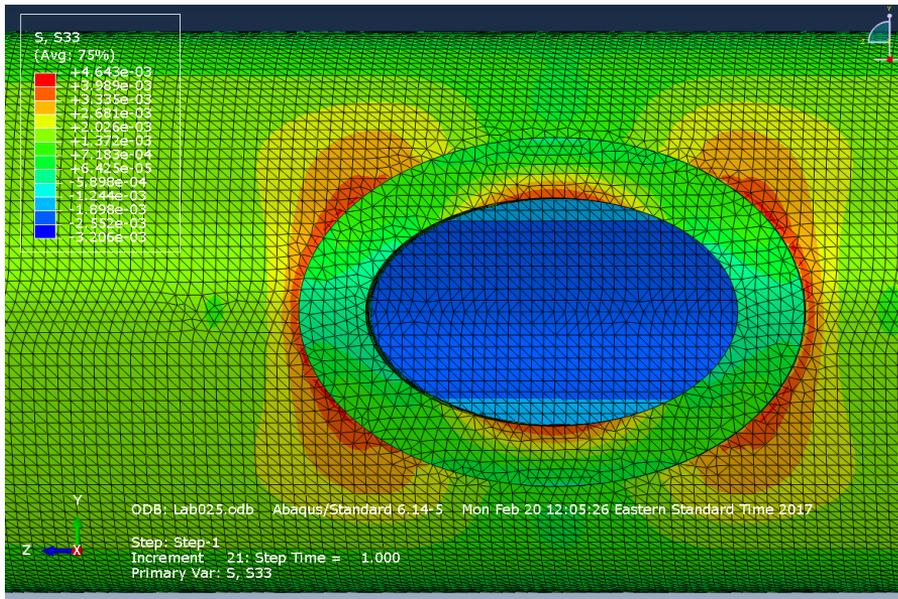
In comparing the finite element results to a previous study, the change in detail affects the stress concentration around the hand-holes. Figure 19 shows the stresses in the longitudinal direction of the specimen with a cast insert joined to the outside of the pole. In this figure, the stress is most prevalent around “ends” of the cast insert whereas the flush inserts had a larger and more prevalent stress concentration on the inside of the pole near the corners of the reinforcement extrusion.

Fig. 19 Longitudinal stress map old study
