## Evaluation of runways for Al-Habbaniya air base in Iraq

### Abstract

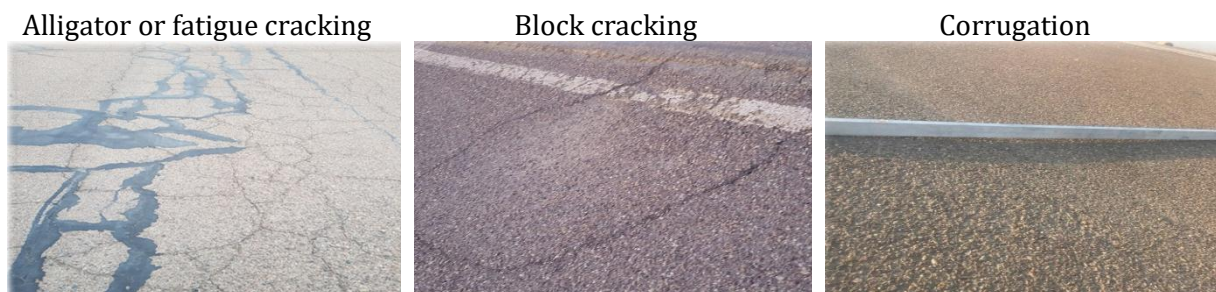
Fig. 2. Asphalt pavements distresses

The evaluation revealed significant distress in the asphalt layers, including alligator or fatigue cracking, characterized by interconnected cracks resembling alligator skin caused by repeated traffic loading. These cracks, originating from the bottom layer and extending to the surface, often require reconstruction in severe cases [11]. Block cracking, another common defect, is primarily caused by asphalt shrinkage and temperature fluctuations, resulting in rectangular patterns unrelated to traffic loads but varying in severity. Corrugation, or wash boarding, was identified as closely spaced ridges and valleys perpendicular to traffic direction, caused by unstable pavement or subbase layers. Reconstruction is necessary to meet ASTM standards, Figure 2.

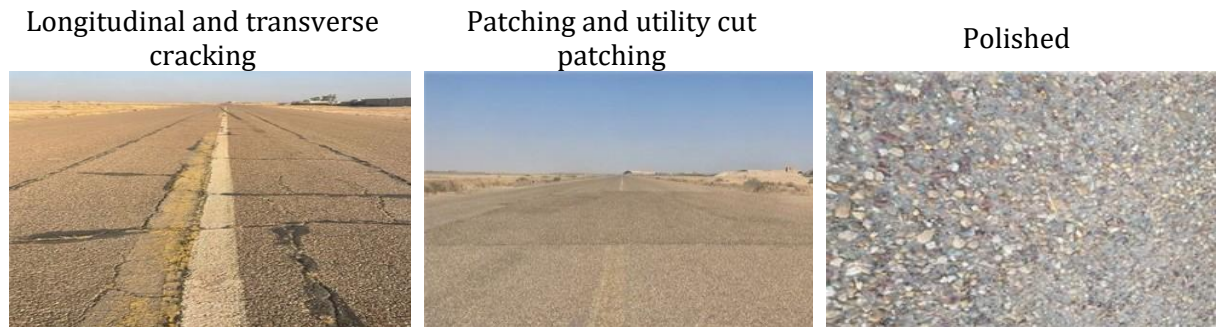
Fig. 3. Problems of asphalt runways

Longitudinal and transverse cracks, indicative of sub-structural concerns, were noted. Potential longitudinal cracks are appearing along the direction of the pavements which are connected to bad quality in construction or material deterioration, while transverse cracks where emerged induced by temperature stress. Other repairs, like patching and utility cut patching, are all noted as defects,

since they generally show roughness and will deteriorate much faster than the original pavement, which has an impact on ride quality. Traffic wear results in polished aggregate, creating a smooth surface that decreases skid resistance and decreases vehicle traction, Figure 3.

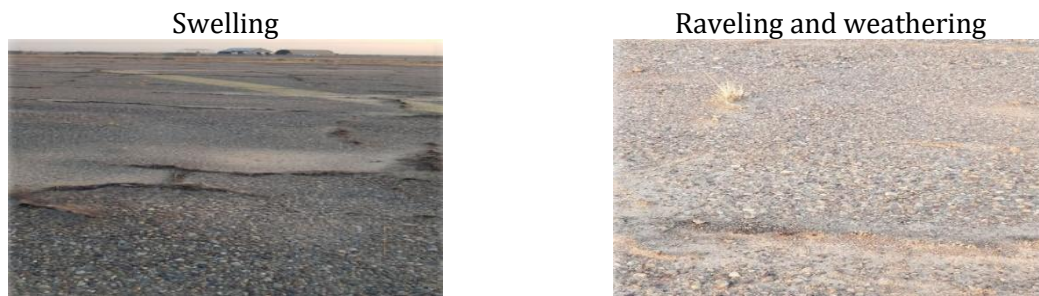
Fig. 4. Soil and weather problems

Swelling, identified by upward bulges in the pavement, is caused by swelling soil, leading to surface deformation and cracking. Lastly, raveling and weathering were prevalent, with surface degradation attributed to asphalt aging, poor-quality mixtures, or environmental factors like oil spills, resulting in the loss of aggregate particles and compromised pavement performance, Figure 4.

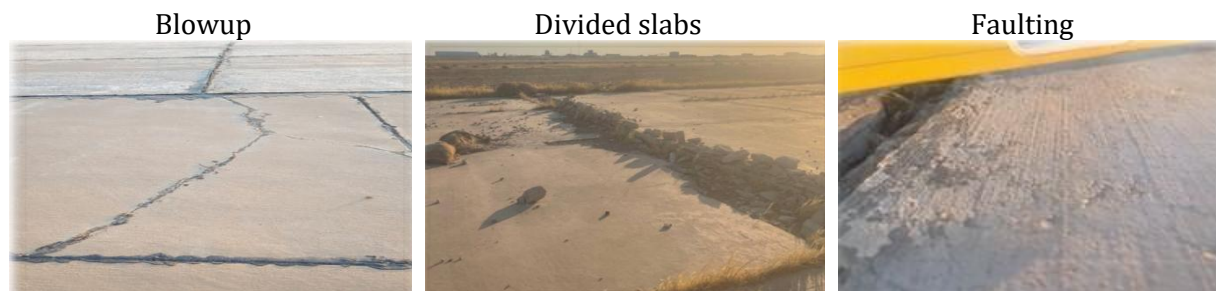
Fig. 5. Concrete pavement distresses

The evaluation of concrete pavements at the runway revealed several significant defects [12]. Instances of blowup or buckling were observed, particularly during hot weather, caused by insufficient expansion space due to incompressible materials infiltrating joints. This results in upward slab movement and deformation, requiring immediate intervention. Divided slabs were another common defect, where slabs fractured into multiple pieces due to overloading or inadequate support. Repairs ranged from sealing cracks to full slab replacement. Faulting was identified across several joints, characterized by elevation differences between slabs, caused by foundation settlement or erosion. Slabs with significant elevation differences require recasting, Figure 5.

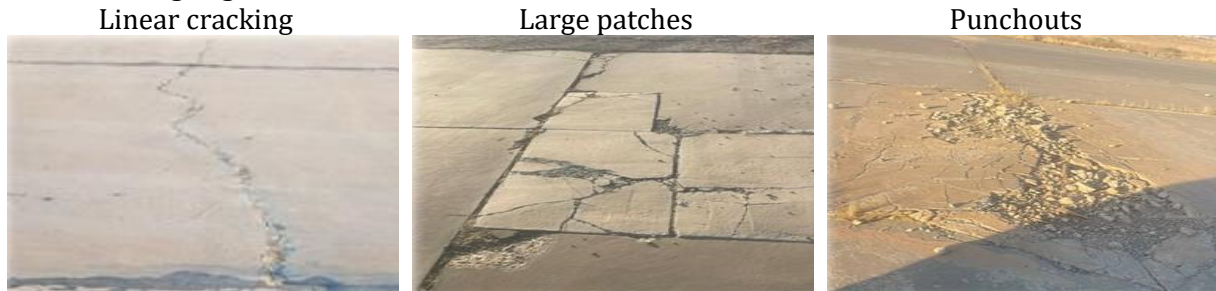
Fig. 6. Types of cracks and patches in runway slab

- Linear cracking in the form of longitudinal, transverse, and diagonal cracks was observed, often caused by repeated loads, thermal gradients, and moisture. Low-severity cracks posed minimal risks, but medium-to-high severity cracks were structurally significant.

- Large patches and utility cut repairs exceeding 5 square feet were found, often deteriorating faster than original pavement. Severe cases require recasting to meet ASTM standards.
- Punchouts, or localized slab fragmentations were common near cracks and joints, often resulting from repeated heavy loads and insufficient slab thickness. These necessitate recasting, Figure 6.

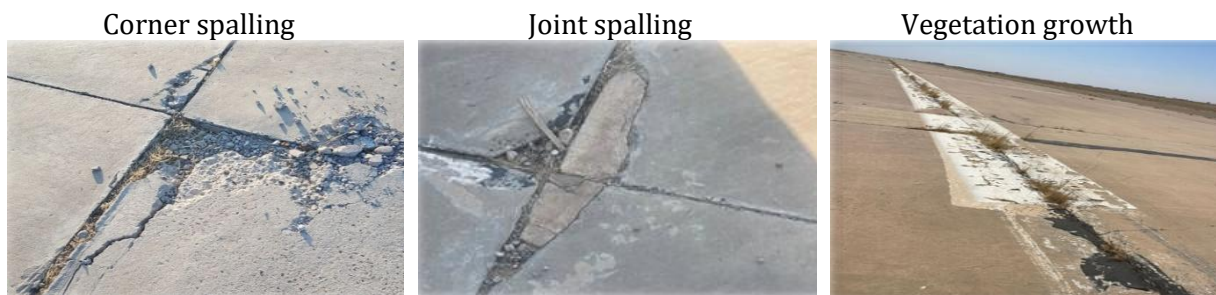
Fig.7. Stress and material

Corner spalling was identified as deterioration near slab corners due to stress and material degradation. Partial-depth patching was recommended for minor cases. Similarly, joint spalling, occurring along slab edges, was caused by traffic stresses, material infiltration, with repairs ranging from patching to joint reconstruction. Lastly, vegetation growth in cracks indicated possible water infiltration and soil salinity issues, suggesting inadequate drainage and potential structural instability. Comprehensive repairs and preventive measures are recommended to mitigate these distresses, Figure 7.

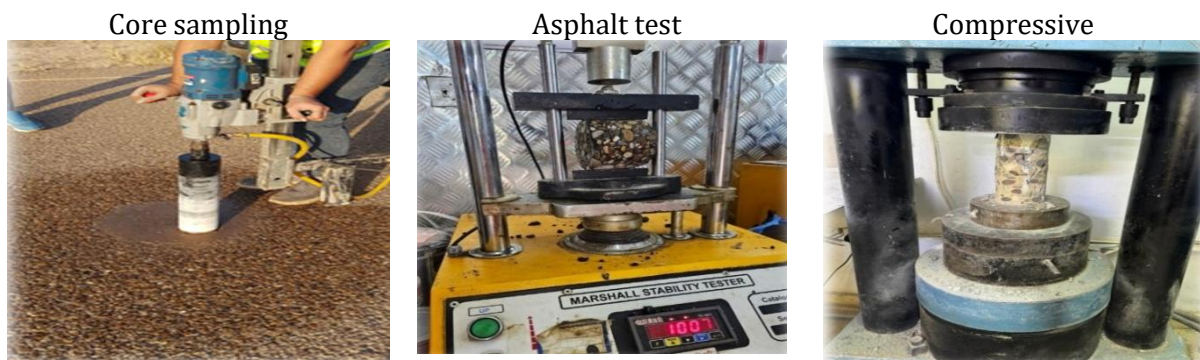
Fig. 8. Sampling and tests

These tests are essential for evaluating the structural integrity and quality of the pavement [13]. The data provides insights into the core samples' condition, helping us assess whether the pavement meets the required standards, in regarding the asphalt, 18 cores were extracted from the main runways, taxiways, and branch runways as shown in Figure 8.

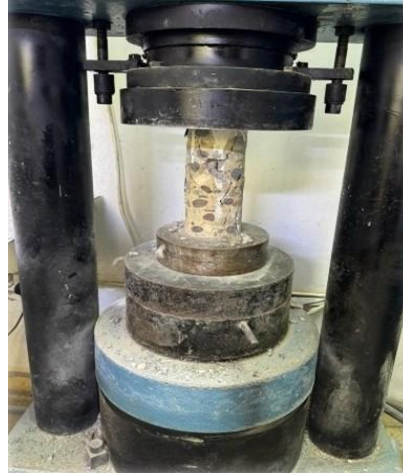
Fig. 11. Cores are being tested

In regarding the concrete, 12 cores were extracted from the main runways, taxiways, and branch runways. Concrete core sampling test was conducted as well, it involved extracting cylindrical samples to analyze the material composition and condition and for further laboratory analysis to assess material quality and perform the necessary physical and chemical laboratory test, Figure 11 [14]. The compressive strength results shown in Table (3), which range from 11.95 MPa to 29.01 MPa, indicate that most of the samples do not meet the required standards for concrete used in runway construction. The majority of the values fall below the acceptable threshold, suggesting that the concrete is generally weak.
