## Using digital modelling for the partial reconstruction of Sheikh Al-Arab Hammam citadel, situated in Farshout, Qena, Egypt

Essam H. Mohamed

Archaeological conservation dept., Faculty of Archaeology, South Valley University, Qena, Egypt

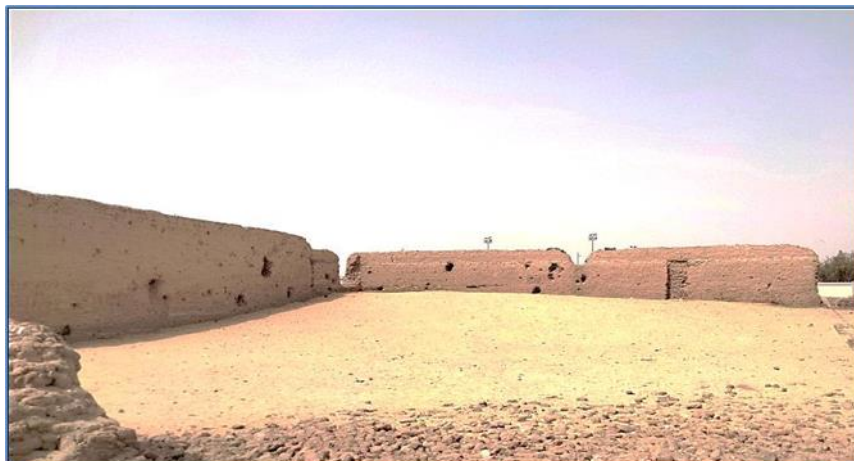
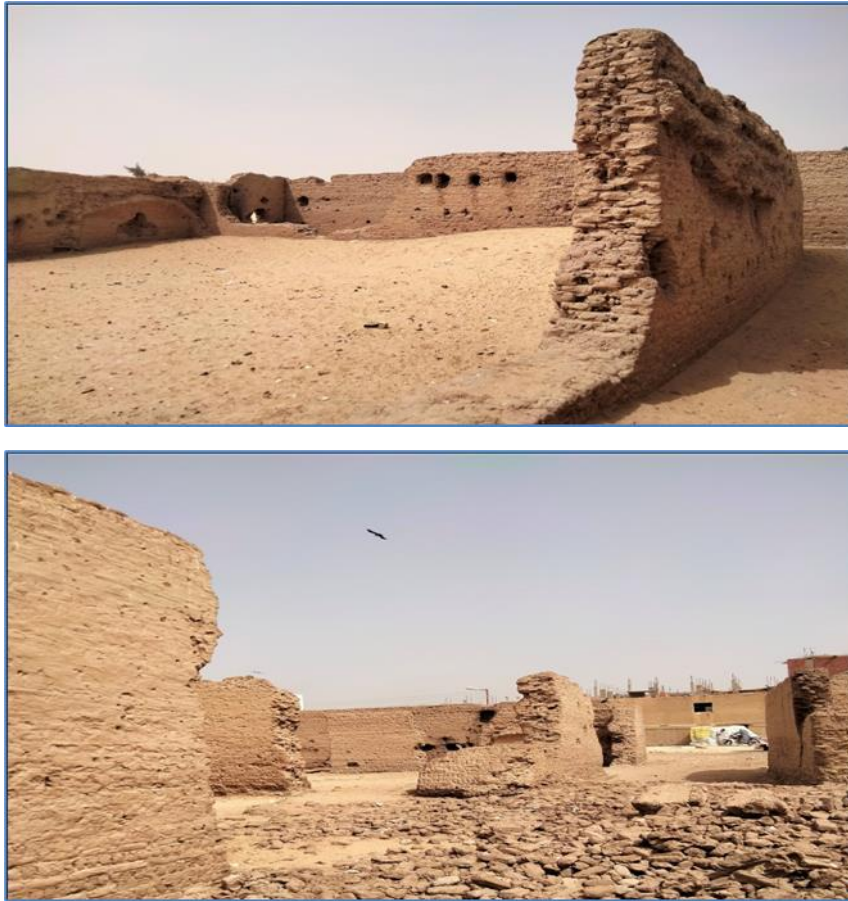
Fig. 8. A.B. the courtyard of the citadel. C. the destroyed architectural units of the citadel

The citadel building was photographed from different angles to highlight on the architectural details. (Fig. 7 and Fig. 8).
