## In-situ investigation of earthen building materials in the Ksour of the Ziban region, Algeria: A comparative study between Chetma and Lichana

Amdjed Islam Dali <sup>\*,1,2,a</sup>, Sami Zerari <sup>2,b</sup>, David Gandreau <sup>1,c</sup>

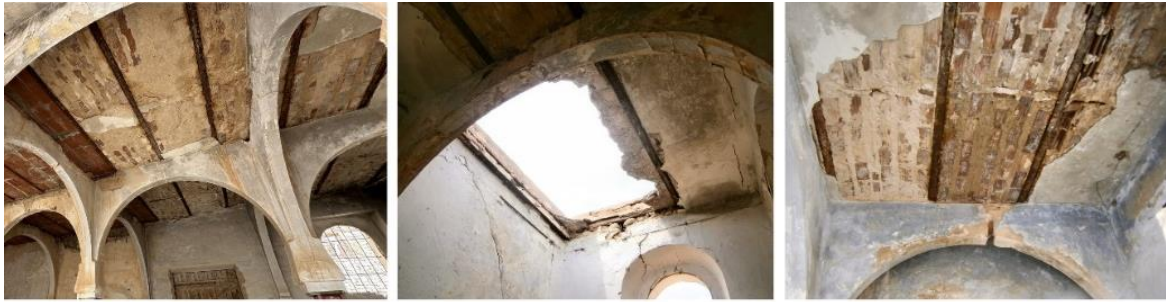
Fig. 7. Views of the roof structures in the ksar of Lichana: palm wood post-and-beam; b) IPN joists of the mosque. Photos by authors, 2024

The mosque of Lichana features a distinctive building element: its roof was constructed using IPN joists (I-beams) filled with fired hollow bricks, a building technique that reflects French colonial influences (Fig. 7), as stated by Dali and Belakehal [20]. However, the locals have managed to preserve the authenticity of the two ksour, as no significant changes in construction techniques or new materials have been observed. This resilience is primarily attributed to *Touisa*, an ancestral

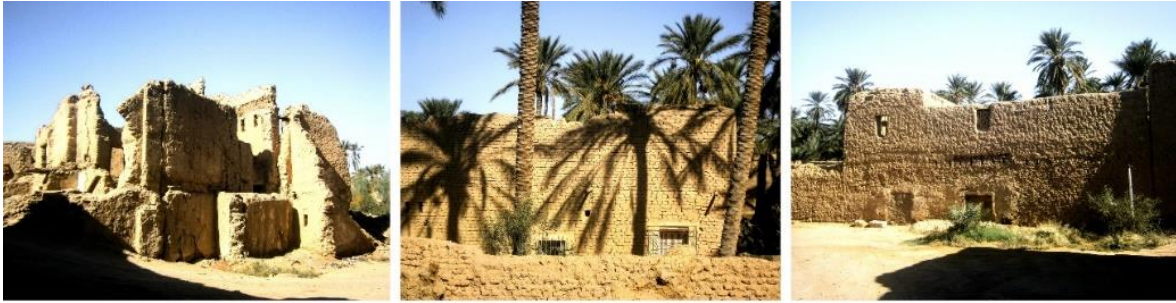
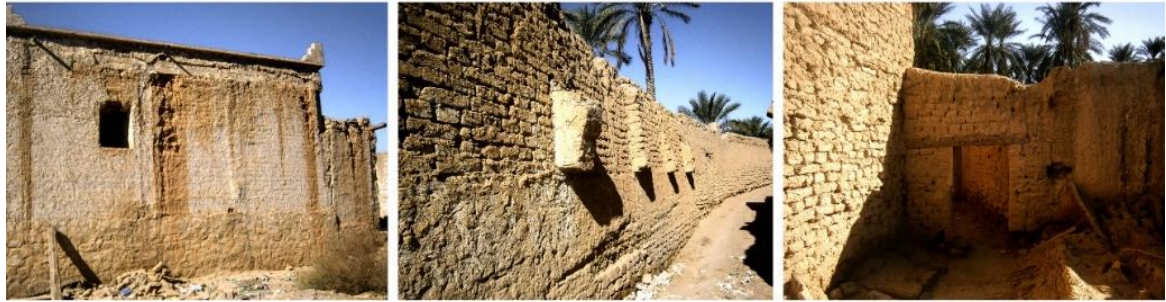
Fig. 8. Views of the wall systems in the ksar of Chetma: a) load-bearing walls (base, wall, crowning, and surface); b) construction systems of the base of load-bearing walls. Photos by authors, 2024

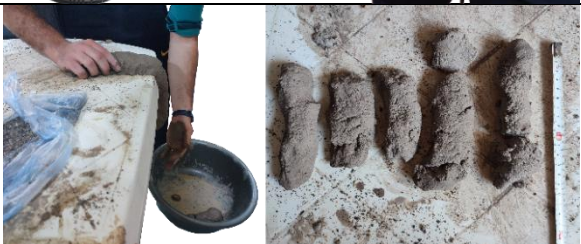
| Tests | Observation and interpretation | Tests' illustrations |
|---|---|---|
| Cigar test | The cigar is cut to an average length of 11.73 cm, indicating a significant level of earth cohesiveness. | |

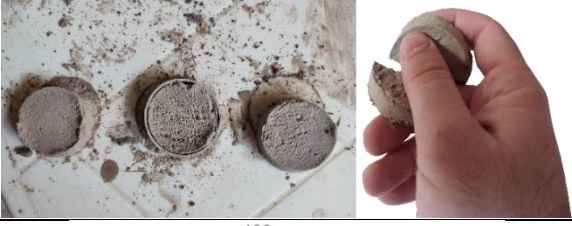
| Pellet test | No shrinkage was observed, and the breakage required little force and was easy to reduce to powder. This indicates sandy earth. | |

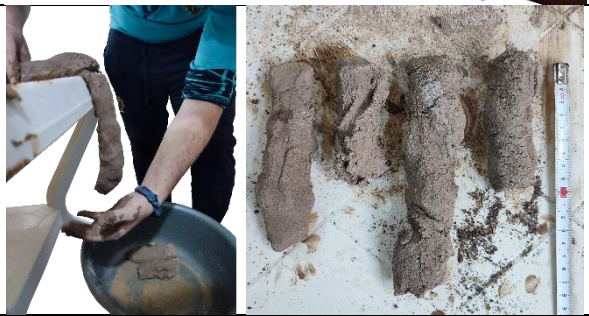
| Tests | Observation and interpretation | Tests' illustrations |
|---|---|---|
| Cigar test | The cigar is cut to an average length of 13.67 cm. This earth is more cohesive than the first sample from Lichana. | |

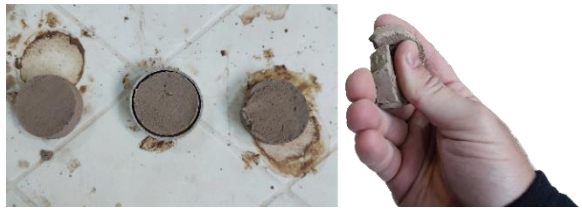
| Tests | Observation and interpretation | Tests' illustrations |
|---|---|---|
| Pellet test | The shrinkage of the pallet was greater than 1 mm. Breaking it required significant force, and the sample was not very friable. This demonstrates the excellent cohesion of the clay in the earth. | |
