In-situ investigation of earthen building materials in the Ksour of the Ziban region, Algeria: A comparative study between Chetma and Lichana

Amdjed Islam Dali ^{*,1,2,a}, Sami Zerari ^{2,b}, David Gandreau ^{1,c}

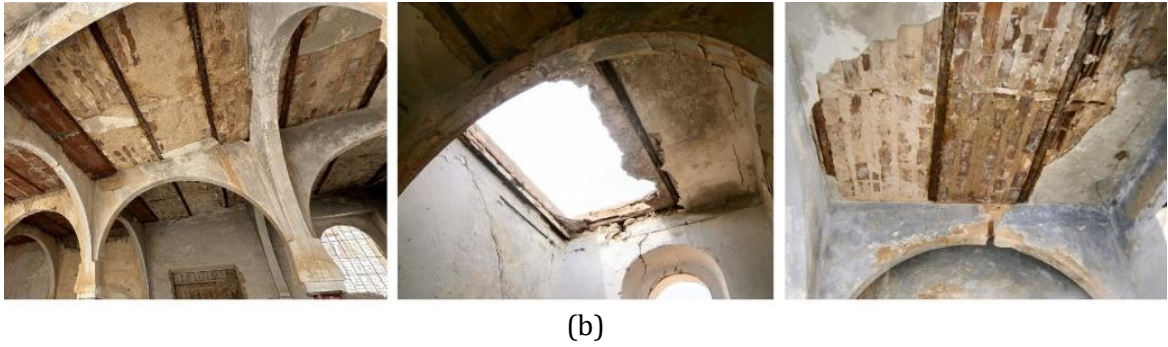
Fig. 7. Views of the roof structures in the ksar of Lichana: palm wood post-and-beam; b) IPN joists of the mosque. Photos by authors, 2024

The mosque of Lichana features a distinctive building element: its roof was constructed using IPN joists (I-beams) filled with fired hollow bricks, a building technique that reflects French colonial influences (Fig. 7), as stated by Dali and Belakehal [20]. However, the locals have managed to preserve the authenticity of the two ksour, as no significant changes in construction techniques or new materials have been observed. This resilience is primarily attributed to *Touisa*, an ancestral

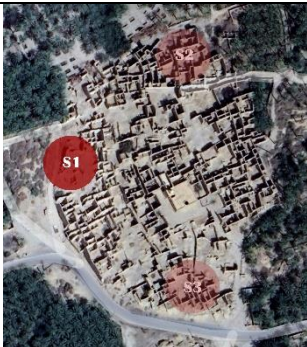
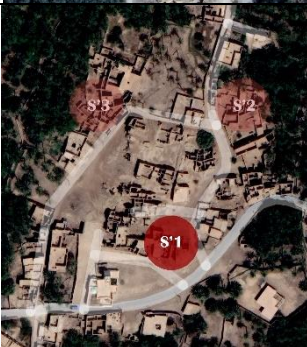
Table 1. Collection and preparation of mud brick samples (S1 and S'1) for testing. Elaborated by authors, 2024

Ksar	Source of the mud-brick	Samples	
		Mud brick samples	Crushed mud brick
Lichana

Field tests were carried out on two samples: one taken from the ksar of Lichana (S1), specifically a piece of mud brick that was retrieved from a ruined house near the western gate of the ksar. Despite the deterioration of its original structure, the piece of brick appeared in relatively good condition, making it a viable specimen for detailed earth analysis (Table 1). The second sample (S'1), concerning the ksar of Chetma, was taken from a ruined property between the two mosques of the

ksar. According to the local people's oral history, the brick-making earth originated from Ouldja, north of the ksar, and was transported by donkeys. The mud bricks appeared in relatively good condition, making them viable specimens for detailed earth analysis (

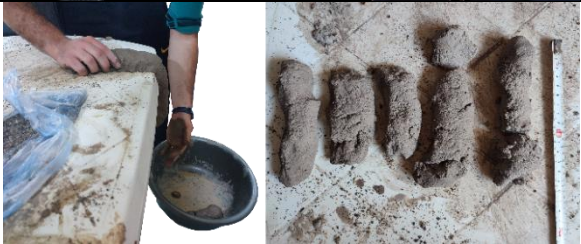
Cigar test	The cigar is cut to an average length of 11.73 cm, indicating a significant level of earth cohesiveness.

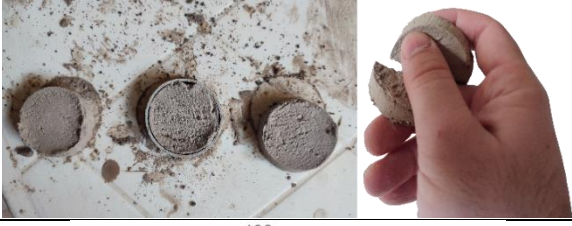
Pellet test	No shrinkage was observed, and the breakage required little force and was easy to reduce to powder. This indicates sandy earth.

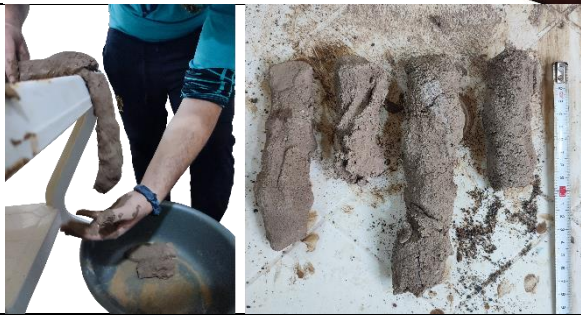
Cigar test	The cigar is cut to an average length of 13.67 cm. This earth is more cohesive than the first sample from Lichana.

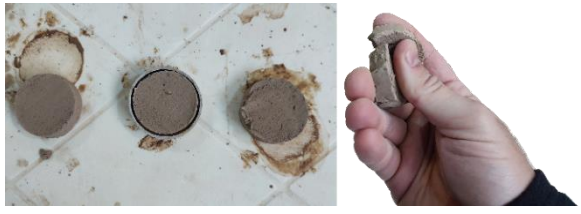
Pellet test	The shrinkage of the pallet was greater than 1 mm. Breaking it required significant force, and the sample was not very friable. This demonstrates the excellent cohesion of the clay in the earth.
