## Structural performance of carbon-FRCM in strengthening and repairing pre-damaged RC slabs

Ali A. Abdulridha <sup>\*1,2,a</sup>, Majid M.A. Kadhima <sup>1,b</sup>

<sup>1</sup>Department of Civil Engineering, University of Babylon, Hilla, Iraq

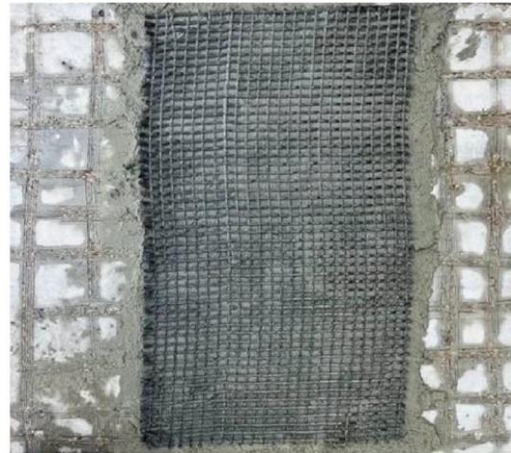
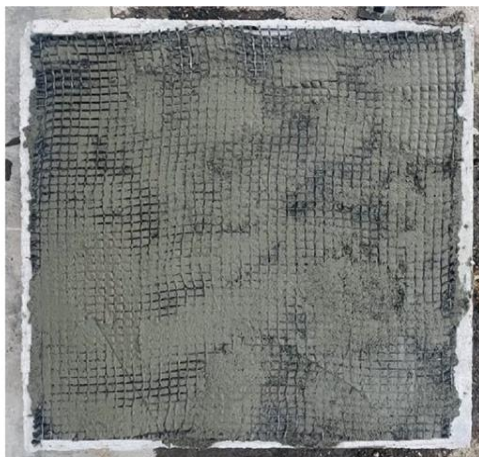
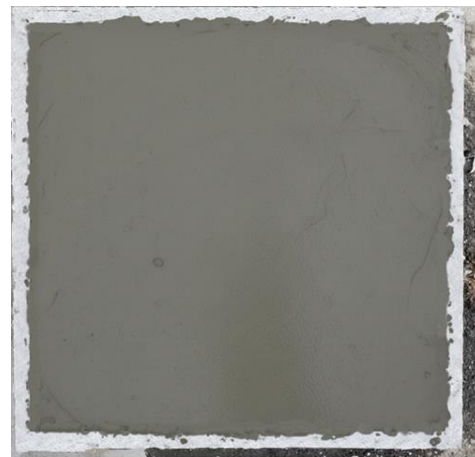
Fig. 4. Application steps for FRCM reinforcement: (a) Preparing and Moistening the concrete surface for strengthening; (b and e) Application of the first mortar layer together with the carbon textile; (c) Application of the second mortar layer along with the carbon; (d and f) Application and finishing of the final mortar layer

on the concrete surface to increase the bond effectiveness and the mechanical interlock between the substrate and the cementitious matrix (Fig. 4a).

Moistening of the prepared surfaces was performed to improve adhesion before mortar application. Then, a first layer of cement-based mortar (approximately 3 mm thickness on

average) was applied on the area where the strengthening would be performed, according to the strengthening layout given by the notation of the specimens. The carbon textile reinforcement for each specimen was specifically prepared and cut in accordance with the designated strengthening configuration. The textile was embedded and lightly compacted by hand, while the mortar was still fresh, to guarantee proper contact and impregnation as well as avoid air voids (Fig. 4b and e).

More layers of mortar were applied to fully encapsulate the textile, followed by the placement of another layer of textile (Fig. 4c). This successive layer was applied with sufficient care for to settle correctly and bond. The strengthening process concluded with the application of a final thin layer of mortar and meticulous finishing/smoothing of that surface, as seen in Fig. 4(d and f). Following strengthening, all the specimens were cured until the adequate mechanical performance of the FRCM system was achieved before proceeding with the tests. To facilitate evaluation and comparison of the effects FRCM system in both strengthening and repairing for the flexural behavior of the slabs, the same strengthening treatment was uniformly applied across all slabs.
