Behavior of structure type 82/2 (RC frame), during the earthquake of 26 November 2019 in Durrës, Albania

Anjeza Gjini, Hektor Cullufi, Enio Deneko, Princ Xhika

Research Article

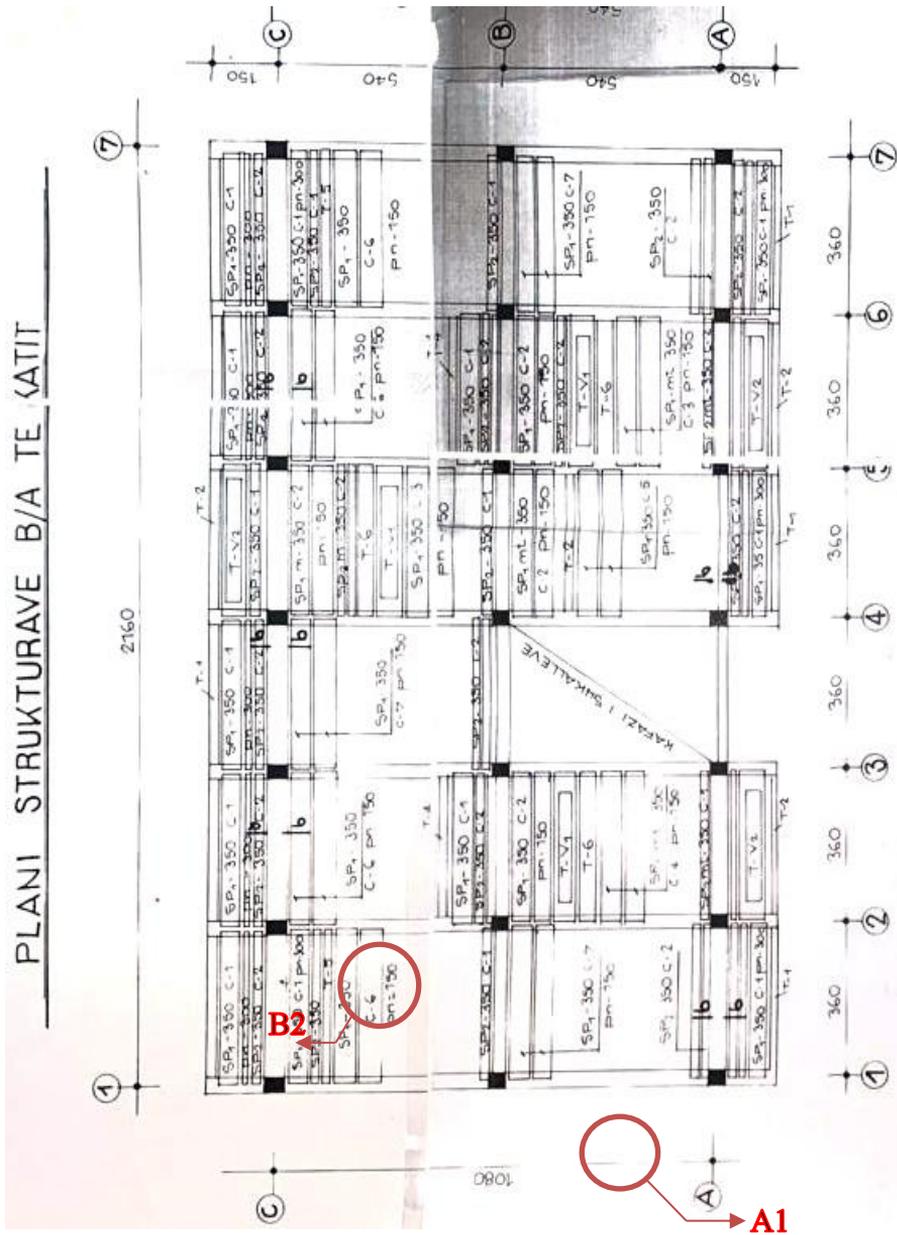
Fig. 6 Structural plan for building type 82/2, with monolithic RC frame system (as constructed)

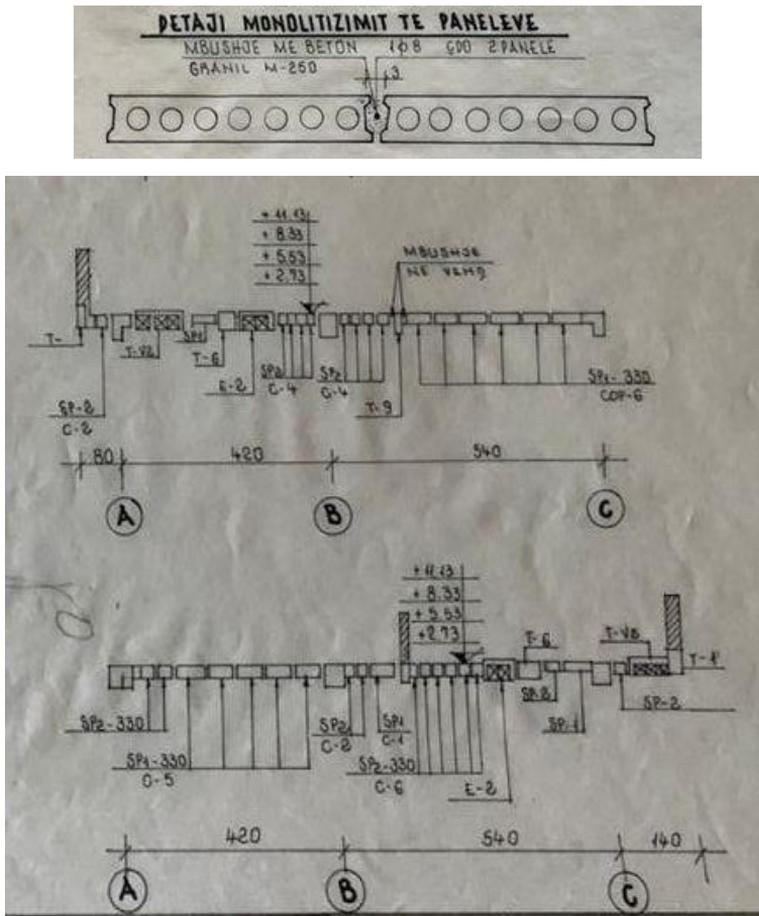
Fig. 7 Details of slabs (as constructed)

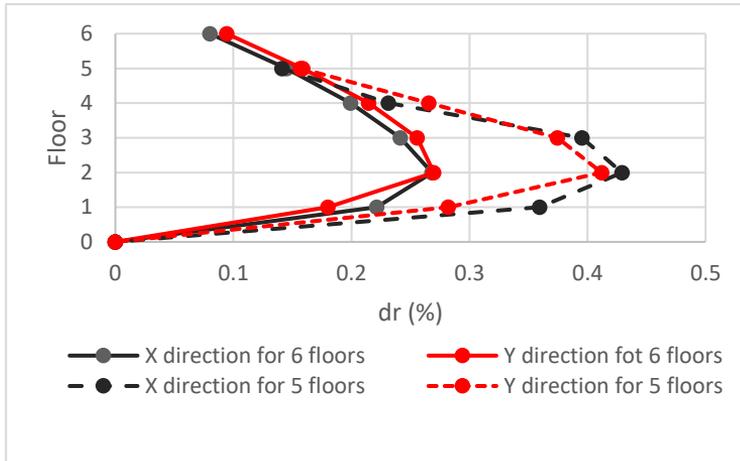
Fig. 15 Maximal drifts

As can be seen from the Figure 15, the interstorey drift reach up to 0.0043 for the 6 storey building and 0.0042 for the 5 storey building. For both studied cases, the requirement of EC-8 and KTP 89-2 are met (according to code maximum drift is 0.0087).

The interstorey drifts are higher in the 2nd-3rd floors because the amount of the columns reinforcement decreases. Referring to Figure 8, in the ground floor the columns are reinforced with 10 ϕ 20+2 ϕ 16. In the first floor there is a reduction to 6 ϕ 20+2 ϕ 16 (35.5% lower), and in the second floor (up to the last floor) it ends with 4 ϕ 20+2 ϕ 16 (27.4% lower). While, the dimensions of the columns section do not change.

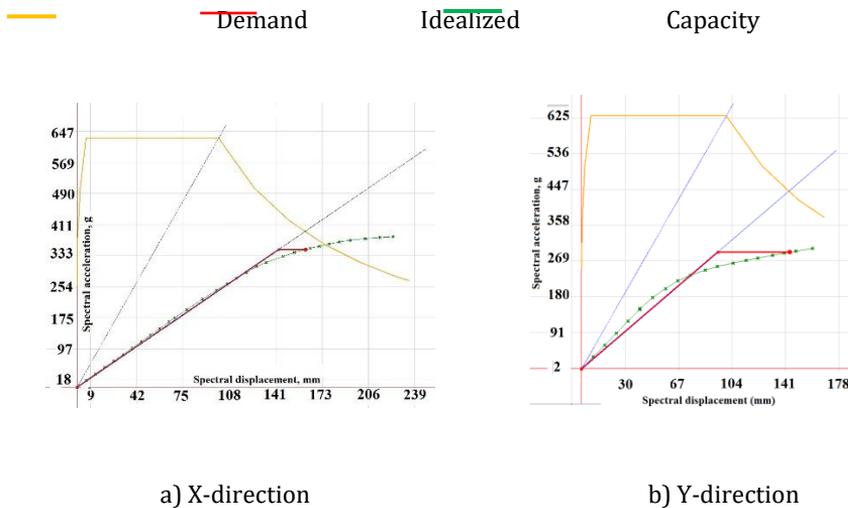
Fig. 16 Capacity diagrams for 5-storey building

From the nonlinear static analysis (Pushover), the 5-storey building exhibits a seismic capacity that does not fulfill the seismic demand (for y-direction). This phenomenon is also evidenced in the 6-storey building (as shown in Figure 16 and 17).

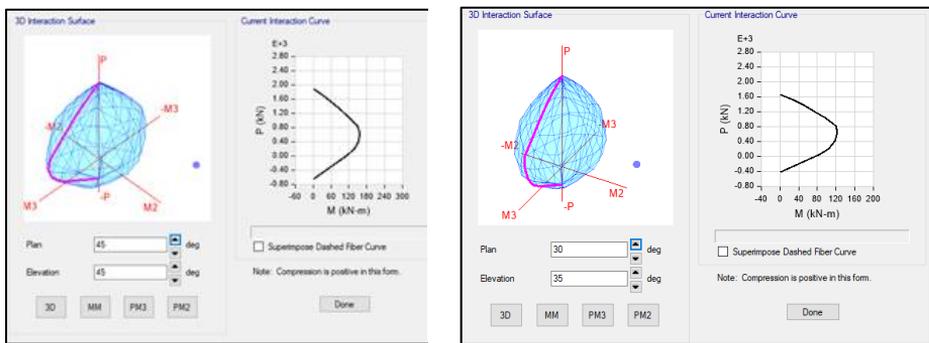
Fig. 18 Interaction curves for column in axes A1 (specified in Fig.6) of 5-storey building

The P-M2-M3 interaction generated from response spectrum is represented by a point outside the interaction curve (Figs. 18 and 19). It is clear the reduction of the bending capacity of the ground floor and first floor columns also identified from the damaged state, with the appearance of plastic hinges at their ends. From the development of plastic hinges, it is evidenced that the expected mechanism of collapse develops on the first floor rather than ground floor (Figure 21). This is a reasonable explanation considering the immediate change in the quantity of the longitudinal reinforcement of columns on this floor.

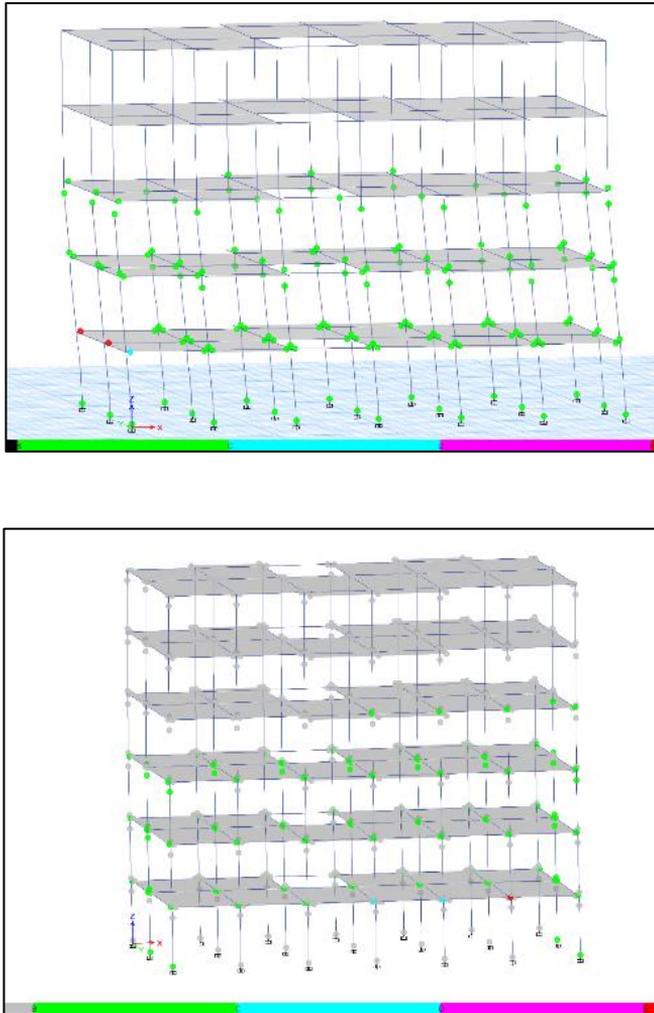
The level of performance is described referring the corresponding damage limit state. In Figure 20, the force-deformation (moment-rotation) curve of a typical plastic hinge is given. Referring to Figure 22 (the plastic hinge distribution), for the 5-storey building the plastic hinge is developed in the first floor, and corresponds to the point B (represents yielding) and in some elements to the point E (represents total failure). For the 6-storey building plastic hinges also develop in the first floor, representing by the point C (ultimate capacity) and E in some elements. Acceptance criteria for deformation or deformation ratios for primary members (P) and secondary members (S) corresponding to the target Building Performance Levels of Collapse Prevention (CP), Life Safety (LS), and Immediate Occupancy (IO) as shown in Figure 20, are given in FEMA 2000 [18].

Fig. 22 Development of plastic hinges (generally in state A to B in plastic hinge development curve and a few in the highly plastic, near rupture D region) from the nonlinear static analysis (Pushover) a) 5-storey and b) 6-storey building
