Performance of URM structures under earthquake shakings: Validation using a template building structure by the 2019 Albanian earthquakes

Altin Bidaj, Huseyin Bilgin, Marjo Hysenlliu, Irakli Premti, Rrapo Ormeni

Research Article

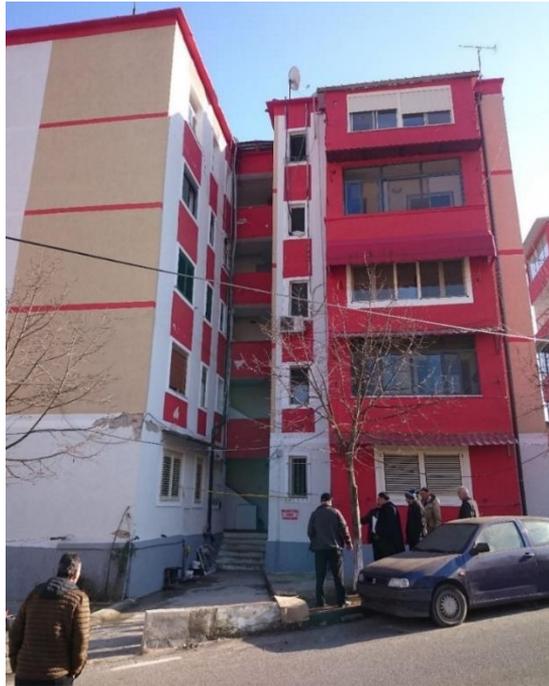
Fig. 22 The examined building

As seen from the photos, the material quality especially the mortar is very weak and could not prevent the segregation of the bricks in several parts. Damage was concentrated on the 1st, 2nd and 3rd floors. Level of the damage on load bearing walls was severe whereas the partition walls were heavily damaged. Typical damage patterns like bending and shear cracks, spalling of mortar, separation of the load bearing wall segments especially over or under the openings are observed all over the first three floors and are shown in the Figs 23-25.
