Experimental research of quality of the adhesive repairs of composite structures using non-destructive testing

Kirill Ibrishev, Ekaterina Prilipko, Maksim Soldatkin, Nikolay Kononov

Ibrishev K, Prilipko E, Soldatkin M, Kononov N. Experimental research of quality of the adhesive repairs of composite structures using non-destructive testing. *Res. Eng. Struct. Mater.*, 2025; 11(3): 1051-1065.

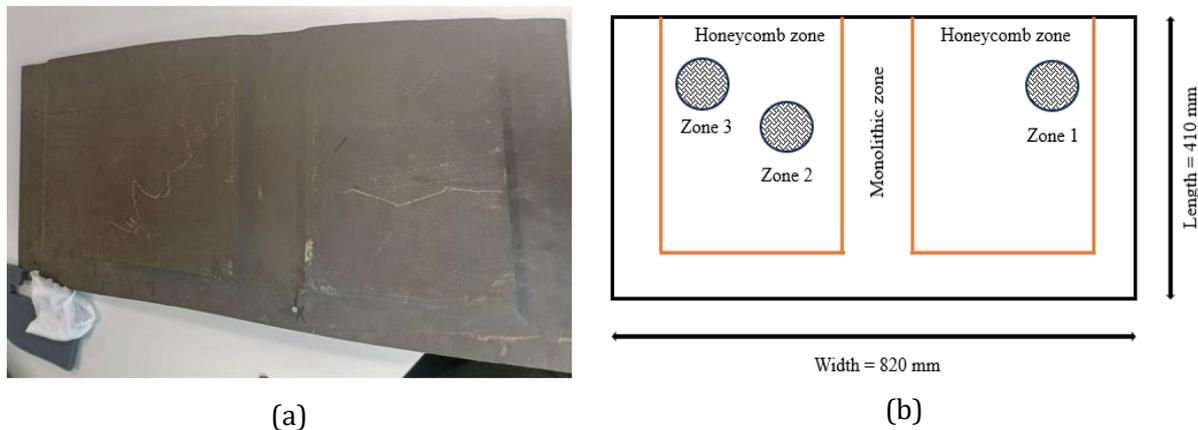
The subject of this research is a three-layer honeycomb panel, consisting of a middle layer of honeycomb filler and external top and bottom skins. The panel is made of composite material, used in the aviation industry. This research focuses on the repair process of the panel, represented in figure 2, to study its structural properties after damage upon impact. Defects are inflicted by singular impacts along the monolithic part of the panel and across the part of the panel with a honeycomb filler from a height of 0.5 meters using a drop test rig with an impact energy of $E = 1.398 \text{ J}$.

Fig. 2. Repair three-layer carbon fiber honeycomb panel (a) External appearance of the panel (top view); (b) Schematic view of the repair panel with marked repair zones and overall dimensions

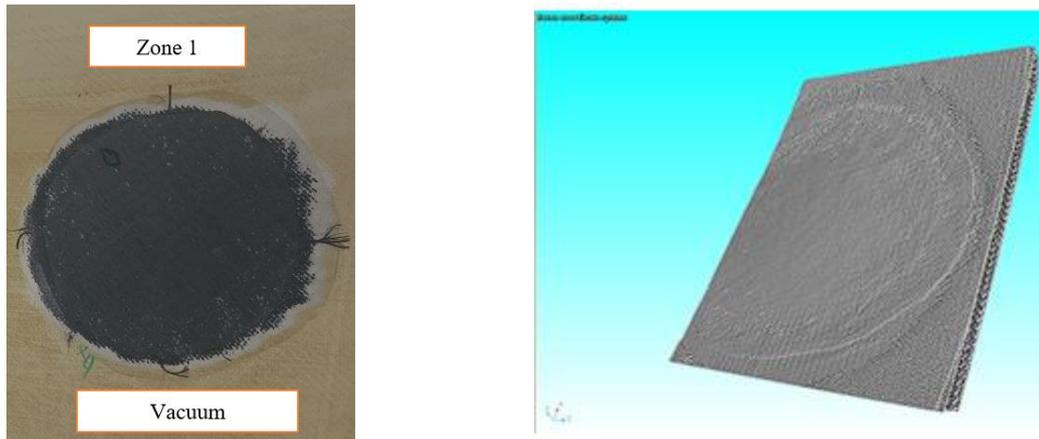
Fig. 7 – Repair patch in zone 1

The general view of repair zone 1, done by vacuuming and the isometry view of the 3D model are presented in figure 7. The results of the study of repair samples by means of X-ray computed tomography are given in figure 8.

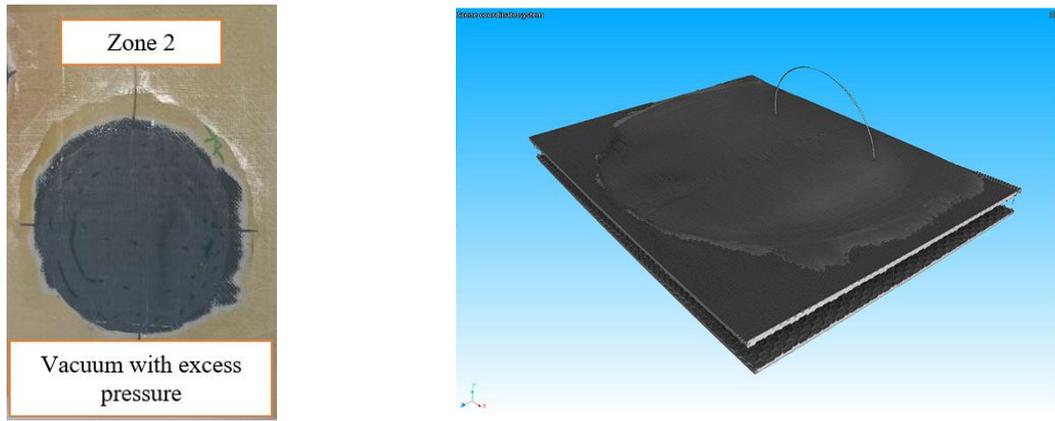
Fig. 9. Repair patch in zone 2, performed by vacuum method with excess pressure

The general view of zone 2, executed by a vacuum method with excess pressure, and a 3D isometric view of the model, are presented in figure 9. When examining the projections of the repair patch, areas of non-adhesion, measuring 25 mm x 35 mm, and metallic inclusions were found, as shown in figure 10.

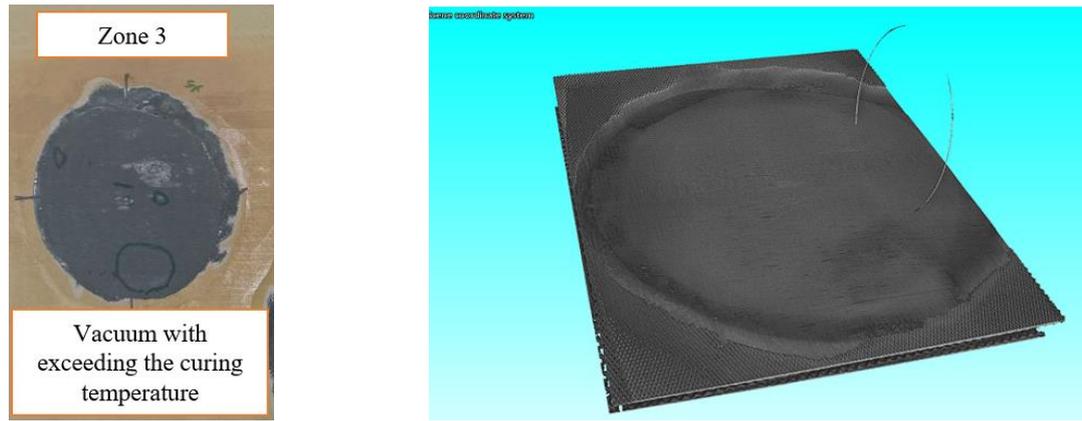
Fig. 11. Repair patch in zone 3

The general view of zone 3 with a repair performed by a vacuum method with an exceeding curing temperature and a 3D isometric view of the model are presented in figure 11. When studying the sections of the repair patch, numerous voids of sizes from 2 to 10 mm were also found, as shown in figure 12.

The side section of the patch was also studied for defects. In the XY plane, in the transition area of repair patch - honeycomb filler, extensive delamination was found with a linear size of 40 mm. Based on the results of tomography, the following conclusions can be made:
