Crack healing and flexural behaviour of self-healing concrete influenced by different bacillus species

Cheredy Sonali Sri Durga^{1,a}, Chava Venkatesh*^{1,b}, T. Muralidhararao^{1,c}, Ramamohana Reddy Bellum^{2,d}

¹Department of Civil Engineering, CVR College of Engineering, Hyderabad, 501510.

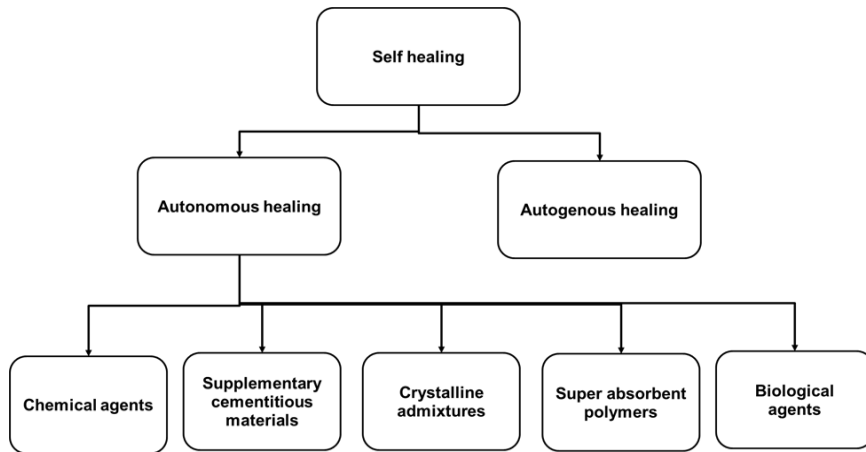
Fig. 1. Self-healing methods

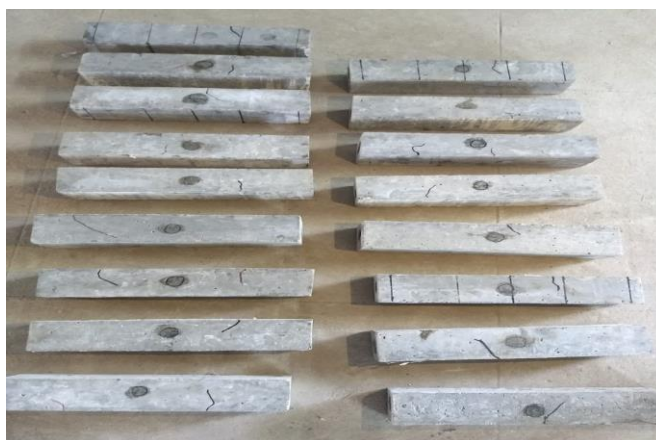
Fig. 2. Setup of cracked concrete specimens

The non-destructive studies were carried out on the hardened concrete by performing an ultrasonic pulse velocity test as per IS: 13311 (Part 1) – 1992 [38]. An Ultrasonic Pulse Velocity (UPV) test is an in-situ, non-destructive test to check the concrete quality. In this, the strength and quality of concrete are evaluated by measuring the velocity of an ultrasonic pulse passing through a concrete structure. Higher velocities indicate good quality and continuity of the material, while a lower velocity indicates concrete with many cracks or voids. The pulse velocity will be calculated by using Eq 1. The specimens (prisms) are cracked from the mean strengths as shown in Fig 2 and are placed in different curing agents such as calcium lactate, water and air in Fig 3. The experimental setup of UPV measurement to the concrete specimen is represented in Fig 4. A white precipitate was formed on the concrete specimen's surface indicating crack healing shown in Fig 5.

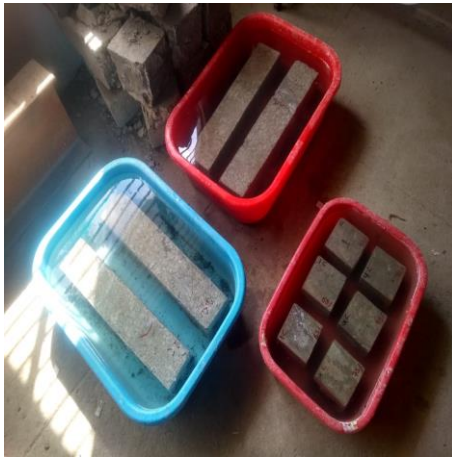
Fig.3 Concrete specimens cured at various curing agents

According to IS 10262-2009 [37], the mix calculations for 40MPa strength concrete are evaluated and listed in Table 2. Additionally, two different bacterial cell concentrations, namely 5.79×10^8 and 5.79×10^9 , are used in the concrete throughout the present research work. The crack healing ability of bacterial agents and the flexural behavior of bacterial agent-induced concrete are carried out. All the prepared concrete samples are cured in normal water for 28 days before testing. The surface cracks are formed using 65% and 75% stress level concentrations [16]. To evaluate the healing ability of bacterial agents, three different curing conditions are adopted, namely water, calcium lactate, and air (i.e., ambient curing).

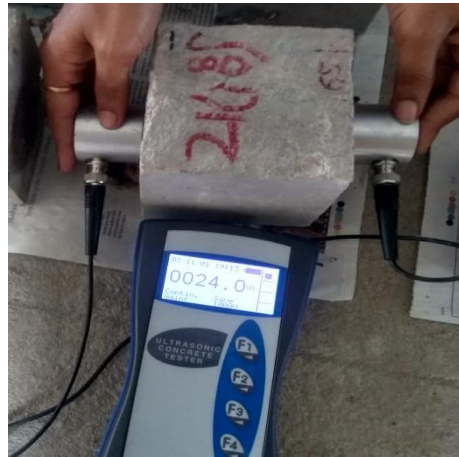
Fig.4 Setup of UPV measurement

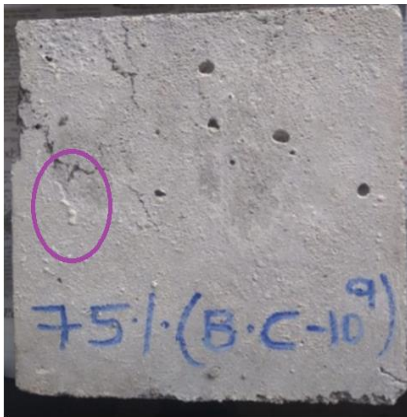
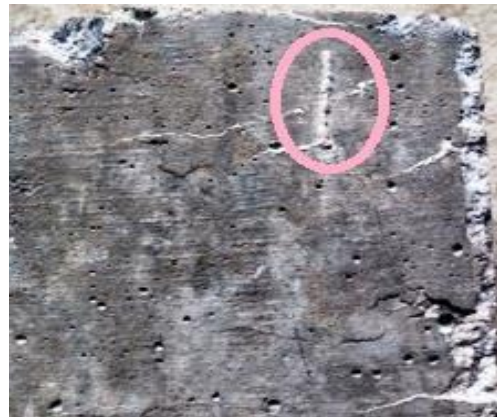
Fig. 5. Crack healed specimens

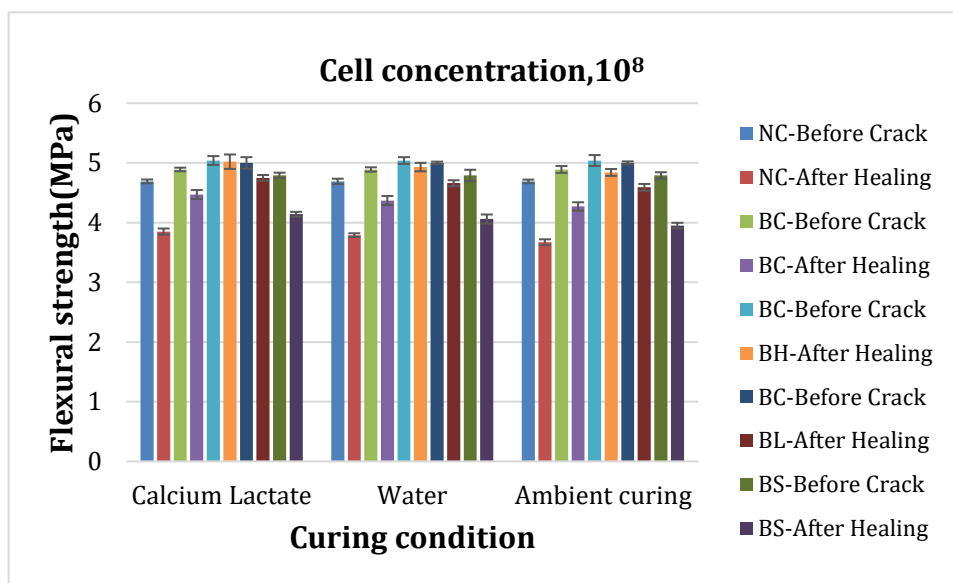
Fig. 7 Flexural strength of bacteria cell concentration of 10^8

in BL, 86.78 in BS, and 82.09 in NC, respectively. Similarly, BH has shown better strength recovery under water and ambient air curing conditions, i.e., 98.23% and 96.46%, respectively. From the UPV values, it was observed that the bacteria can seal the crack by observing the surrounding moisture and air, which is the reason for the recovery of strength. Similar results were observed in the case of bacteria with a cell concentration of 10^8 , which are shown in Fig. 7.
