## Large-scale in-situ infiltration and load testing on collapsible soils: A case study from Egypt's new administrative capital

Soha Emad Said, Yasser Moghazy El-Mossallamy , Hossam El-Din Ali, Ashraf Ahmed Reda El-Shamy

Journal Abbreviation: *Res. Eng. Struct. Mater.*

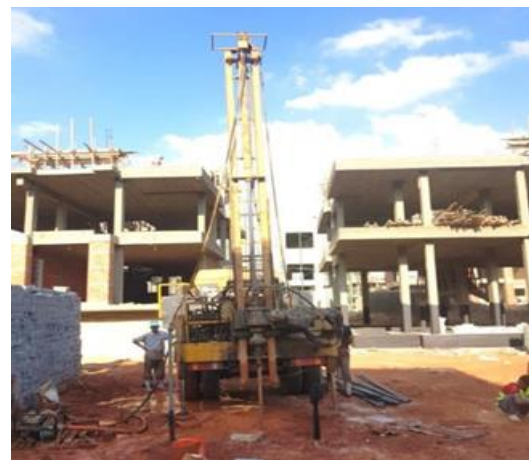
Fig. 9. Deep infiltration system (a) Schematic (b) Photograph

The setup for the proposed large-scale in-situ test consisted of 2 main aspects: a loading system and a wetting system. The wetting system was subdivided into subsurface wetting and deep infiltration. The importance of the deep infiltration system was to accelerate the soaking of the relatively thick fill layer ( $\approx 10$  m), which is highly sensitive to small increases in water content depending on fines content and compaction degree. Five wells, approximately 9 m deep, were drilled at the start of the test setup, as shown in Fig. 9. These wells were equipped with perforated PVC pipes connected to a water tank via a valve to control the amount of water being fed to the system. Then the test location was prepped for the installation of the subsurface water feeding system, which consisted of horizontal perforated pipes in a filter layer connected to the same water tank via a separate valve, as shown in Fig. 10.

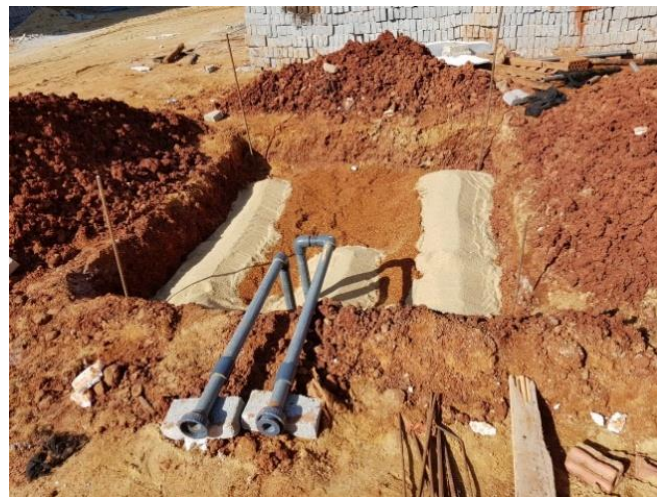
Fig. 11. A thin sand layer to prevent the settlement of pipes

To ensure the pipes remained unaffected by settlement, they were overlain with a thin layer of sand, as shown in Fig. 11. After the completion of the wetting system, preparation for the loading system began. The loading system consisted of a reinforced square concrete footing with dimensions (2 m x 2 m x 0.4 m), which was poured above the subsurface layer, as shown in Fig. 12.
