Performance of the pile group foundation supporting multi-story building under repeated earthquakes

Omar K. Ali, Jasim M. Abbas, Laith K. Al-Hadithy

Journal Abbreviation: *Res. Eng. Struct. Mater.*

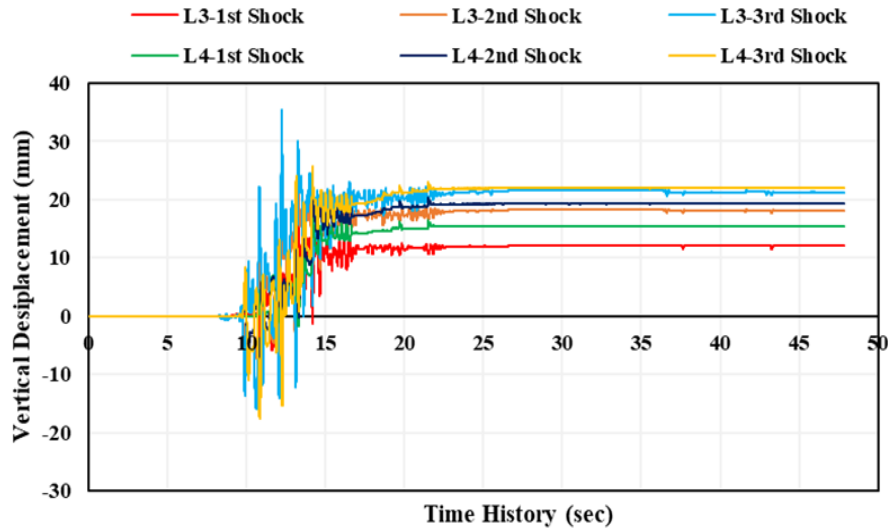
Fig. 5 demonstrated the relation between the vertical displacement and the time history at both sides of piles cap for the 10-story building during exposing to three consecutive shocks. It can be seen that the waveforms recorded at both sides of pile caps across the three successive shocks have approximately the same trend and show no significant vertical displacement roughly until 7 seconds, indicating that the earthquake impact did not directly affect the piles cap during this initial phase. This stable interval presumably signifies the period prior to the interaction of seismic waves with the foundation piles, wherein considerable forces are exerted. After this point, a noticeable change in vertical displacements which recorded at the pile cap sides were observed in between second ten to second fifteen for the three consecutive shocks, that can be attributed to the

increasing intensity of the seismic activity simulated in the laboratory environment. This period is likely aligned with the peak shaking, which exerted maximum stress on the piles cap, resulting in rapid variations (i.e., rotation) in vertical displacement values. This observation indicates that the earthquake's intensity was sufficient to exceed the initial resistance of the piles group foundation. After a duration of 20 seconds, the rates of observed vertical displacements stabilize at each shock of the three consecutive shocks applied.

Fig. 5. Vertical displacement of the pile cap vs. time history for the 10-story building under three consecutive earthquakes

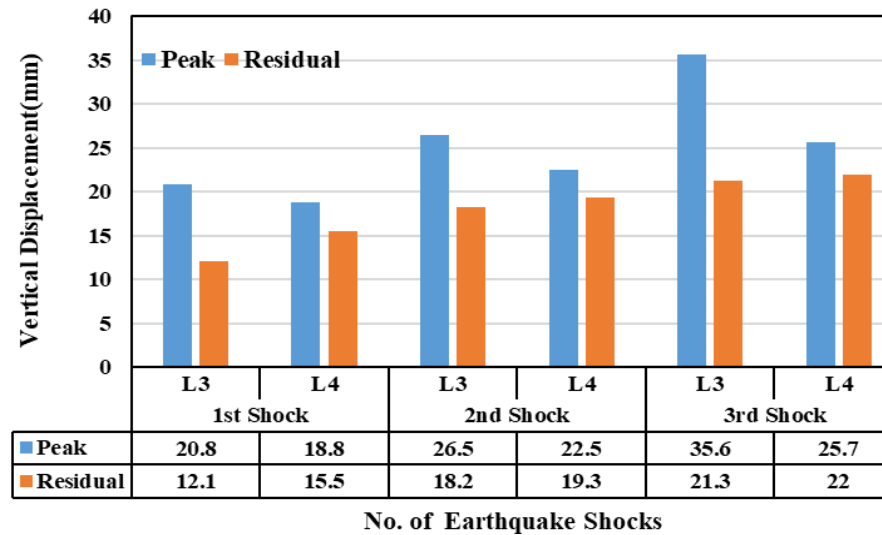
Fig. 6 presents the relation between the vertical displacement of the Piles cap (peak and residual values) with number of shocks applied. The data illustrated in this figure clearly indicates that the peak vertical displacement values recorded at the pile cap side that directly subjected to seismic activity larger than that at the opposite side. In contrast, the residual values show reverse response. This observation holds true for all values recorded during the three consecutive earthquakes that were applied. For instance, during applied the first shock, the peak vertical displacement value recorded at the cap side directly exposing to seismic activity equal to 20.8 decrease to 18.8 mm at the opposite side, indicating a reduction in peak displacement between both side of about 9.5%. Subsequently, a modest elevation in the reduction ratio of peak displacement between the both sides of the pile cap is noted, assessed at around 15.1%, upon the application of the second shock. This ratio experiences an additional rise to reach 27.8% with the application of the third shock. This phenomenon can be attributed to the fact that seismic loading induces an asymmetric interaction between the soil, piles, and building. Specifically, the leading (front) piles row experiences greater horizontal resistance and axial compression compared to the trailing row, particularly when seismic event integrates kinematic drag of soil with the inertial forces exerted by the building. The effect of group pile shadowing causes the cap to rocking towards direction of the seismic load. This results in an increased compression on the leading piles row, while the trailing row experiences reduced compression, and occasionally, transient conditions of tension or gapping may arise among those piles. Concurrently, the process of repeated seismic load results in local densification of the surrounding sand (characterized by volumetric strains of ratcheting), thereby amplifying down-drag (negative skin friction) along the greater sheared leading-pile shafts. This combination of higher cyclic densification and greater compressive axial force, leads to a more substantial vertical displacement. This observation is consistent with the findings of [16,17]. With respect to the observed values of residual vertical displacement, it can be noticed that the residual displacement increased from 12.12 mm at the direct side to 15.54 mm at the opposite pile cap side, indicating an inflation rate of approximately 28.1% during applied the first shock event. Moreover, a comparison of the residual vertical displacement between both sides of pile cap during applying the second and third shocks revealed increasing rates of (6 and 3.3) % respectively. The potential explanations for the increased residual displacement observed at the side of the pile cap opposite to the seismic load possibly due to the cumulative finding of its distinct stress

trajectory experienced during seismic loading. While the cap side directly subjected to seismic load shows high vertical displacement due to several direct pulses at the earthquake's peak, the opposite side undergoes fully-reversed, more symmetric cyclic shear. This change in shear strain, coupled with the cap rocking that diminishes confining stress on the opposite side during forward motion, renders the soil in that area more vulnerable to cyclic compaction across numerous cycles. Consequently, the opposite side accrues a more substantial amount of residual displacement from a greater number of effective stress cycles, ultimately surpassing the peak vertical displacement experienced at the pile cap side exposed directly to the seismic shock, and this agree with [17,18].

Fig. 6. The relation between the vertical displacements of the pile cap and the number of earthquakes applied

Another important finding is that the effect of multiple earthquakes on the piles cap tilt. It can be seen that the vertical displacement measured at both piles cap sides show increasing values with each subsequent earthquake applied. That can be inferred clearly, when applied the second earthquake, the peak vertical displacements measured on the pile cap side directly subjected to seismic load, and the opposite side, increased by 27.4% and 19.7% respectively, relative to the values obtained during the first shock event. After applying the third shock, the peak values witnessed an additional increase, reaching 71.2% on the direct side and 36.7% on the opposite side when contrasted with their original values at the first shock. Furthermore, similar behavior was observed in case of residual vertical displacement. Following the second shock, the value of residual vertical displacements measured on both direct and opposite cap sides exhibited increases of 50.4% and 24.5%, respectively, relative to the data acquired during the first earthquake. Subsequently, after the third earthquake application, the residual displacements surged to even higher levels, reaching 76% on the direct side and 42% for on the opposite side, when compared to its values recorded during the first seismic event. It seems possible that these results of increase in vertical displacements observed following each earthquake may be attributed to factors such as cumulative plastic deformation. Dense sand exhibits plastic deformation when subjected to multiple seismic loading. Although dense sand initially demonstrates a degree of resistance to deformation owing to its stiffness, each successive earthquake induces further rearrangement of soil particles. Consequently, this phenomenon results in a cumulative reduction in soil volume, which in turn contributes to the observed increases in vertical displacements. and this agree with [19, 20 and 21]. Another possible explanation for this result is that it is due to stress redistribution, and the effects of soil-pile interaction. These mechanisms gradually diminish the soil's capacity to withstand vertical displacement, leading to increased deformation and pile cap tilting with each seismic occurrence and this agree with [17].

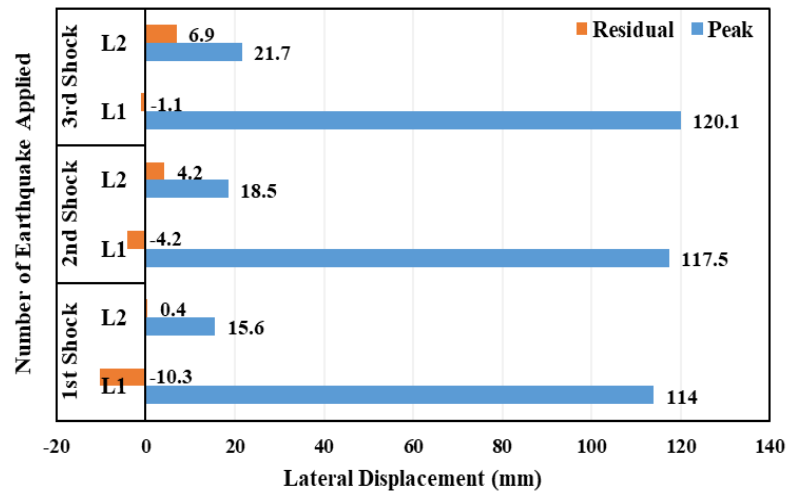
Fig. 8 presents the relation between the lateral displacement (peak and residual values) measured at the top side of 10-story building, as well as the pile cap by (L1 and L2) respectively, during applied of the three successive earthquakes. As shown in Figure 8, the peak lateral displacement for the 10-story building which recorded by (L1) increases slightly across the three earthquakes: 114 mm in the first, 117.5 mm in the second, and 120.1 mm when the earthquake is applied for third time. That's mean that the ratio of increasing in value of peak lateral displacement for 10-story building during the second and third earthquakes greater than that recorded at the first earthquake by 3.1% and 5.4% respectively. This trend suggests an accumulation effect, likely due to minor degradation or residual displacement in the building after each seismic event. As for the peak lateral displacement for piles cap measured by (L2), its increases progressively: 15.6 mm at the first earthquake, 18.5 mm at the second earthquake, and 21.7 mm at the third earthquake. This designate that the increasing ratio in peak lateral displacement value for piles cap throughout the second and third earthquake events larger than that noted at the first shock by (18.61 and 39.14) % respectively. The observed upward trend designates in the peak values of lateral displacement that the pile-soil system is undergoing a gradual increase in response, with improvement in energy dissipation over time producing lower values of residual lateral displacements recorded at the end of each shock.

Moreover, these findings show that the 10-story building displays higher peak lateral displacements when compared to those measured at the piles cap. This performance can be attributed to several factors, including dynamic amplification effects, geometric influences and energy transmission. The building height amplifies the seismic forces that it encounters, producing greater lateral displacements occurring at the higher stories of building. Conversely, the piles cap undergoes a relative decrease in lateral displacement, which can be attributed to mechanism of energy dissipation occurring during interactions between soil and piles, in addition the effects of damping by the adjacent soil. The diminished lateral displacements at the piles cap designate its closeness to the source of seismic event in addition to the soil capacity to energy dissipate. Alternatively, the 10-story building shows larger lateral displacements, associated with the increase in the arm of moment and reduced lateral stiffness in the building higher storis and this accord with [22-24]. Moreover, the increase in peak lateral displacements during multiple earthquake events can be explained by a combination of factors, such as residual deformations in the interaction between the soil and pile, nonlinear behavior of the soil, and dynamic amplification

effects within the structure. These factors lead to a reduction in stiffness of pile foundations and an escalation of seismic forces at the upper stories of building, which in turn results in increased lateral displacements. This observation aligns with the conclusions drawn [25,26].

Fig. 8. The relation between the lateral displacements and the number of earthquakes applied

Another observation is that the residual lateral displacement of the 10-story structure during consecutive earthquake events showed a progressive decline, reducing from -10.43 mm in the first earthquake event to -4.21 mm in the second, and further to -1.11 mm in the third event (the negative values indicate that the structure is inclining in the direction of the earthquake). This trend reveals that the reduction rate in the residual lateral displacement of the 10-story structure, during the second and third earthquake events were (147.62 and 845.54) % respectively, compared to the first earthquake event. This behavior suggests that the building exhibits improved stabilization over time, as indicated by the decrease in residual displacements as the system adapts to the effects of successive seismic loading. Conversely, the value of residual lateral displacement noted at the pile cap, demonstrated a progressive increase during applying the earthquake events, 0.41 mm through the first seismic event, reach to 4.19 mm through the second seismic event and 7.99 mm through the third seismic event.

This behavior indicates that the rise in the residual lateral displacement observed at the pile cap through the second and third earthquakes was 10.5 and 20 times greater, respectively, than that recorded during the first earthquake. A potential reason for this phenomenon may be attributed to the nonlinear characteristics, which significantly influences the seismic response of the pile group foundations. As seismic events continue, the soil-pile interaction can result in greater lateral displacements, attributed to a reduction in group pile stiffness due to soil-pile interaction. Furthermore, the cyclic loading from successive seismic events may enhance the cumulative impacts on the response of pile's group, resulting in increased residual lateral displacements at the piles cap as time progresses. The overall behavior of the building is primarily determined by dynamic and geometric factors. Such behavior is consistent with well-recognized theories of soil-structure interaction and the principles underlying seismic dynamics and this agree with [27,28]. Another interesting result is that the measurements of residual lateral displacement noted at the piles cap increased during the three consecutive earthquakes, while decreasing at the 10-story structure. This performance is linked to the cumulative effects of energy dissipation and residual deformation taking place within the soil. As each earthquake occurs, the sand around the piles can undergo densification or minor plastic deformation, leading to a decrease in stiffness and allowing for increased lateral displacement at the piles cap. Moreover, the piles cap experiences greater displacements as a result of the lateral forces impacting it, in conjunction with the restricted lateral displacement of the adjacent soil, which contributes to an increase in the residual lateral displacement at the cap. In case of 10-story building, the inertia of the building aids in dissipating seismic forces, thereby leading to diminished displacements observed at the top side of building. These findings this consistent with [29, 30].
