Effect of elevated temperature on strength and durability properties of concrete using nano-silica and alccofine

Research Article

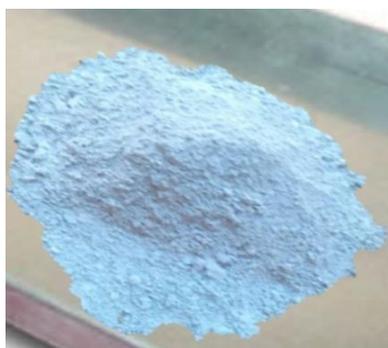
Fig. 1 Alccofine

Alccofine (Al) which is an ultra-fine slag or ggbs having particle size 4-6 μ m and specific gravity 2.86. It was procured from local dealers. Nano silica (Ns) having size of 17nm and specific gravity 2.2-2.4 shown in Fig. 2 was used. The properties alccofine and Ns obtained from manufacturer are given below in Table 2. As a fine aggregate, locally accessible river sand with specific gravity 2.65 has been used and coarse aggregates with a size of 20 mm having specific gravity 2.79 were used. Conplast SP430DIS is a high range water reducer superplasticizer that is used to maintain the workability of concrete mix. The laboratory tap water was used.

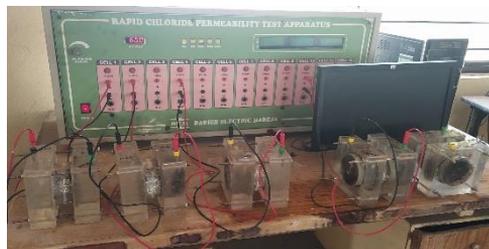
Fig. 4 Rapid chloride permeability test apparatus

Using the ASTM C 642-06 [19] procedure, 100 mm samples were used to determine water absorption and porosity. The ASTM C1202 [20] specification was used as a guide for the rapid chloride permeability assessment using a 50 mm disc samples. After completing the compressive strength test, the specimens were ground into fine powder for microstructural analysis using Scanning Electron Microscopy (SEM) test. Test apparatus for compressive strength test and rapid chloride permeability test shown in the Fig. 3 & 4. The results at room temperature (RT) were compared to those obtained at higher temperatures.

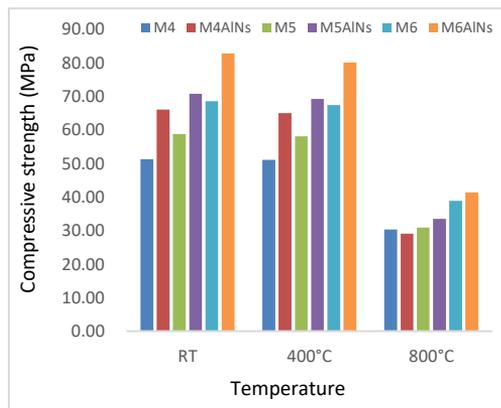
Fig. 6 Compressive strength values at elevated temperatures

The Compressive strength results of concrete specimens subjected to elevated temperatures are depicted in the Fig. 6 as the average of the observations. It can be seen from the Fig. 6 that increasing the temperature decreases compressive strength. Compressive strength results of Al+N_s concrete mixes were between 66 to 83 Mpa at RT, 64.9 to 80 MPa at 400°C, and 29 to 41.3 MPa at 800°C, respectively, as shown in Fig. 6. And compressive strength results of control mixes were between 51.1 to 68.5 MPa, 57 to 67.4 MPa and 30.3 to 30.9 MPa at RT, 400°C, and 800°C, respectively. Compressive strength

decreased by 0.3 to 1.7% at 400°C, 40 to 48% at 800°C for control mixes, and 1.5 to 3.3% at 400°C, 50 to 56% at 800°C for Al+N_s mixes.

The percentage decrease in compressive strength was greater for Al+N_s concrete mixes M4AlN_s, M5AlN_s, & M6AlN_s compared to control mixes M4, M5 & M6 because of degradation of calcium silicate hydrates [1]. Despite the fact that Al+N_s mixes had higher compressive strength than control mixes at 400°C, the percentage decrease in compressive strength was significantly higher for Al+N_s mixes. Fig. 13 shows that the compressive strength decreases as the porosity increases. Therefore, increase in porosity with temperature is one of reason for decrease in compressive strength at higher temperatures. Cross sections of concrete samples at different temperatures are shown in Fig. 7, 8 & 9. The color of hardened concrete changed after exposed to higher temperatures. Cracks appeared in the aggregate & paste's interfacial transition zone (ITZ), as well as within the aggregate at 800°C from Fig. 9 which is another reason for reduced compressive strength. Because the interfacial transition zone (ITZ) is the weakest connection between cement paste and aggregate, it can enhance crack propagation. As a result, increasing temperature raises internal stresses, which accelerates material cracking, multiplies defects, and thereby lowers strength [21, 22].

- The compressive strength of all concrete mixes decreased with increase in temperature, a slight loss of strength was noticed between room temperature and 400 °C and the percentage reduction of Al+ Ns mixes was grater at 800°C. Compressive strength decreased by 0.3 to 1.7% at 400°C, 40 to 48% at 800°C for control mixes, and 1.5 to 3.3% at 400°C, 50 to 56% at 800°C for Al+Ns mixes.
- Cracks appeared in the aggregate & paste's interfacial transition zone (ITZ), as well as within the aggregate and also color of hardened concrete changed with temperature.

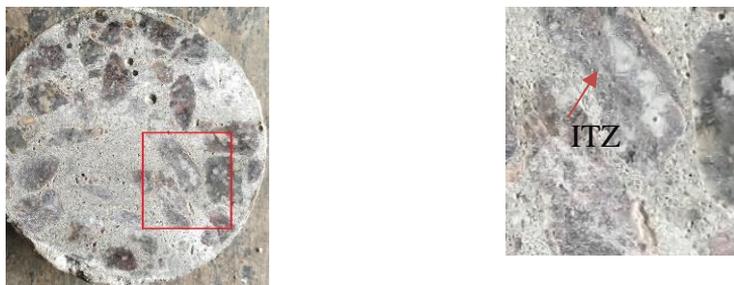
Fig. 7 Cross section of a hardened concrete at room temperature.

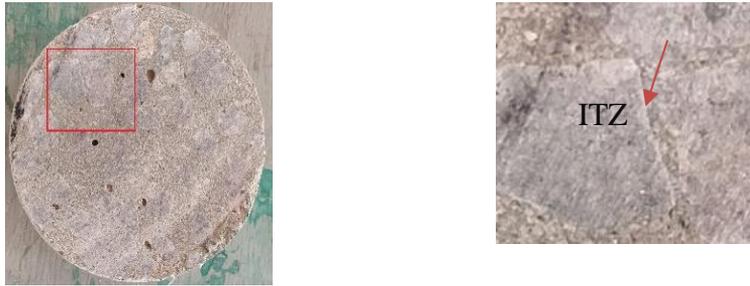
Fig. 8 Cross section of a hardened concrete at 400°C.

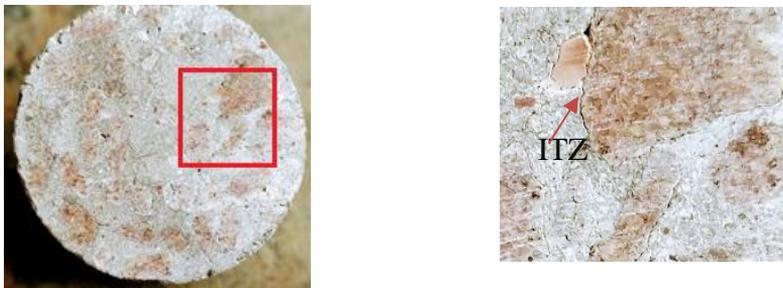
Fig. 9 Cross section of a hardened concrete at 800°C.

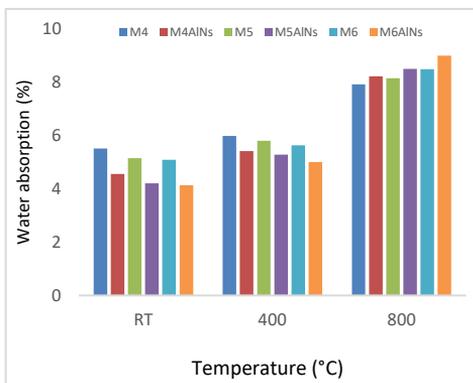
Fig. 10 Water absorption values at elevated temperatures

Water absorption and porosity values of concrete with and without Al and Ns were calculated using test procedure given in ASTM C642 for all the concrete grades. The water absorption of concrete specimens subjected to elevated temperatures are depicted in the Fig. 10 as the average of the observations.

It can be seen from the Fig. 10 that increasing the temperature increases water absorption due to internal cracking. The three major reasons of such an internal cracking could be the breakdown of crystalline calcium hydrate particles, development of steam pressure, and degradation of C-S-H [7].

Concrete with a water absorption value of less than 5% is considered to be of high quality [23]. Water absorption of Al+N_s concrete mixes ranged from 4.1 to 4.6 %, 5.4 to 5.8 %, and 8.2 to 9% at RT, 400°C, and 800°C, respectively, as shown in Fig. 10. And water absorption of control mixes ranged from 5 to 5.5 %, 5.6 to 6%, and 7.8 to 8.5 % at RT, 400°C, and 800°C, respectively. At RT, concretes mixes containing Al+N_s showed less than 5% water absorption. At 400°C and 800°C, all the concrete mixes showed water absorption greater than 5%. The percentage increase in water absorption of control mixes is 8 to 13% at 400°C, 43 to 67% at 800°C and for Al+N_s mixes is 18 to 26% at 400°C, 80 to 118% at 800°C. The percentage increase in water absorption was greater for mixes M4AlN_s, M5AlN_s, & M6AlN_s mixes at 800°C compared to M4, M5 & M6 mixes.

- The percentage increase in water absorption of control mixes is 8 to 13% at 400°C, 43 to 67% at 800°C and for Al+Ns mixes is 18 to 26% at 400°C, 80 to 118% at 800°C.

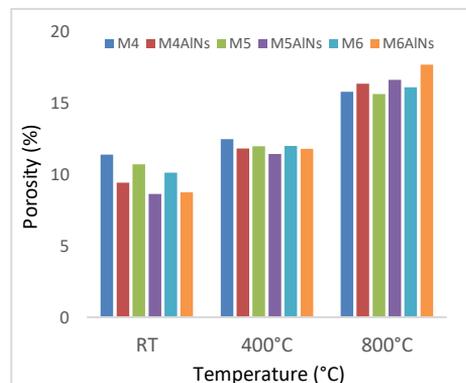
Fig. 11 Porosity values at elevated temperatures

Increase in temperature leads to the formation of large number of air voids due to evaporation of free water, accompanied by capillary water, and then physically bound water [24]. Porosity of Al+N_s concrete mixes ranged from 8.6 to 9.5 %, 11.4 to 11.8 %, and 16.3 to 17.7 % at RT, 400°C, and 800°C, respectively, as shown in Fig. 11. And porosity of control mixes ranged from 10.1 to 11.4 %, 11.9 to 12.5 %, and 15.6 to 16.1 % at RT, 400°C, and 800°C, respectively. The percentage increase in porosity of control mixes is 9 to 18% at 400°C, 38 to 59% at 800°C and for Al+N_s mixes is 25 to 35% at 400°C, 73 to 102% at 800°C. The percentage increase in porosity was greater for Al+N_s concrete mixes M4AlN_s, M5AlN_s, & M6AlN_s at 800°C compared to control mixes M4, M5 & M6. Because at high temperature as water evaporates, the internal pore pressure increases, which causes significant internal pressures upon on solid skeleton of concrete due to the compact structure and lower permeability of Al+N_s concrete mixes. And thereby increases no. of micro cracks leading to increase in no. of voids in concrete matrix [24].

- The percentage increase in porosity of control mixes is 9 to 18% at 400°C, 38 to 59% at 800°C and for Al+Ns mixes is 25 to 35% at 400°C, 73 to 102% at 800°C

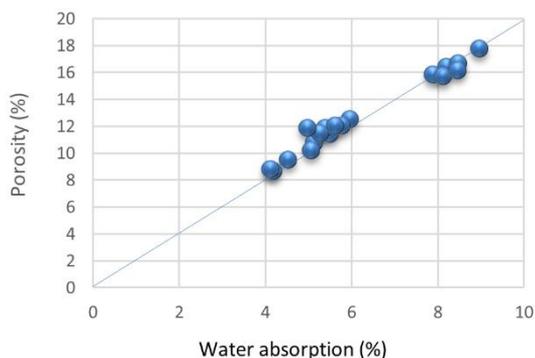
Fig. 12 Water absorption vs. Porosity

The graph of water absorption versus porosity is plotted considering all concrete mix at all temperatures as shown in Fig.12. The porosity of concrete is linearly proportional to water absorption [25]. Therefore, increase in porosity increases water absorption due to increase in total pore volume of concrete. Similar results were reported by Karahan et al. [12] for concrete using slag with the porosity values varying between 9.3–11.0% at 20°C, 10.4–11.7% at 400°C, and 16.2–17.4%, at 800°C, and water absorption varied between 4–4.5% at 20°C, 4.5–5.5% at 400°C, and 7.5–8.5%, at 800°C, respectively.

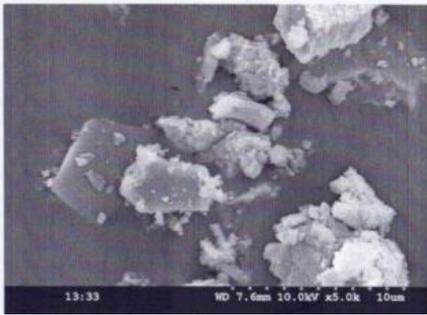
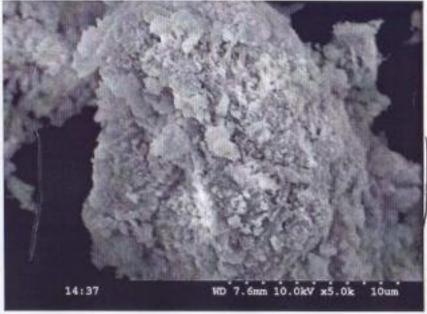
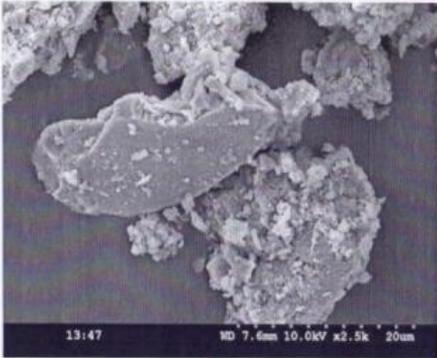
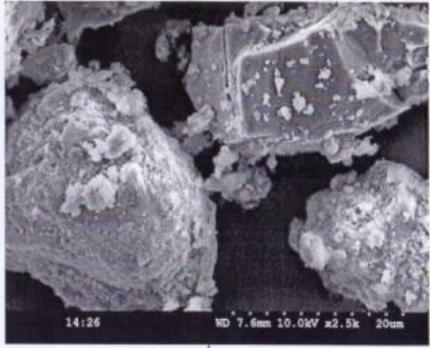
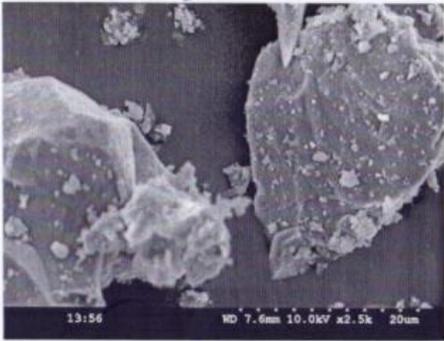
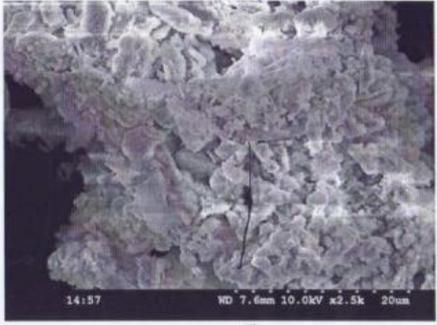
Table 5. SEM images of different concrete mixes

Microstructural analysis using SEM examinations of concrete specimens revealed distinct morphological changes as a result of exposure to high temperatures [27]. At 400°C, the concrete matrix appeared coarser and no ettringite was detected [28]. On concrete specimens heated to 400°C & 800°C, microcracks and voids are identified as shown in Table 5. The CH disintegrated at 800°C, resulting in a porous concrete matrix [28]. The microstructure seemed to be very porous in comparison to specimens heated to 400 °C, and porosity increased with concrete grade. Wide voids were noticeable in many areas of the M6AlNs mix concrete specimens as shown in Table 5. The number of voids in Al + NS mixes was higher than control mixes which is consistent with the strength characteristics and durability test results provided above. Due to voids, microcracks, and partially deteriorated CSH, concrete specimens subjected to 800°C showed substantial modifications in the micro - structural of the concrete [29]. As a result, the microstructure of the concrete deteriorated, affecting its strength and durability. Arioz et al. [29] and Handoo et al. [27] investigated the microstructures of concrete specimens exposed to 800°C and found similar results.

- According to microstructural analysis, the percentage of voids increased and became wider as the temperature rose. As a result, the microstructure of the concrete deteriorated, affecting its strength and durability.
