## Evaluation of the physical and mechanical properties of pressed blocks and Caramelo blocks used in infill masonry for framed structures

Concrete blocks;  
Compressive strength;  
Water absorption;  
Infill masonry;  
Construction costs

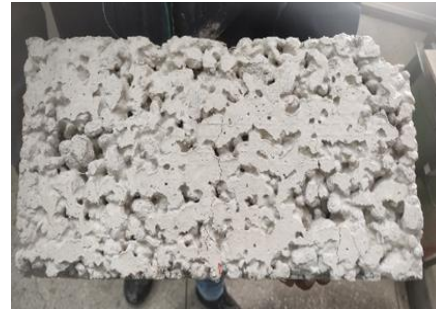
guarantees dimensional uniformity, lower porosity, and greater compressive strength; while the latter, made manually with metal or plastic molds, present geometric irregularities, greater absorption, and strengths below regulatory values [4]. This productive heterogeneity has a direct impact on the quality of the infill masonry, which must maintain sufficient stability against service loads and deformations imposed by the structural framework [5].

Fig 2. Caramelo Block

The pressed blocks (Fig 1) have much better visual appearance than the caramelo block (Fig 2), especially in the dimensions, regular surface, and chipping established in the standard [16]. The caramelo blocks have surface voids and irregular edges; the comparison between the two is shown in Table 4.

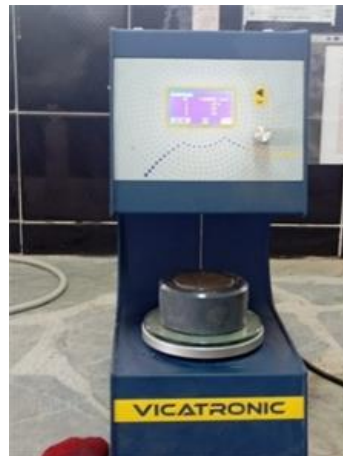
Fig. 6 shows the cement consistency test using the Vicat method, resulting in a setting time of 318 minutes according to [25]

Fig. 6. Setting test using the Vicat method

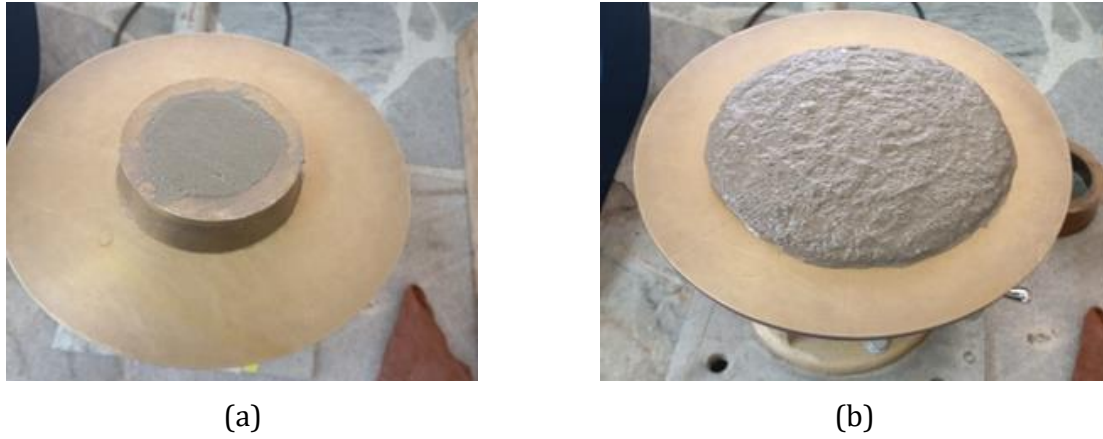
A mortar flow test was performed [26], yielding a flow of 108 %, establishing the dosage: 1:2.75 (cement:sand) by mass with a water/cement ratio of 0.485 (Fig 7). Based on these results, 12 mortar cubes (Fig 8) with dimensions of 50mm x 50mm x 50mm were prepared and tested to determine their compressive strength in accordance with [27]. The cubes were divided into four groups of three specimens and tested in compression at ages of 1, 3, 7, and 28 days, following the requirements of [22]. For each age, the mean compressive strength of the three cubes was reported.

Fig. 7. Mortar flow test (a), Mortar in mold (b) Mortar on fluidity table

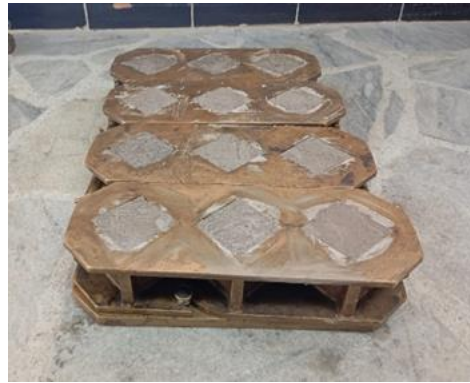
Fig. 8. Mortar cubes in mold

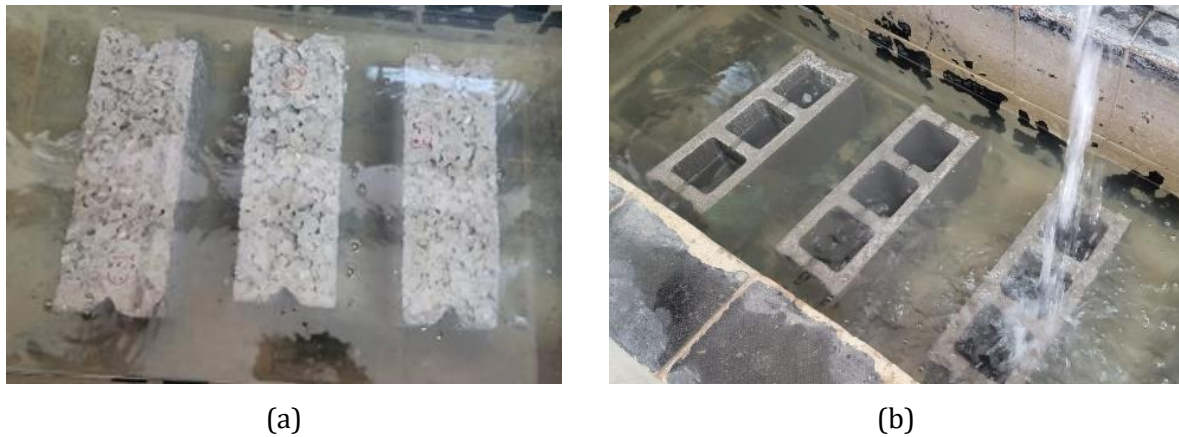
- Dimension Measurement: Three blocks of each type were used, according to [16].
- Water Absorption Tests: The three blocks of each type (Fig 10) were tested, according to [16].

Fig. 10. Water Absorption Test on Blocks (a) Caramelo block and (b) Pressed block

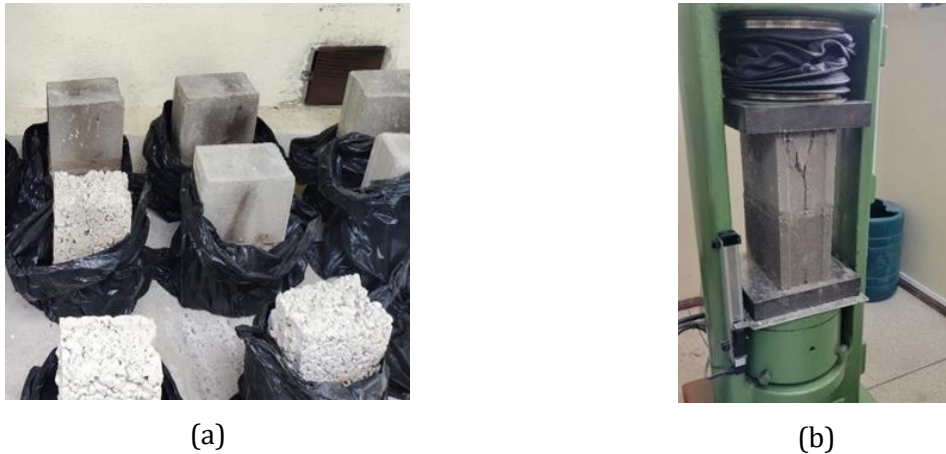
The walls constructed with pressed blocks had a width of 24.8 cm and a total height of 41.5 cm, corresponding to a height-to-width ratio ( $h/b$ ) of 1.67. Low walls made of caramelo blocks had a width of 24.6 cm and a height of 39.0 cm, with an  $h/b$  ratio of 1.59. These dimensions and proportions are consistent with the model of perforated unit walls specified in [17]. Due to the limitations of the testing machine, the blocks were cut following the geometric requirements of the standard, to preserve the configuration of the wall before carrying out the compression tests (Fig. 13).

Fig. 13. Compressive Strength Test of Low Walls (a) Low walls and (b) Compression test of low walls

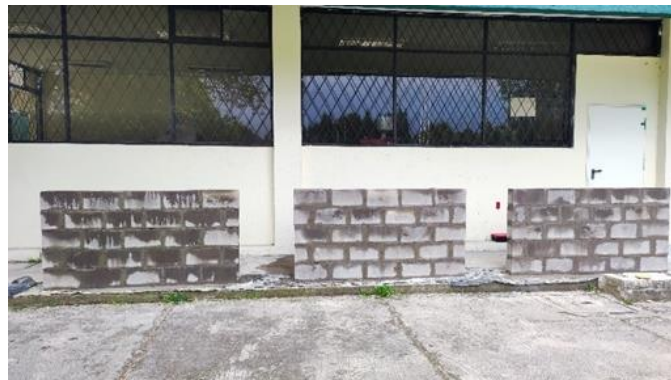
To evaluate the construction and economic performance of the masonry units, three panels of approximately  $2 \text{ m}^2$  were built for each block type (caramelo and pressed), with 25 blocks per panel, as shown in Fig. 14. The area of approximately  $2 \text{ m}^2$  was selected because it provides a sufficiently representative surface area for the behavior of a masonry wall in construction and, at the same time, allows for more reliable quantification of material consumption and construction time per unit area. Constructing three panels per block type is aimed to introduce variability in the construction process and obtain more robust average consumption and yield values. Subsequently, both sides of the panels were plastered (Fig. 15). The plastering mortar was applied with a 1:4 dosage (cement:sand, by mass) and an average thickness of 1.5 cm, a value that is within the range usually used in construction practice in Ecuador (0.5–2.0 cm), and which corresponds to the most commonly used thickness to achieve a uniform surface in enclosure walls.

Fig. 14. Pressed block masonry

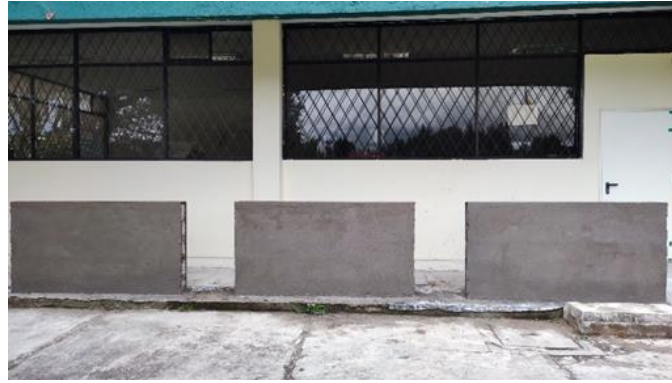
Fig. 15. Plastered Pressed Block Masonry

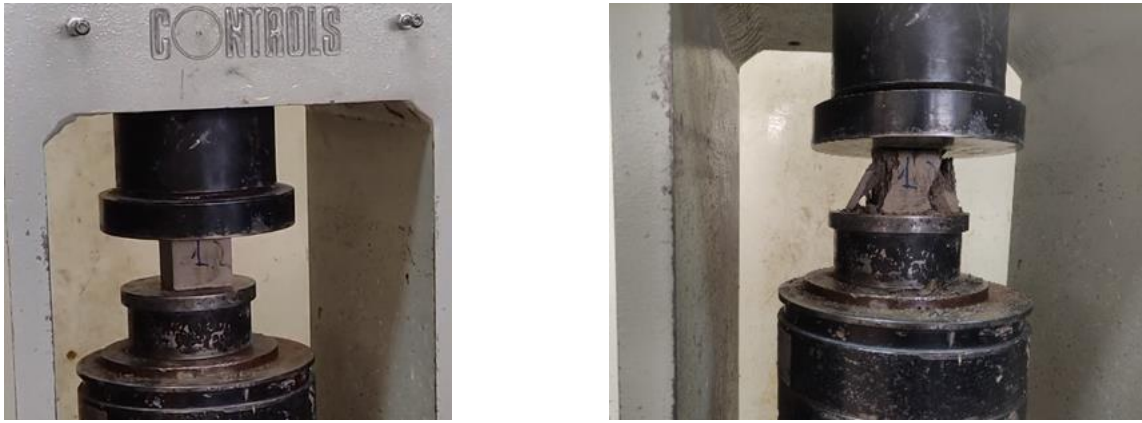
The compressive strength of mortar cubes (Fig 16) was tested in three samples at different ages (1, 3, 7, and 28 days). The results for 3, 7, and 28 days of age exceeded the minimum requirements established by the standard [22], as shown in Figure 17. There is no minimum age requirement for 1 day; however, the standard requires the test to be performed.

Fig 16. Compressive strength test of mortar cubes
