## Performance of cement–clay interlocking hollow brick masonry walls with grout and vertical reinforcement

Cement–clay  
interlocking bricks;  
Hollow masonry walls;  
Diagonal compression;  
Vertical reinforcement;  
Grout infill

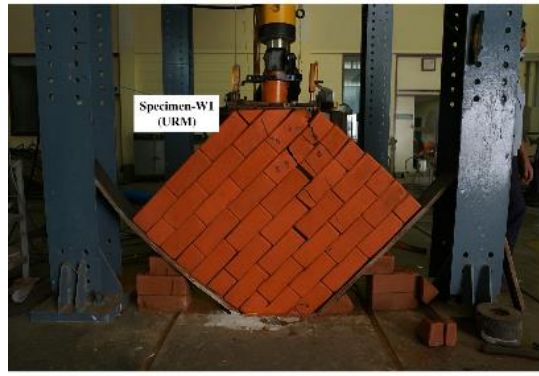
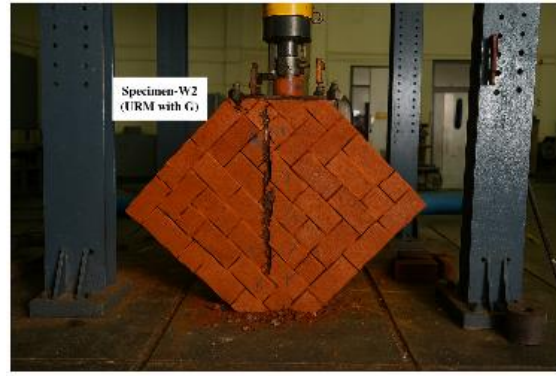
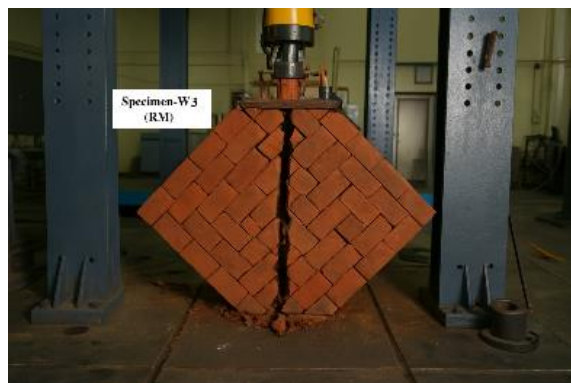
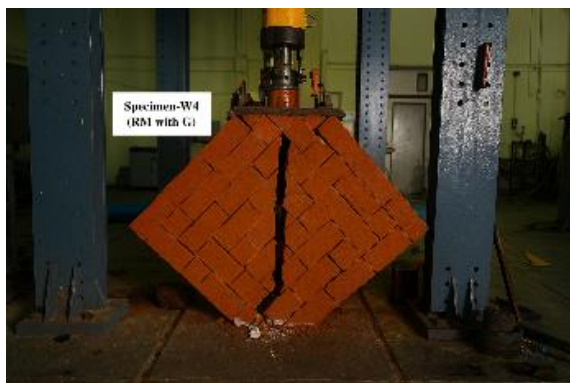
Fig. 6. Representative cracking patterns and failure modes of W1–W4 specimens (a) W1 – URMW, (b) W2 – URMW – G (c) W3 – RMW and (d) W4 – RMW – G

The cracking pattern and the failure mode of the masonry wall specimens of which were tested present very important details about the mechanisms of shear resistance and deformation behavior of the load masonry walls under through-thick diagonal compression. The nature of failures of the reported four configurations namely unreinforced ungrouted (W1), unreinforced grouted (W2), reinforced ungrouted (W3) and reinforced grouted (W4) was captured in Table 5 and shown in figure 7.

The wall of ungrouted and unreinforced construction (W1) exhibited brittle failures, with only a single and well-defined diagonal crack taking the load through one corner that was load-free to the far constrained corner. When the peak load was attained the crack propagated very quickly and the loss of load-carrying capacity was abrupt. The results that were found showed minimal crushing of the brick units meaning that tensile failure of the masonry led the response.

Conversely, the grouted wall was unreinforced (W2) and it displayed several diagonal and stepped cracks which were evenly spread throughout the panel. Internal restraint given by the grout cores slowed down coalescence of cracks and the formation of a single dominant plane of failure. A more ductile failure mode was achieved and post-peak energy dissipation was enhanced due to localised

crushing of masonry in areas of maximum compressive stress that tend to be found around grouted zones. The increase in the crack distribution in W2 was also an additional factor leading to the increase in load-bearing capacity over W1.

Reinforced ungrouted wall (W3) developed cracks in the diagonal pattern that resembled W1, with the cracks being stepped in the order, followed partially in the mortar joints. The onset presence of the vertical steel reinforced increased the load carrying capacity after a crack and as the reinforcement crossed the cracks the rebars provided dowel action. This meant more moderate appliance of an appliance after peak and better crack control than using W1. Nonetheless, without grout, the reinforcement could not play its roles in limiting the opening of the cracks and sharing the stresses to the fullest capacity.

Reinforced grouted wall (W4) exhibited the best crack pattern and mode of failure of the specimens. A network of diagonal cracks was well distributed over the panel besides splitting cracks around the grouted cores which reveal that there was effective transfer of load among the grout, reinforcement, and units' masonry. The crushing of the brick work was observable near the

load corners as well as the zone of compression struts indicating a possible equal proportion of tensile cracking and compression crushing to cause failure. The comprehensive effect of grout reinforcement improved the shear strength and energy-dissipation ability of the wall besides shrinking large crack gaps and sudden collapse.
